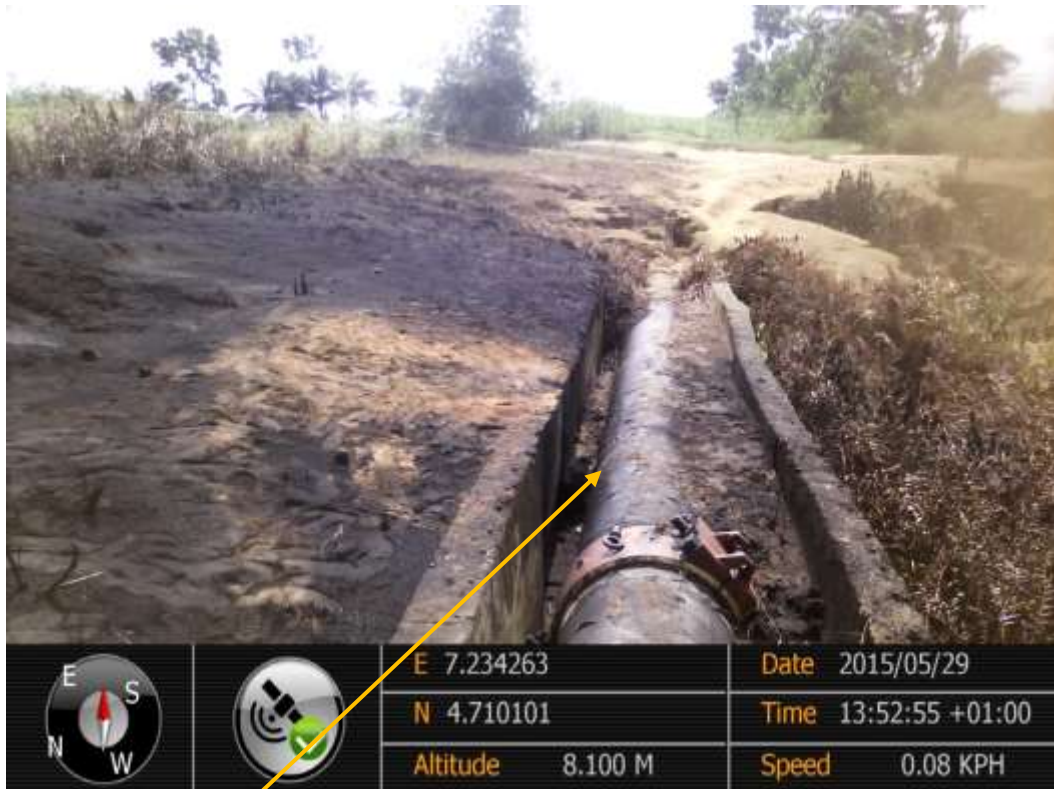
Overview: Location of spill point on 28" Nkpoku-Bomu Pipeline Right of Way at Kpoghor. Picture was taken during Joint Investigation of 29th May 2015.

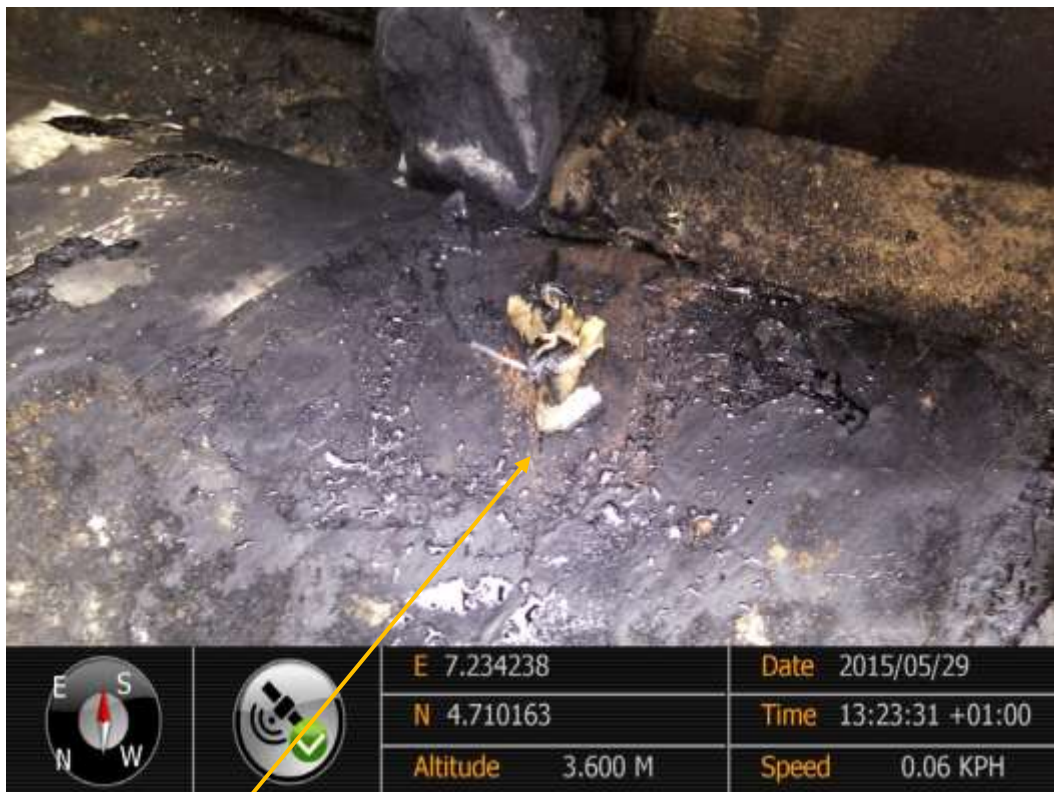
Close-up: Hacksaw cut on 28" Nkpoku-Bomu Pipeline at Kpoghor. Picture was taken during Joint Investigation of 29th May 2015.
