# JOINT INVESTIGATION REPORT

INCIDENT NO: 1399526 JIV report S/N: Nº 0000114

1. Spill incident Number: 1399526 2. Type of incident\* Oil Spill  
3. Name of Location 12" IMO RIVER 2 - OGALE TNP OWAZA  
4. Name of nearest community OWAZA 5. State: ABIA 6. LGA LIKWA WEST.  
7. Type of Production facility/Installation OIL PIPE LINE  
8. Asset owner/District PIPE LINE EAST, SHELL PETROLEUM DEVELOPMENT COMPANY OF NIG. LTD.

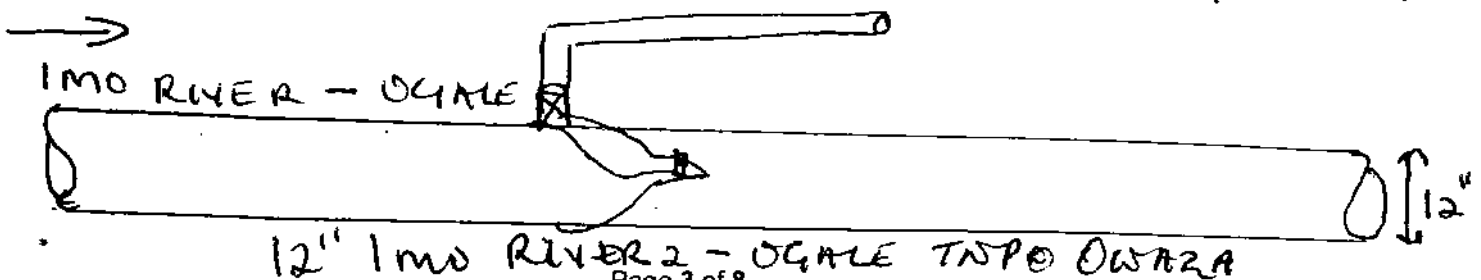
Additional observations around the spill point: ONE ANCHOR PIPE ATTACHED TO THE LINE AT 12:00 CLOCK POSITION

SECTIONAL VIEW OF IMO RIVER 2 - OGME TRANS NIGER PIPELINE @ OWAZA SHOWING: ILLEGAL CRUDE OIL THEFT POINT.

ONE INCH PIPE ILLEGALLY INSTALLED ON THE LINE IN 12:00 CLOCK POSITION.

BUNKERING INSTALLATION WAS REMOVED AND REPAIR WORK WAS SUCCESSFULLY CARRIED OUT.
