# JOINT INVESTIGATION REPORT

INCIDENT NO: 1858269 JIV report S/N: 0912

1. Spill incident Number: 1858269 2. Type of incident\* OIL SPILL  
3. Name of Location 20" KOLO CREEK - RUMUEKPE PIPELINE  
4. Name of nearest community ODAU/OZOCHI 5. State: RIVERS 6. LGA ABUJA/ODUAL/AHOADA-EAST  
7. Type of Production facility/Installation OIL PIPELINE  
8. Asset owner/District THE SHELL PETROLEUM DEVELOPMENT COMPANY OF NIGERIA LIMITED / PIPELINE

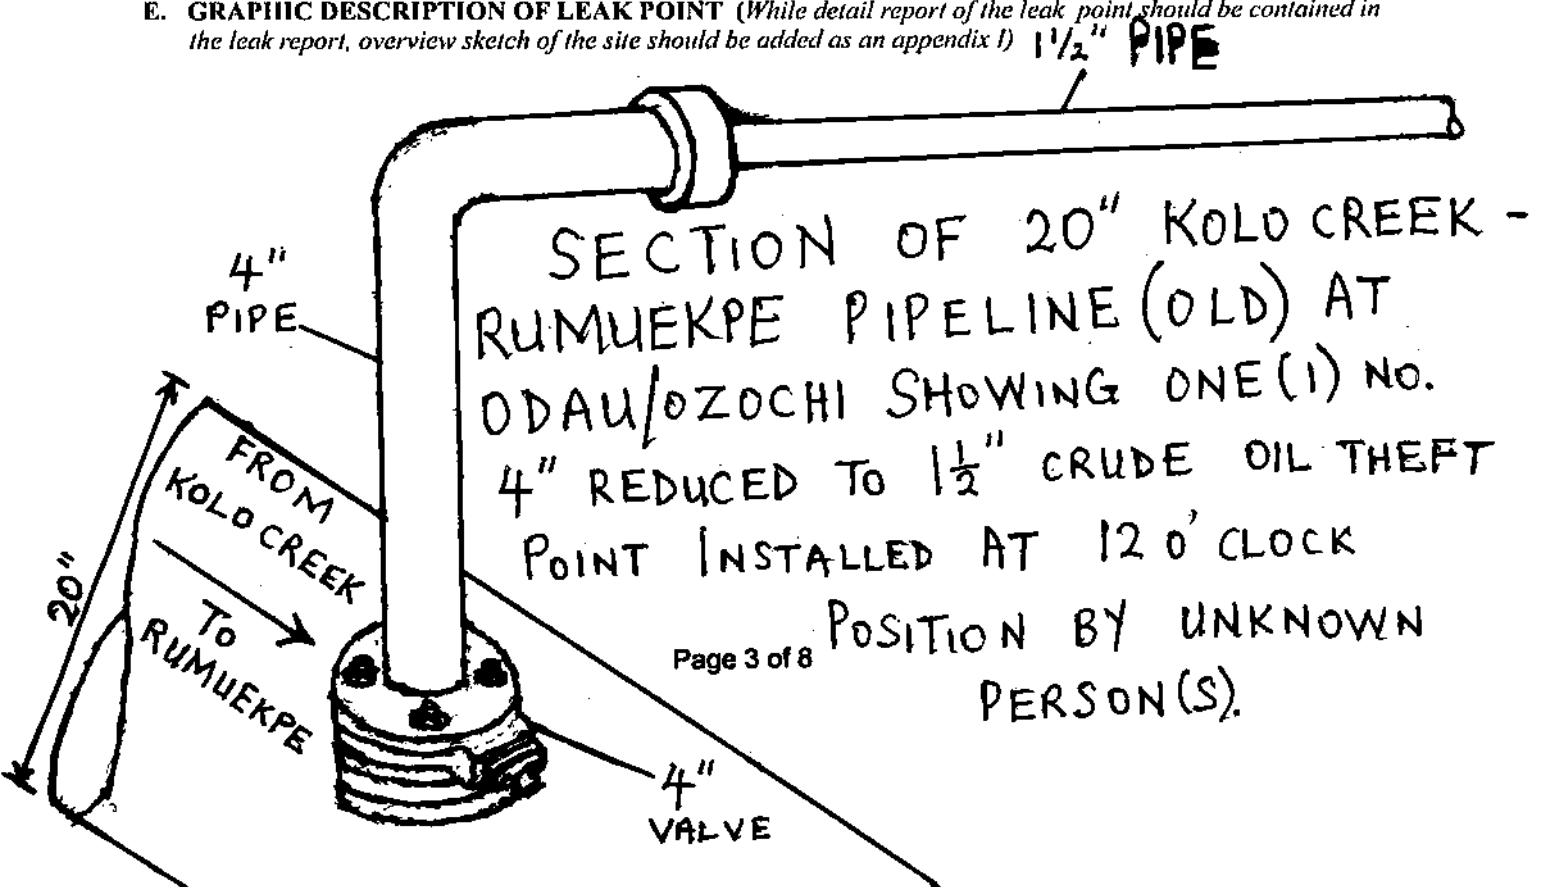
**E. GRAPHIC DESCRIPTION OF LEAK POINT** (While detail report of the leak point should be contained in the leak report, overview sketch of the site should be added as an appendix I)

Additional observations around the spill point: **AN ILLEGAL PIPE CONNECTION WAS OBSERVED RUNNING FROM THE SPILL POINT INTO THE SURROUNDING FOREST. WITHIN THE VICINITY OF THE SPILL POINT WAS ANOTHER SPILL POINT FOR A RECENT INCIDENT (REFERENCE ID 1969308).**

| <input checked="" type="checkbox"/> Crude oil theft (illegal bunkering) point, | <input type="checkbox"/> Saver-pit over flow | <input type="checkbox"/> Third party tampering with Clamp |

REPAIR WAS DONE TEMPORARILY BY BLIND-FLANGING AND INSTALLING RESTRICTION AT THE CRUDE OIL THEFT POINT.
