THE SHELL PETROLEUM DEVELOPMENT COMPANY OF NIGERIA LIMITED

JOINT INVESTIGATION REPORT FOR INCIDENT NO: 0146 737791

1. Spill incident Number: 737791 2. Type of incident* SPILL
 3. Name of Location 14" OKORDIA - RUMUEKPE PIPELINE
 4. Name of nearest community IKARAMA 5. State: BAYELSA 6. LGA YENAGOA
 7. Type of Production facility/Installation OIL PIPELINE 8. Asset owner/District NESP/LAND 2

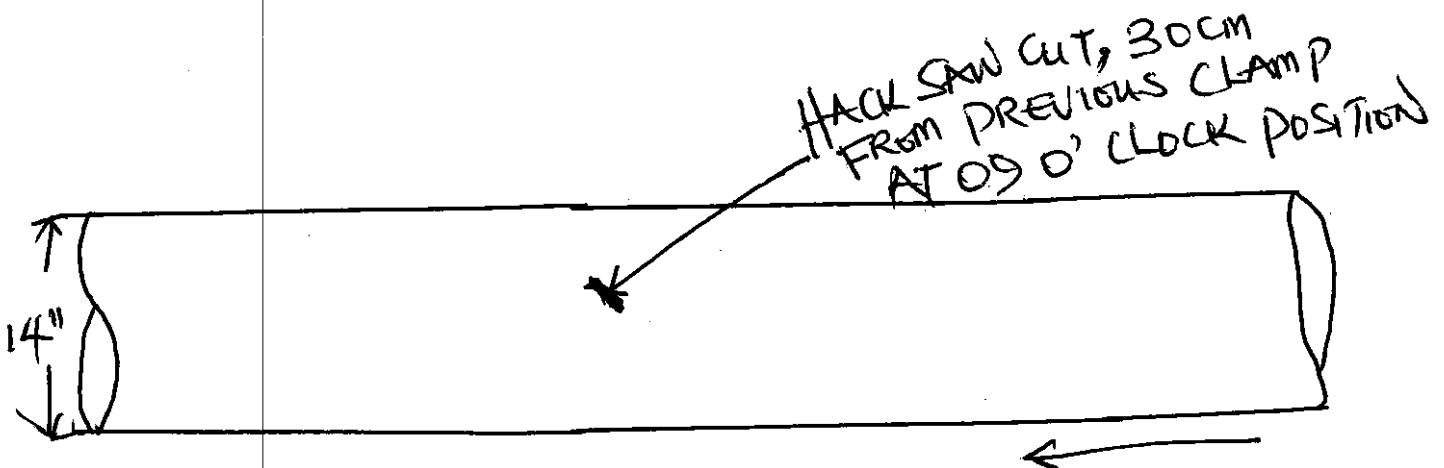
E. GRAPHIC DESCRIPTION OF LEAK POINT (Overview sketch of the site should be added as an appendix)

- Drilled hole Hack saw cut Explosive tear,
 Complete Rupture Inward dent, Well head tampering
 Failed Weld-on illegal hot tap valve, Missing Pipeline/Flowline)
 Crude oil theft (illegal bunkering) point, Third party tampering with Clamp
 Third party tampering with valve setting, Third party tampering with flange,
 External Corrosion Internal Corrosion
 Saver-pit over flow, Surge vessel overflow, Outward dent
 Flare System/Bund wall Failure Valve Failure com unit failure
 Cold vent Relief valve failure Others (specify) _____

A SECTION OF 14" OKORDIA - Rumuekye PIPELINE SHOWING HACK SAW CUT AT 09 O'CLOCK POSITION
