Overview: Part of spill impact on Awoba Well8T flowline at Bille. Picture was taken during Joint Investigation of 6th December, 2011.

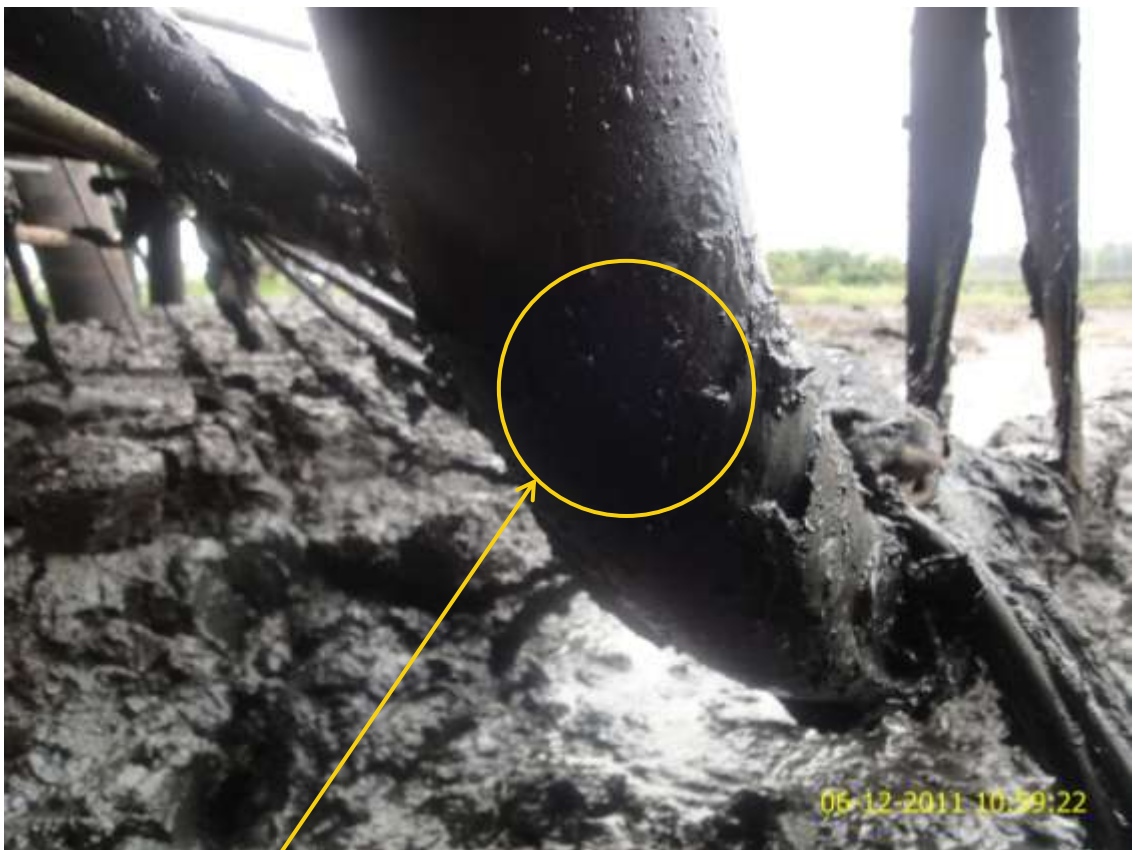
Close-up: Approximate location of pinhole due to corrosion on Awoba Well8T flowline riser at Bille. Picture was taken during Joint Investigation of 6th December, 2011.
