THE SHELL PETROLEUM DEVELOPMENT COMPANY OF NIGERIA LIMITED

JOINT INVESTIGATION REPORT FOR INCIDENT NO: 0168 746463

1. Spill incident Number: 2011-746463 2. Type of incident* OIL SPILL
 3. Name of Location 12" MID RIVER - OGALE PIPELINE
 4. Name of nearest community OWAZA 5. State: ABIA 6. LGA UKWA-WEST
 7. Type of Production facility/Installation OIL PIPELINE 8. Asset owner/District NPE/PH2

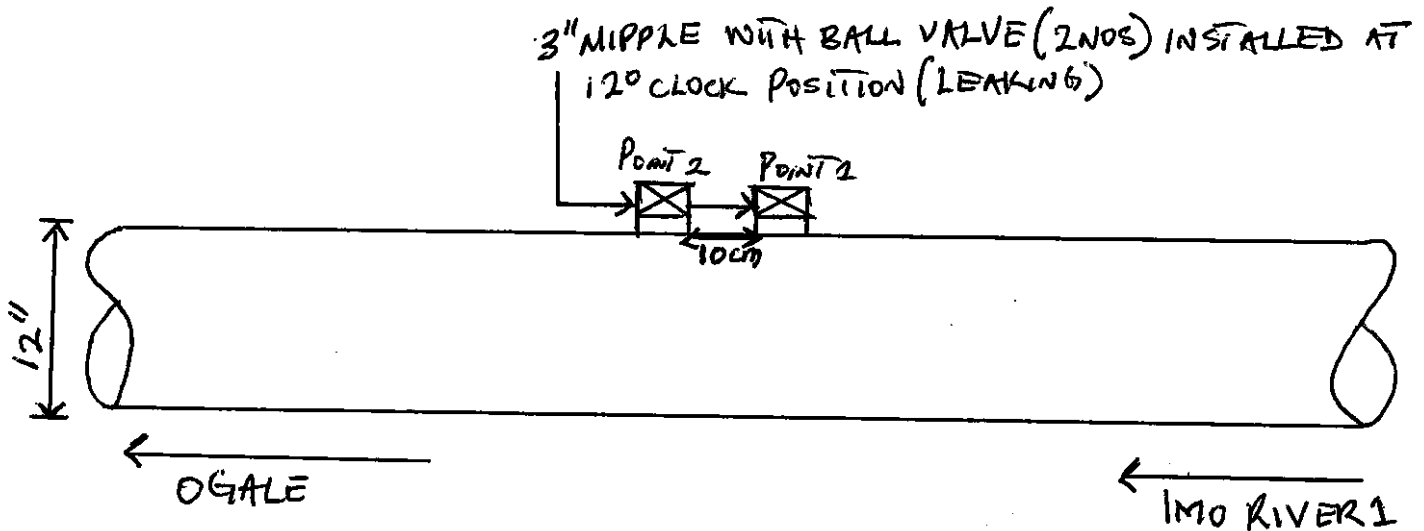
E. GRAPHIC DESCRIPTION OF LEAK POINT (Overview sketch of the site should be added as an appendix 1)

d. Description of leak point (tick as applicable);
 Drilled hole Hack saw cut Explosive tear,
 Complete Rupture Inward dent, Well head tampering
 Failed Weld-on illegal hot tap valve, Missing Pipeline/Flowline
 Crude oil theft (illegal bunkering) point, Third party tampering with Clamp
 Third party tampering with valve setting, Third party tampering with flange,
 External Corrosion Internal Corrosion
 Saver-pit over flow, Surge vessel overflow, Outward dent
 Flare System/Bund wall Failure Valve Failure com unit failure
 Cold vent Relief valve failure Others (specify) NOT APPLICABLE

SECTION OF 12" IMO RIVER 1 - OGALE PIPELINE AT DWAZA, SHOWING LOCATIONS OF 2 NOS CRUDE OIL THEFT FITTINGS INSTALLED AT 12° CLOCK POSITIONS.
