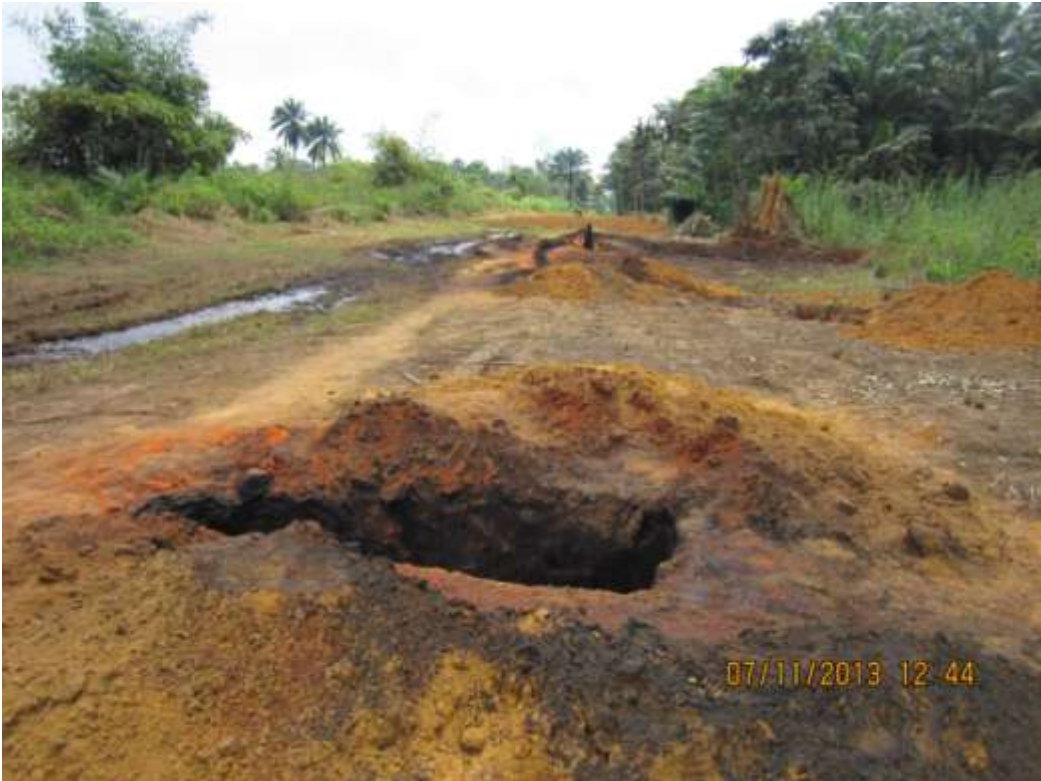
Overview: Part of spill/fire impact on 24" Bomu – Nkpoku Pipeline at Kpите. Picture was taken during Joint Investigation of 7th November 2013.

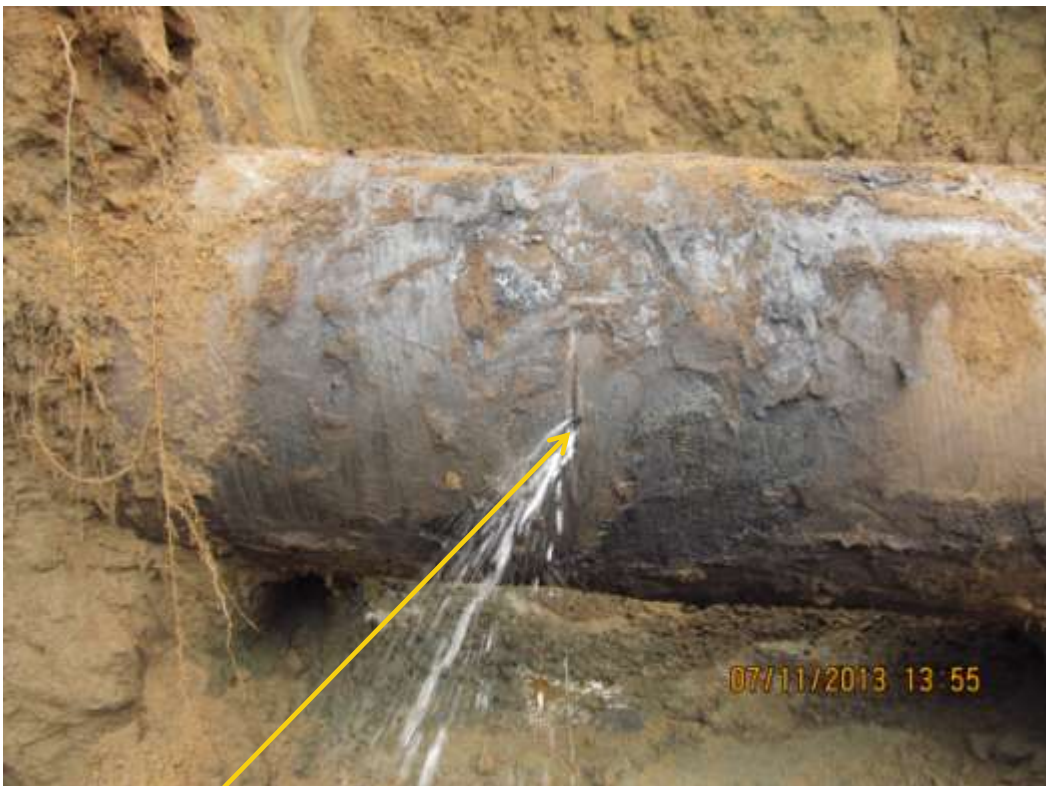
Close-up: Hacksaw cut on 24" Bomu - Nkpoku Pipeline at Kpите. Picture was taken during Joint Investigation of 7th November 2013.
