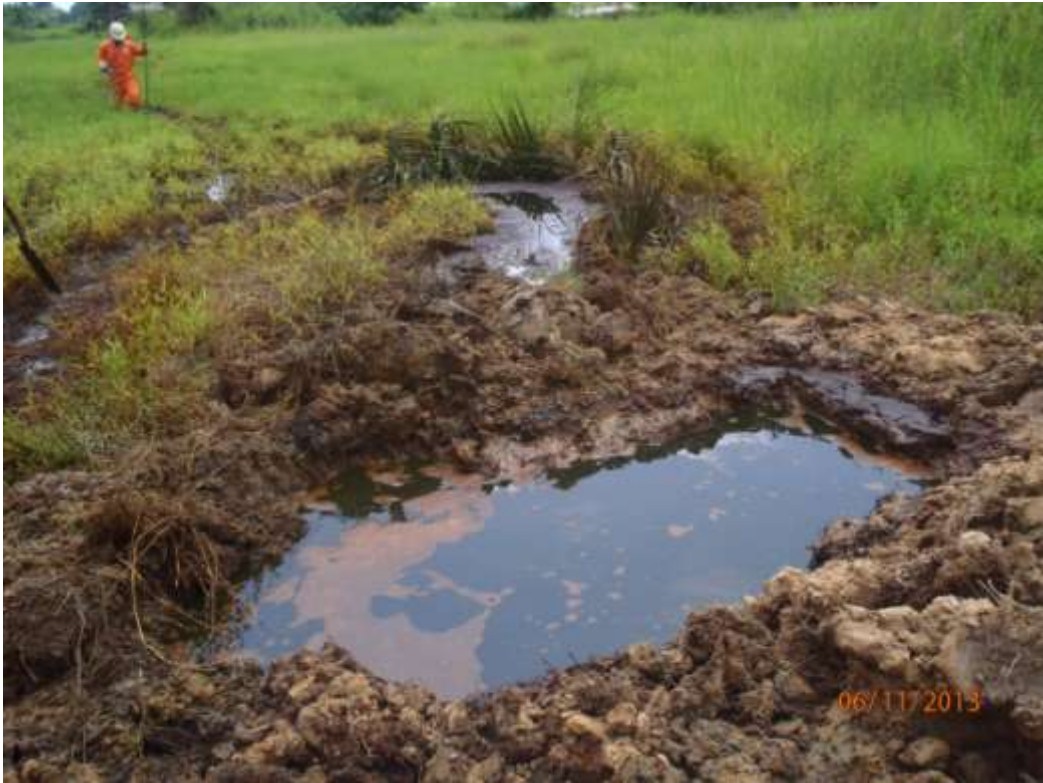
Overview: Part of spill impact on 14" Okordia-Rumuekpe Pipeline right of way at Ikarama. Picture was taken during Joint Investigation of 6th November 2013.

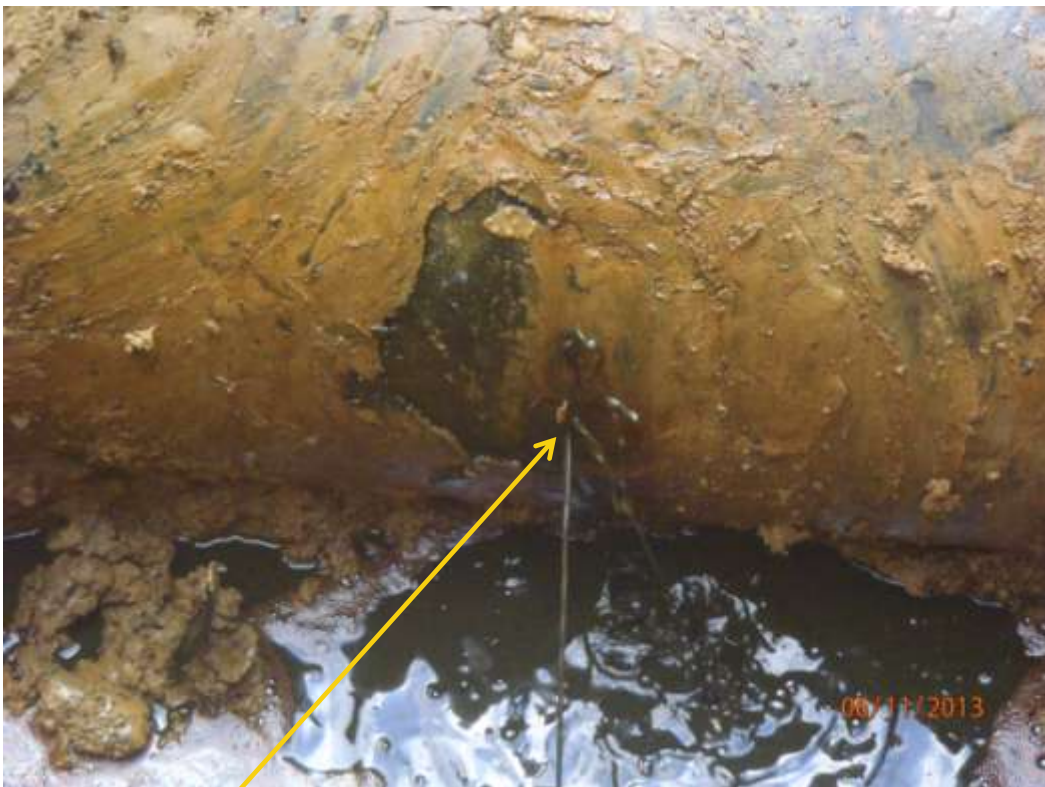
Close-up: Hacksaw cut on 14" Okordia-Rumuekpe Pipeline at Ikarama. Picture was taken during Joint Investigation of 6th November 2013.
