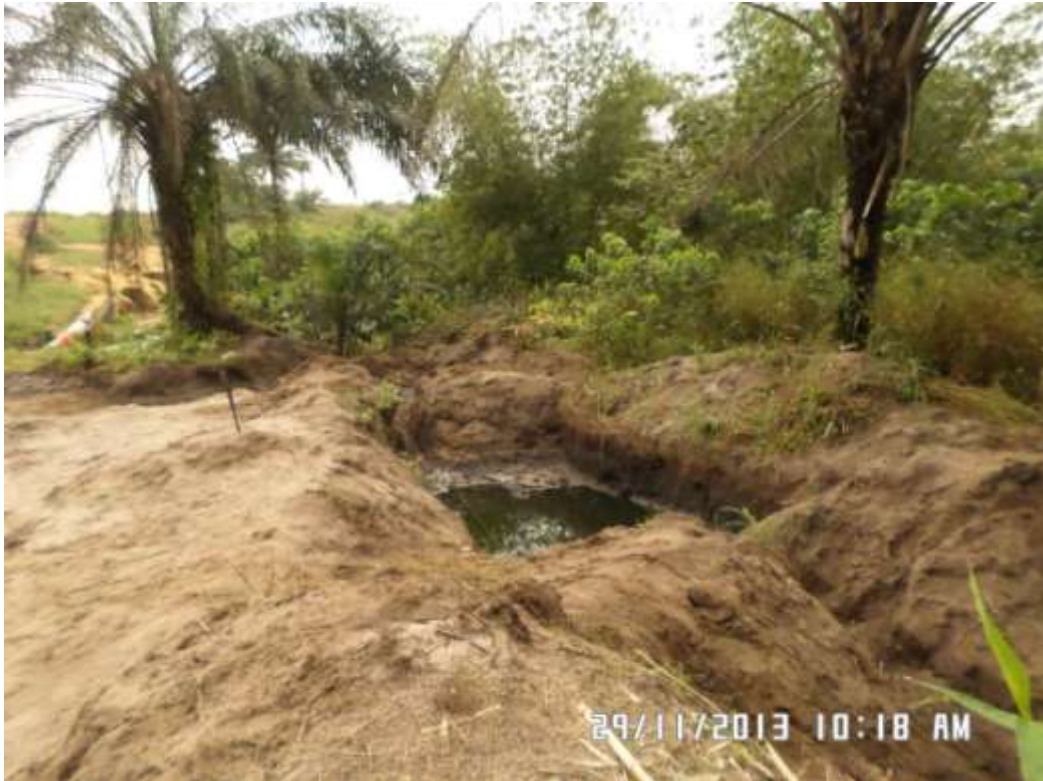
Overview: Part of spill impact on 28" Nkpoku-Bomu Pipeline at Gio. Picture was taken during Joint Investigation of 29th November 2013.

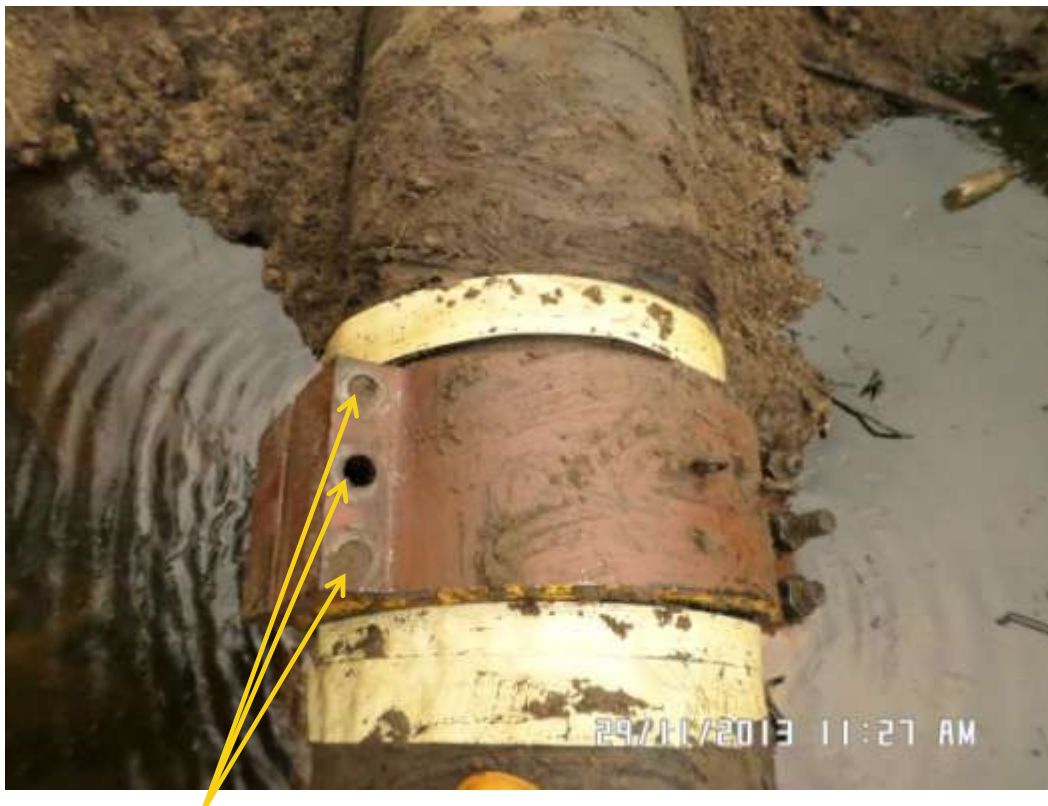
Close-up: Nuts removed from clamp on 28" Nkpoku-Bomu Pipeline at Gio. Picture was taken during Joint Investigation of 29th November 2013.
