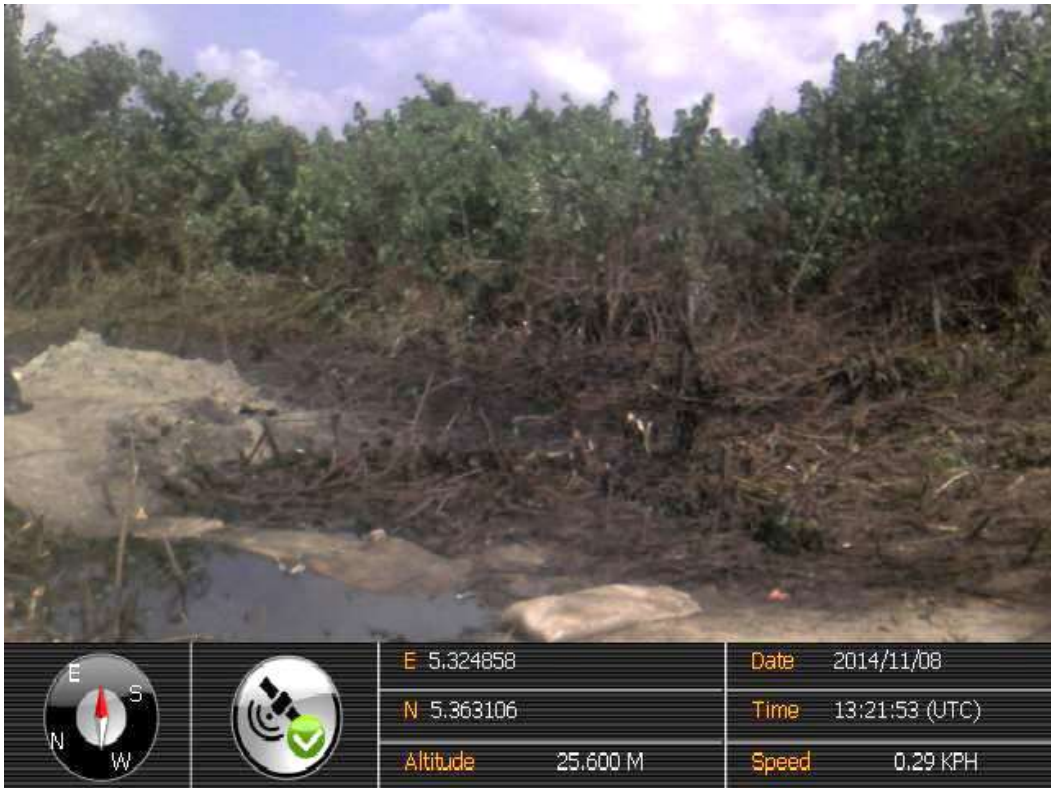
Overview: Part of spill impact on 12" Estuary LP Delivery line Right of Way at Youbebe. Picture was taken during Joint Investigation of 8th November 2014.

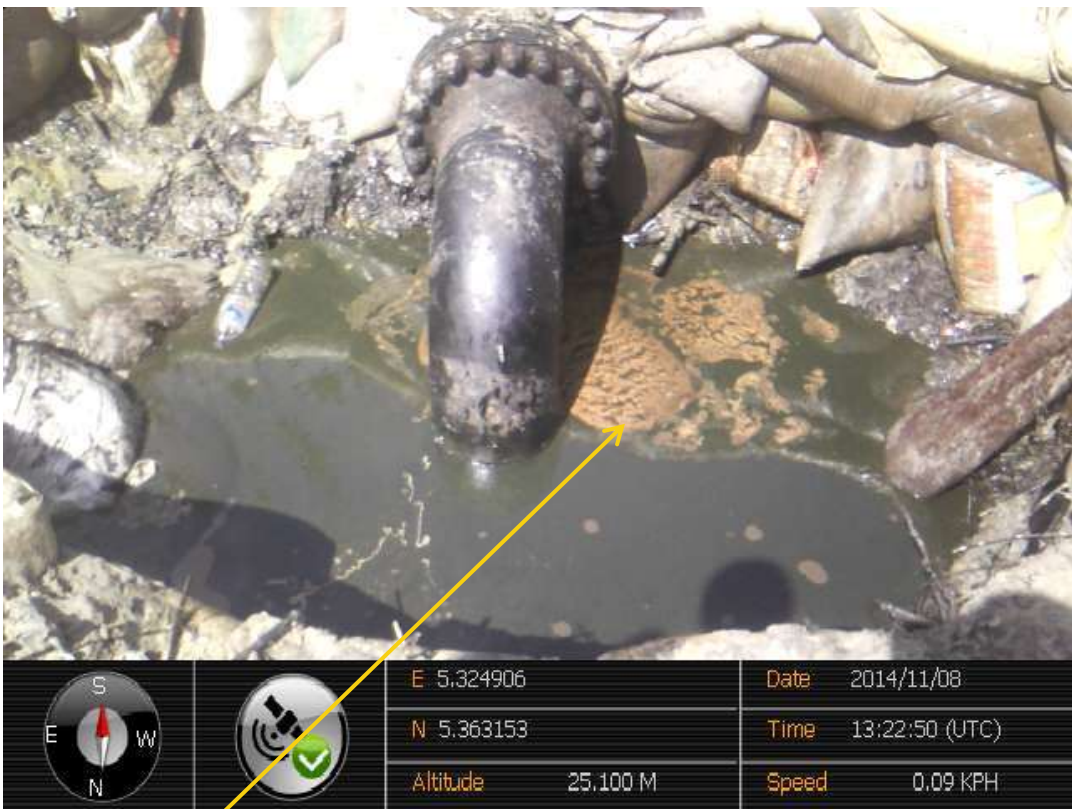
Close-up: Bubbling from corrosion on 12" Estuary LP Delivery line at Youbebe. Picture was taken during Joint Investigation of 8th November 2014.
