THE SHELL PETROLEUM DEVELOPMENT COMPANY OF NIGERIA LIMITED.

JOINT INVESTIGATION REPORT FOR INCIDENT NO: 1287226 JIV report S/N: 00796

1. Spill incident Number: 1287226 2. Type of incident* OIL SPILL
 3. Name of Location EKULAMA 2 WELL 24T FLOWLINE
 4. Name of nearest community FREETOWN (KULA) 5. State: RIVERS 6. LGA AKUKU-TORU
 7. Type of Production facility/Installation OIL FLOWLINE Asset owner/District SWAMP 2

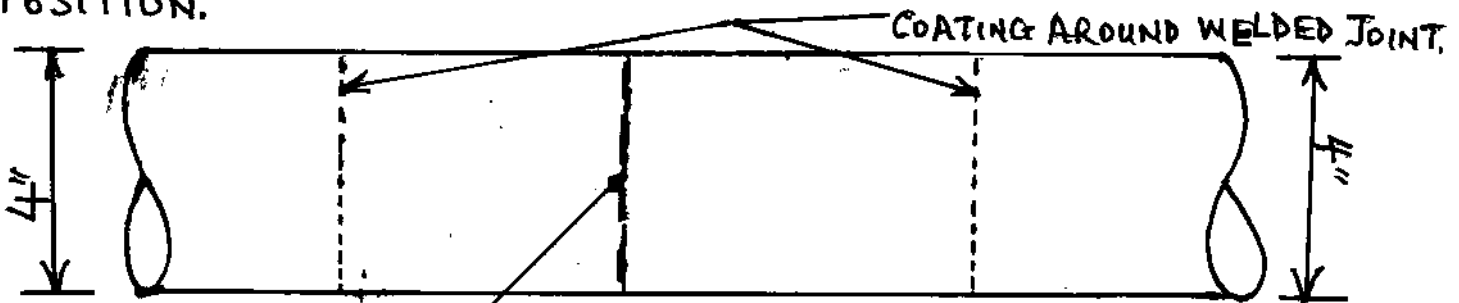
Additional observations around the spill point: ON FIRST DAY OF JOINT INVESTIGATION VISIT, BUBBLES WERE OBSERVED AT SPILL POINT ALONG A CHANNEL ON SWAMPY TERRAIN. ON EXPOSURE (BY EXCAVATION) OF AFFECTED FLOWLINE SECTION ON SECOND DAY OF JOINT INVESTIGATION VISIT, THE FLOWLINE COATING AROUND A WELDED JOINT WAS NOTICED UNTAMPERED WITH UPON REMOVAL OF THE SAID COATING BY THE JOINT INVESTIGATION TEAM TO ASCERTAIN SPILL CAUSE,

- e. Description of leak point (tick as applicable): LEAK WAS CONFIRMED DUE TO A FAILURE AT THE WELDED JOINT.
- | | | |

SECTION OF EKULAMA 2 WELL 24T FLOWLINE AT FREETOWN (KULA) SHOWING FAILURE AT WELDED JOINT (LEAK POINT) AT 3 O' CLOCK POSITION.

FAILED WELDED JOINT LEAK POINT AT 3 O' CLOCK POSITION.
