**THE SHELL PETROLEUM DEVELOPMENT COMPANY OF NIGERIA LIMITED.**

JOINT INVESTIGATION REPORT FOR INCIDENT NO: 1286248 JIV report S/N: 00626

1. Spill incident Number: 1286248      2. Type of incident\* OIL SPILL  
 3. Name of Location 6" YOKRI MANIFOLD - 7 TEST FLOWLINE  
 4. Name of nearest community YOKRI      5. State: DELTA      6. LGA BURUTU  
 7. Type of Production facility/Installation FLOWLINE      8. Asset owner/District SWAMP WEST/YOKRI

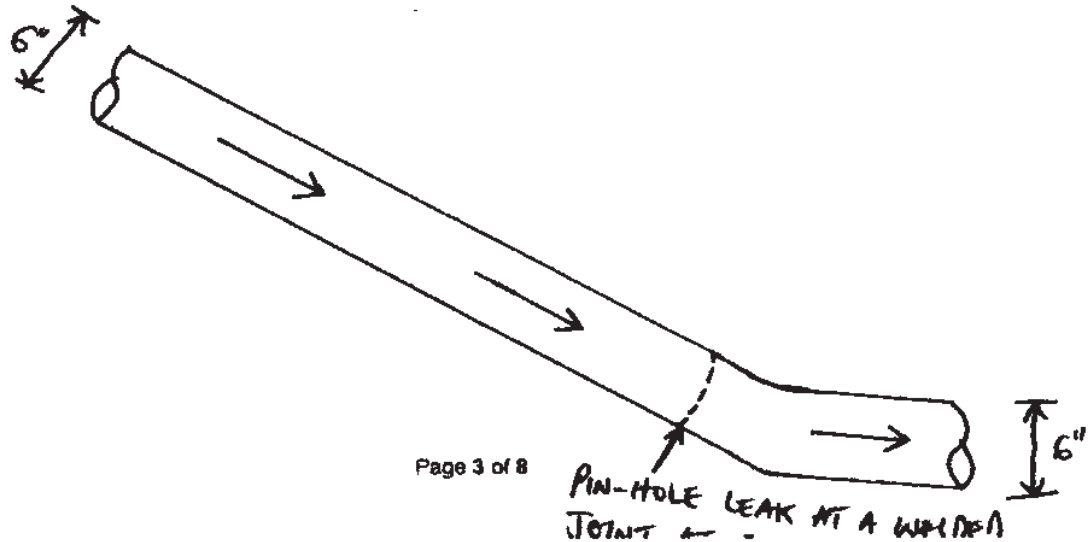
Additional observations around the spill point: UPON EXCAVATION, THE JIT OBSERVED A PIN-HOLE AT A WELDED JOINT ON THE 6" MANIFOLD-7 TEST FLOWLINE AT 6 O' CLOCK POSITION.

| <input checked="" type="checkbox"/> Corrosion ( <u>PIN-HOLE</u> ) | <input type="checkbox"/> Saver-pit over flow, | <input type="checkbox"/> Surge vessel overflow, |

SECTION OF YOKRI MANIFOLD-7 TEST FLOWLINE  
SHOWING; POSITION OF PIN-HOLE LEAK AT A WELDED JOINT

If yes to item 14, give brief description: REPAIR IS BEING PLANNED BY THE ASSET ENGINEERING TEAM.
