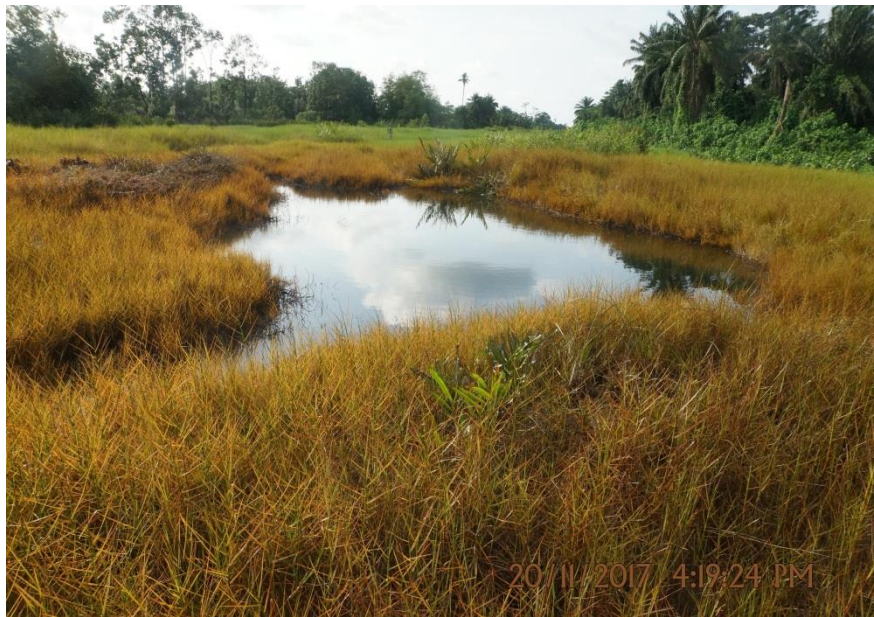
Overview: Part of spill impact on 8" Saghara Tie-in-Saghara Manifold at Ugboegungun. Picture was taken during Joint Investigation of 20th November 2017.

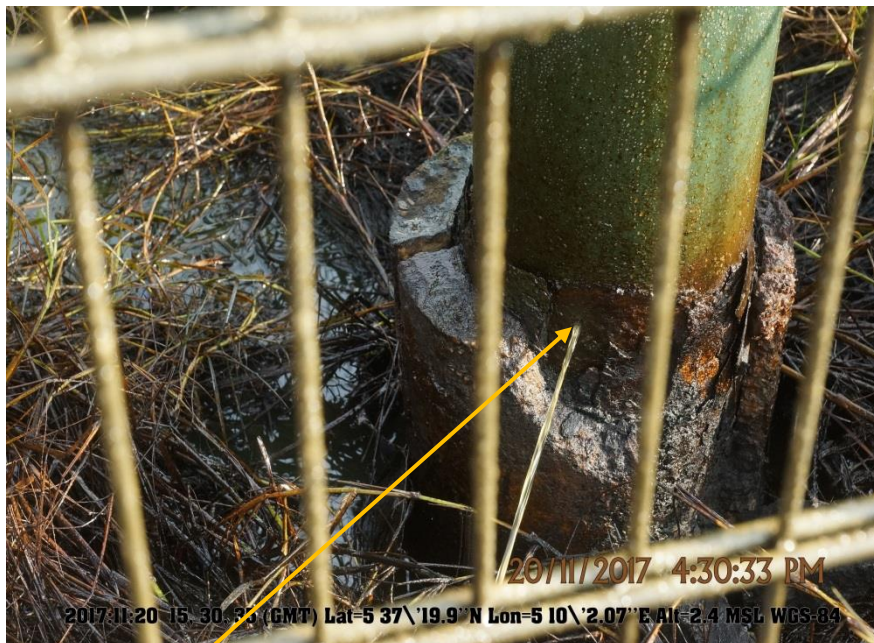
Close-up: Hole due to corrosion on 8" Saghara Tie-in-Saghara Manifold at Ugboegungun. Picture was taken during Joint Investigation of 20th November 2017.
