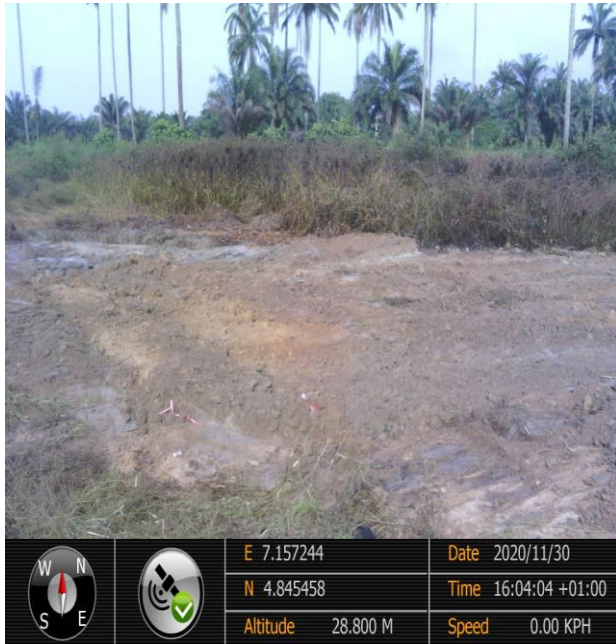
Overview: Part of spill impact on 12inch Imoriver 1 - Ogale Pipeline at Komkom.
 Picture was taken during Joint Investigation on 30th November 2020.

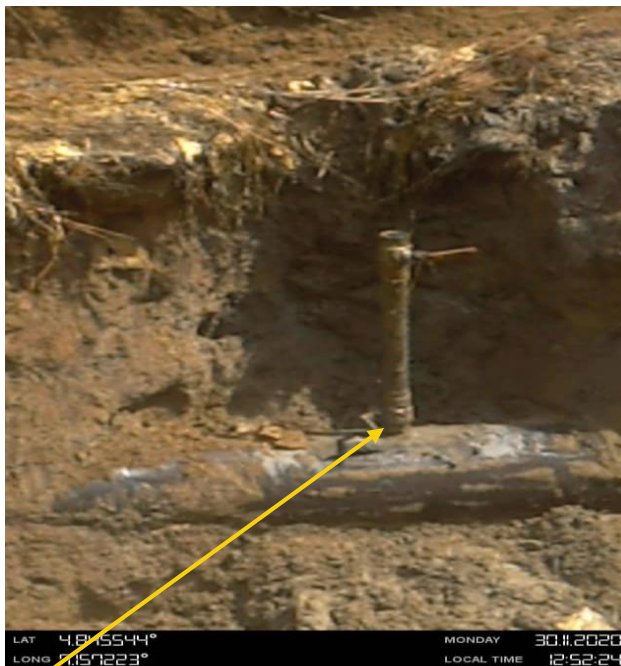
Close-up: 1.5inch pipe fitted with 2nos of 1.5inch valves installed at 12 o'clock position on 12''
 Imoriver 1 - Ogale Pipeline at Komkom.
 Picture was taken during Joint Investigation on 30th November 2020.
