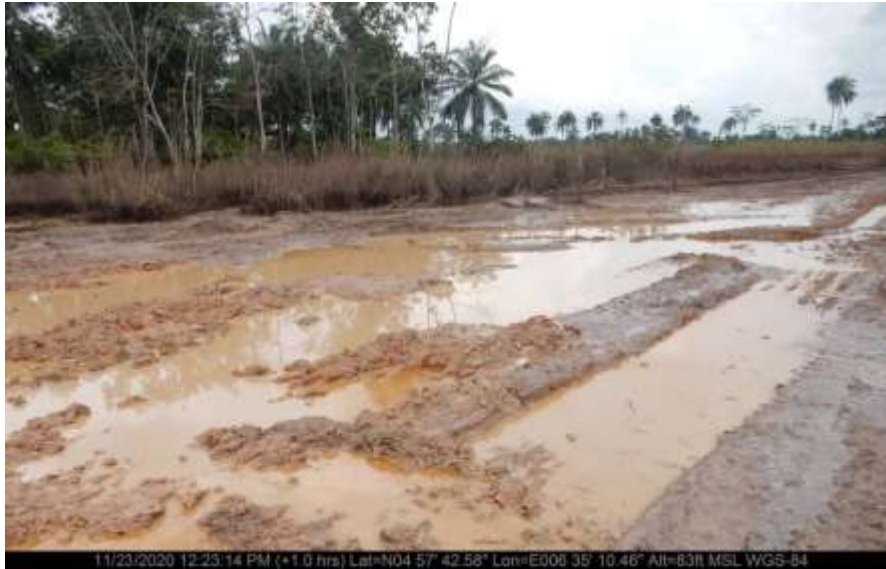
Overview: Part of spill impact on 20inch Kolocreek – Rumuekpe Trunkline at Owerewere. Picture was taken during Joint Investigation on 23rd November 2020.

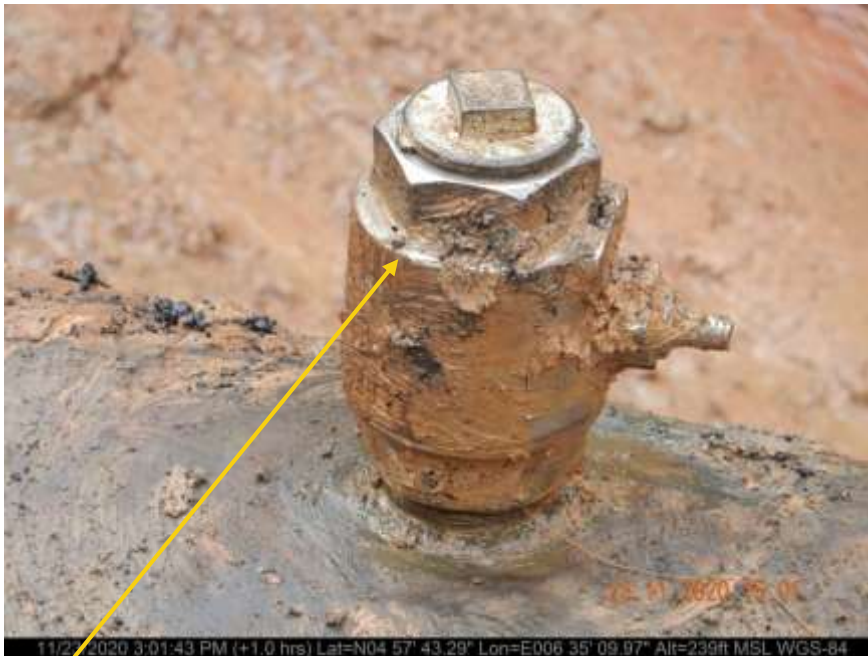
Close-up: 2inch valve installed at 12 o'clock position on 20inch Kolocreek – Rumuekpe Trunkline at Owerewere. Picture was taken during Joint Investigation on 23rd November 2020.
