Overview: Part of spill impact on 12inch Imoriver 1 - Ogale Pipeline at Umulolo.
 Picture was taken during Joint Investigation on 14th November 2020.

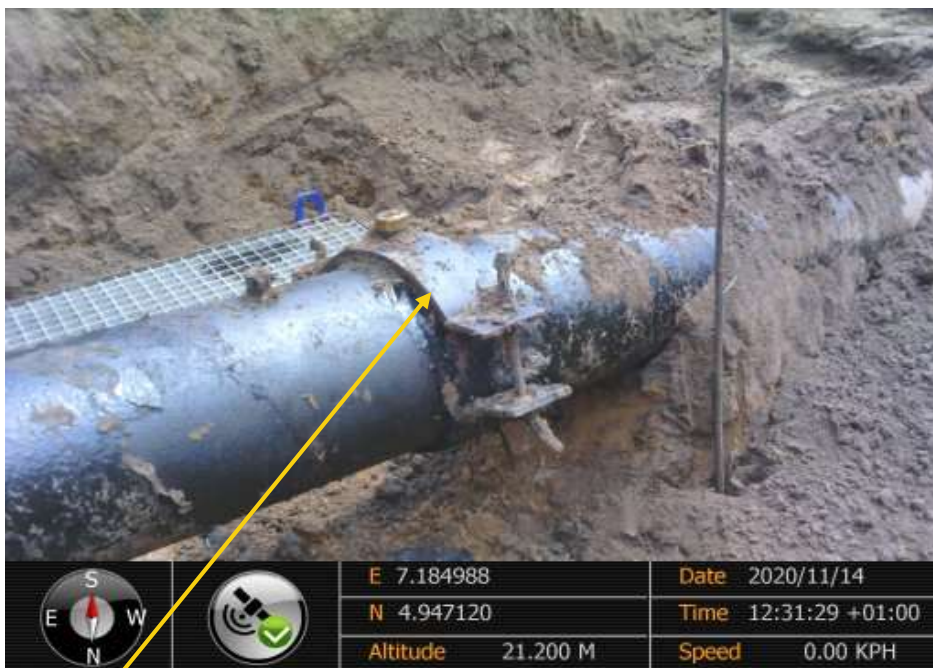
Close-up: Locally fitted clamp with 1.5inch valve installed at 12 o'clock position on 12inch Imoriver 1 - Ogale Pipeline at Umulolo.
 Picture was taken during Joint Investigation on 14th November 2020.
