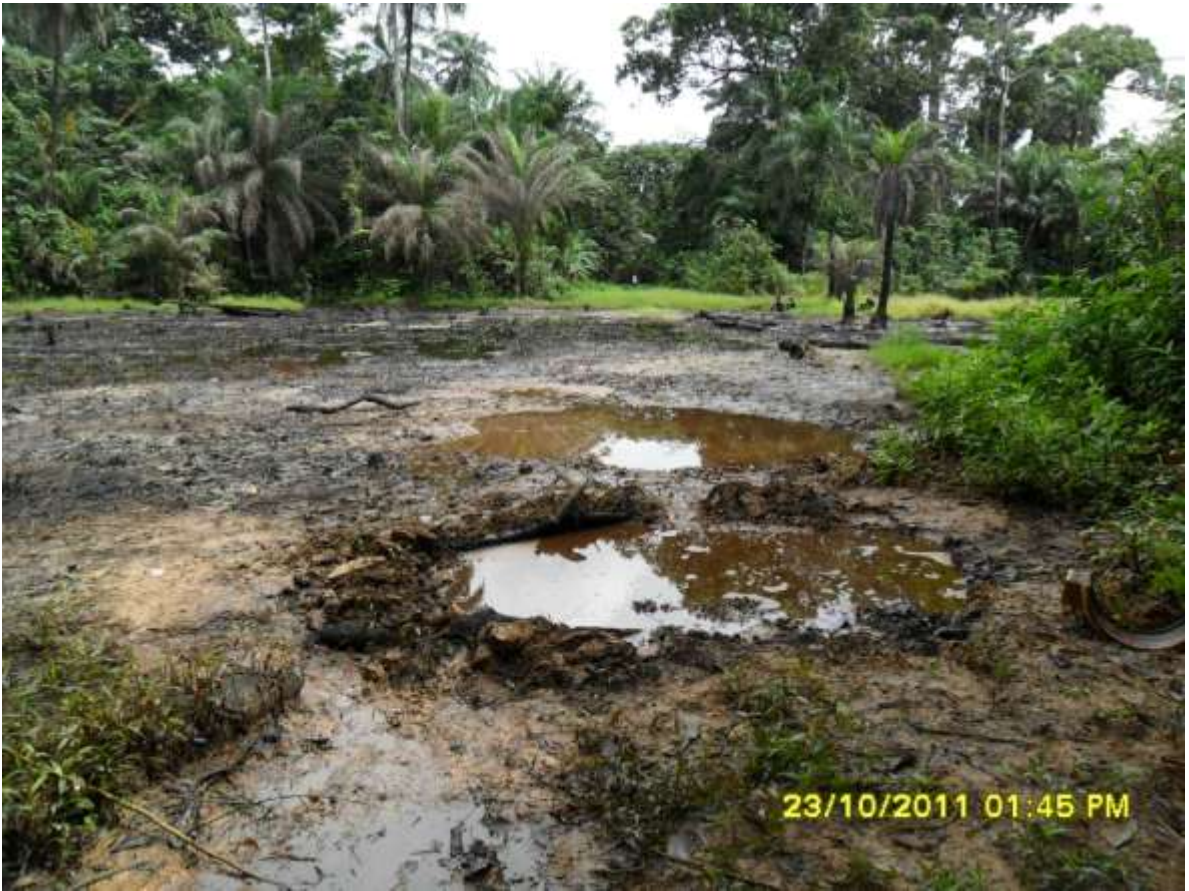
Overview: Part of spill impact on 14" Okordia-Rumuekpe pipeline right of way at Ikarama. Picture was taken during Joint Investigation of 23rd October, 2011.

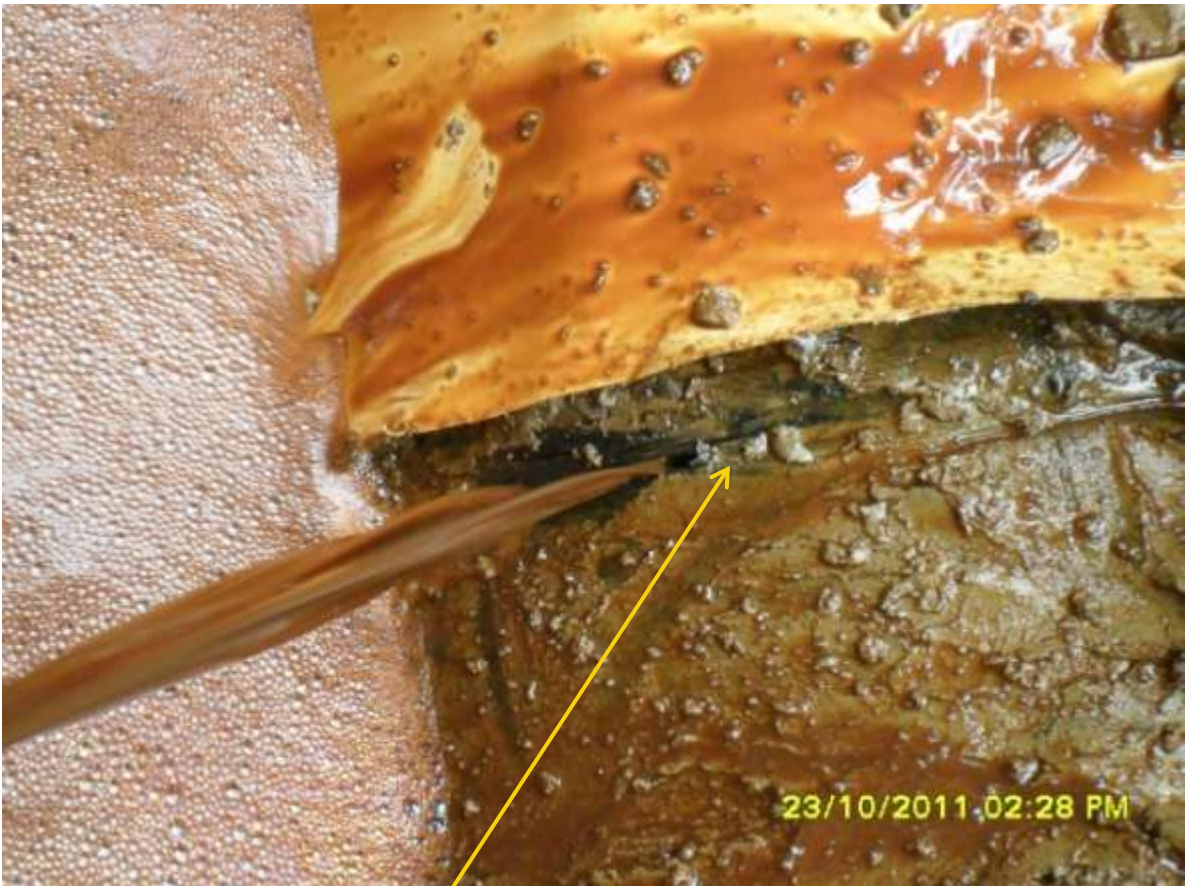
Close-up: Spill due to hacksaw cut on 14" Okordia-Rumuekpe pipeline at Ikarama. Picture was taken during Joint Investigation of 23rd October, 2011.
