THE SHELL PETROLEUM DEVELOPMENT COMPANY OF NIGERIA LIMITED

JOINT INVESTIGATION REPORT FOR INCIDENT NO: 0132 729047

1. Spill incident Number: 729047 2. Type of incident* OIL SPILL
 3. Name of Location 14" OKORDIA - RUMUEKPE PIPELINE
 4. Name of nearest community IKARAMA 5. State: BAYELSA 6. LGA YENAGOA
 7. Type of Production facility/Installation PIPELINE 8. Asset owner/District NRSP / KOLOKO

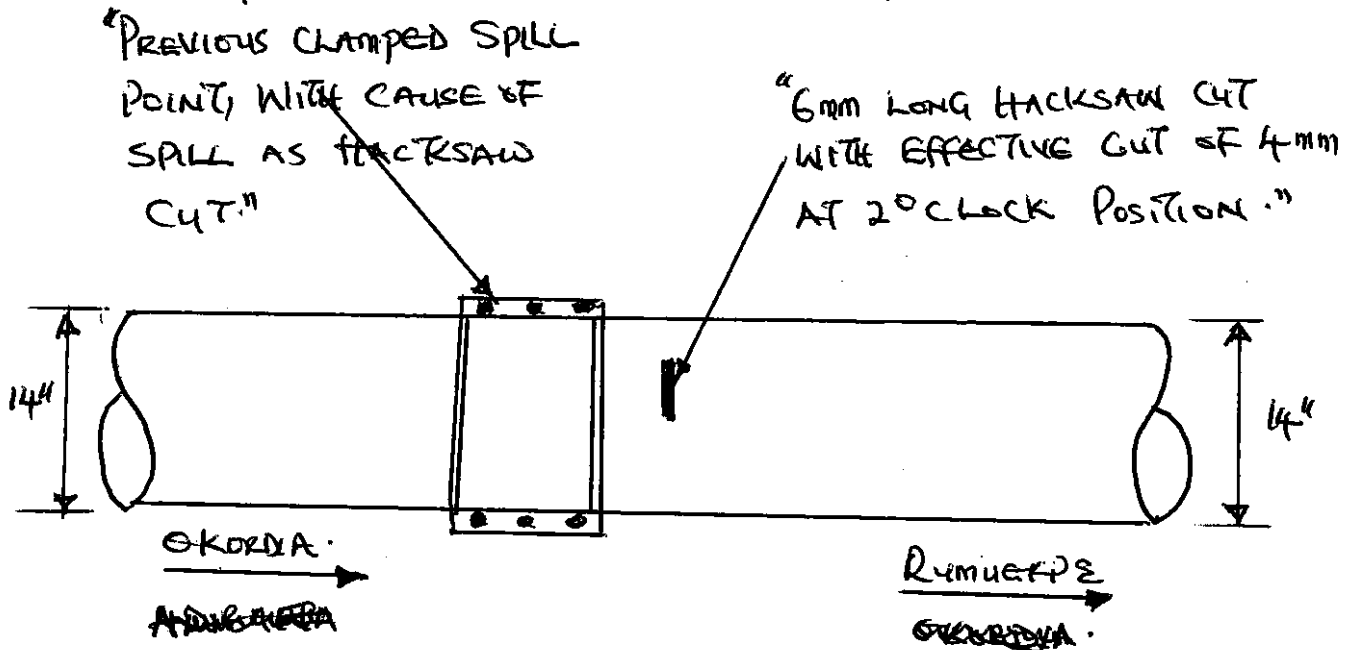
E. GRAPHIC DESCRIPTION OF LEAK POINT (Overview sketch of the site should be added as an appendix)

| <input type="checkbox"/> Drilled hole | <input checked="" type="checkbox"/> Hack saw cut | <input type="checkbox"/> Explosive tear, |

SECTION OF 14" OKORDIA - RUMUEKPE PIPELINE AT IKARAMA SHOWING POSITION OF HACKSAW CUT.
