JOINT INVESTIGATION REPORT

INCIDENT NO: 2490754 JIV report S/N: 1030119

1. Fountain Incident Number: 2490754 2. Type of incident* OIL SPILL
3. Name of Location 4" OBIGBO WELL 38 & 52 FLOWLINE
4. Name of nearest community UMUEBULU 5. State: RIVERS 6. LGA ETCAE
7. Type of Production facility/Installation OIL FLOWLINE
8. Asset owner/District THE SHELL PETROLEUM DEVELOPMENT COMPANY OF NIGERIA LIMITED (SPDC)/LAND EAST HUB

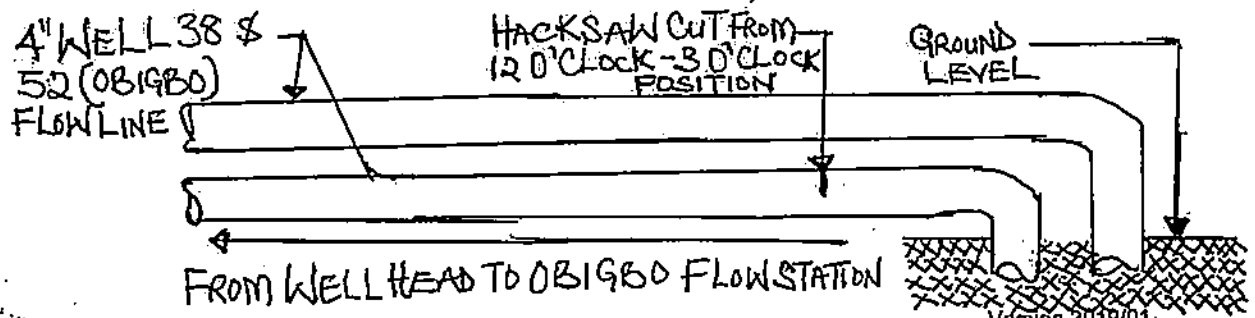
| <input type="checkbox"/> Drilled hole | <input checked="" type="checkbox"/> Hack-saw cut | <input type="checkbox"/> Tear (_____) |

E. GRAPHIC DESCRIPTION OF LEAK POINT (while detail report of the leak point should be contained in the leak report, overview sketch of the site should be added as an appendix 1) A SECTION OF 4" OBIGBO WELL 38 \$ WELL 52 FLOWLINE AT UMUESULU SHOWING A HACKSAW CUT FROM 12 O'CLOCK TO 3 O'CLOCK POSITION
