JOINT INVESTIGATION REPORT

INCIDENT NO: 2495609 JIV report S/N: 1030169

1. Fountain Incident Number: 2495609 2. Type of incident* OIL SPILL
3. Name of Location 12" IMO RIVER - OGALE PIPELINE
4. Name of nearest community OBDLO 5. State: RIVERS 6. LGA ELEME
7. Type of Production facility/Installation OIL PIPELINE
8. Asset owner/District THE SHELL PETROLEUM DEVELOPMENT COMPANY OF NIGERIA LTD (SPDC)/PIPELINE

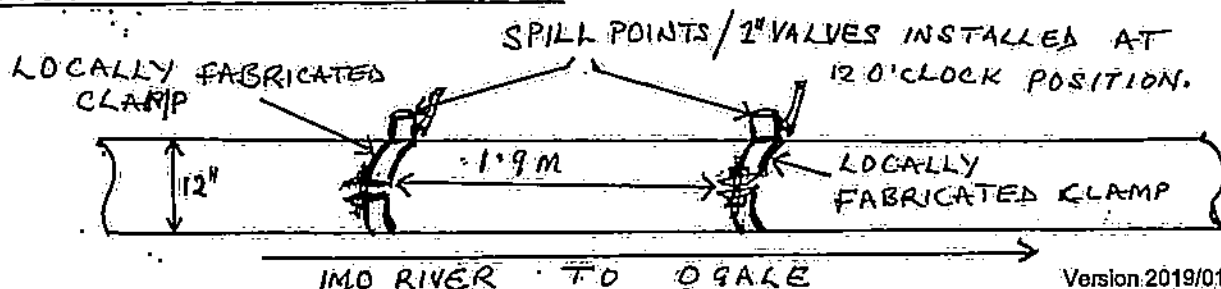
| <input checked="" type="checkbox"/> Crude oil theft (illegal bunkering) point, | <input type="checkbox"/> Saver-pit over flow | <input type="checkbox"/> Third party tampering with Clamp |

E. GRAPHIC DESCRIPTION OF LEAK POINT (while detail report of the leak point should be contained in the leak report, overview sketch of the site should be added as an appendix 1) A SECTION OF 12" IMD RIVER → OGALE PIPELINE AT OBOLO SHOWING 2 NOS 1" CRUDE THEFT VALVES INSTALLED 1.9 METERS APART AT 12 O'CLOCK POSITIONS BY UNKNOWN PERSONS.

REPAIR BY CLAMPING
