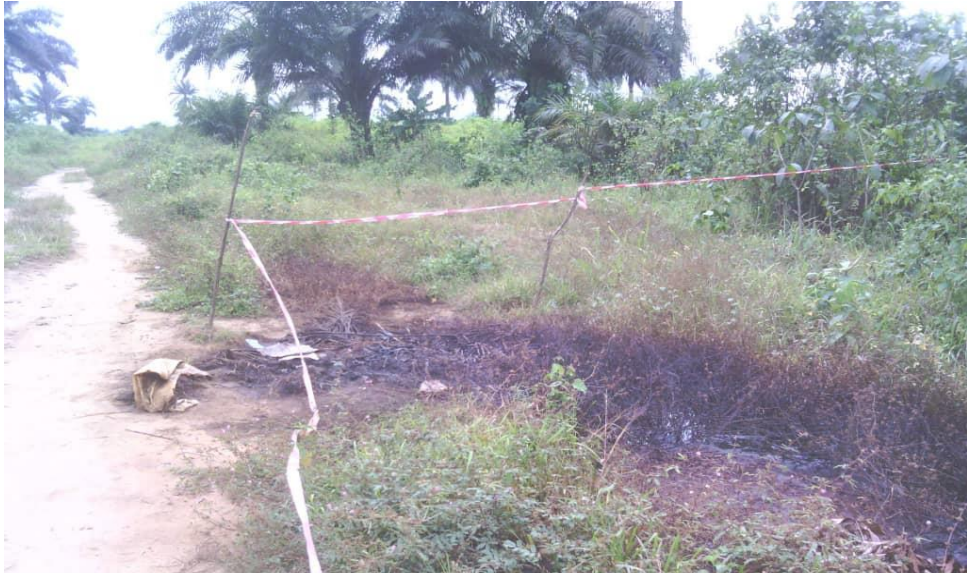
E 7.151346	Date 2019/11/12
		N 4.796889	Time 14:12:19 +01:00
		Altitude 26.400 M	Speed 0.00 KPH

**Overview:** Part of spill impact on 12'' Imo River – Ogale Pipeline Right of Way at Obolo  
 Picture was taken during Joint Investigation of 12<sup>th</sup> November 2019.

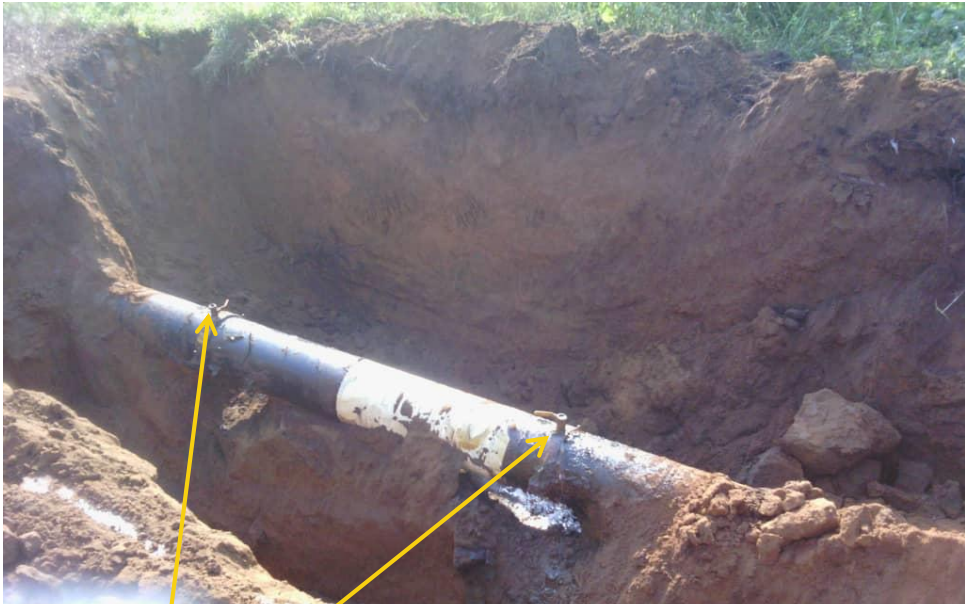
E 7.151351	Date 2019/11/17
		N 4.796876	Time 15:40:12 +01:00
		Altitude 22.000 M	Speed 0.07 KPH

**Close-up:** Illegal fittings on 12'' Imo River – Ogale Pipeline at Obolo . Picture was taken during  
 Joint Investigation of 17<sup>th</sup> November 2019.
