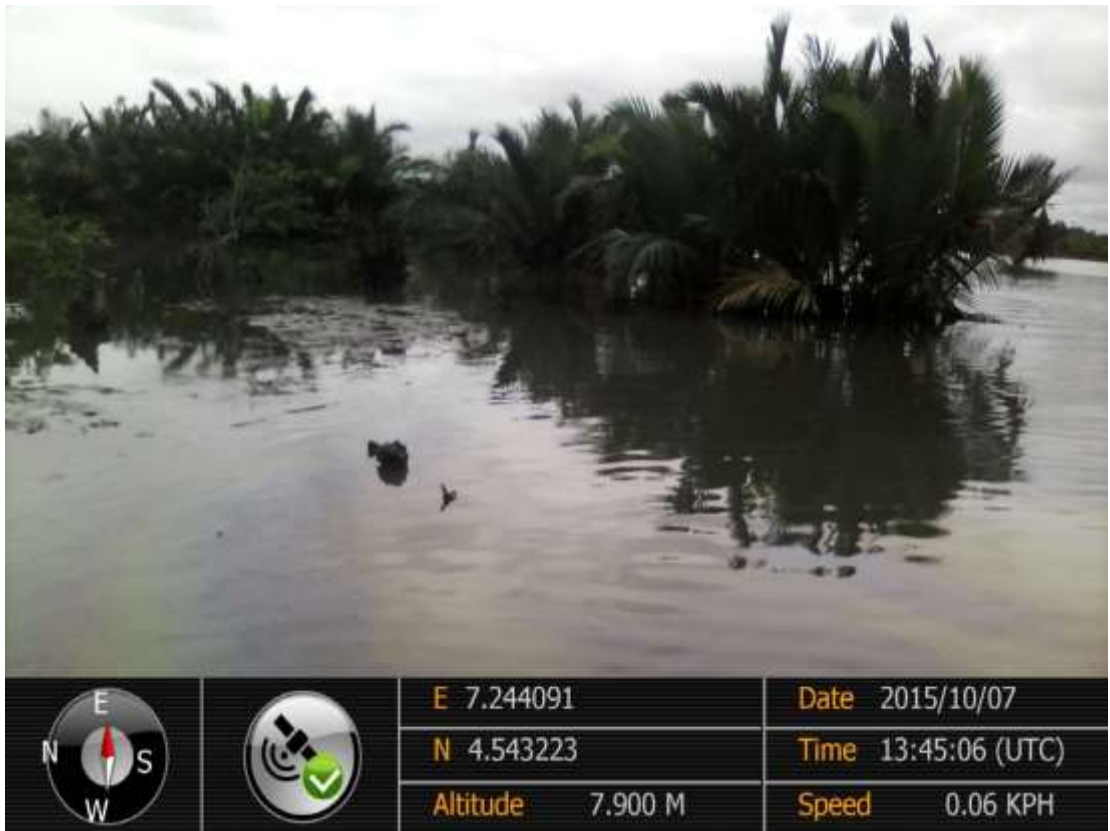
Overview: Part of spill impact on 24" Bomu-Bonny Pipeline Right of Way at Owokiri. Picture was taken during Joint Investigation of 7th October 2015.

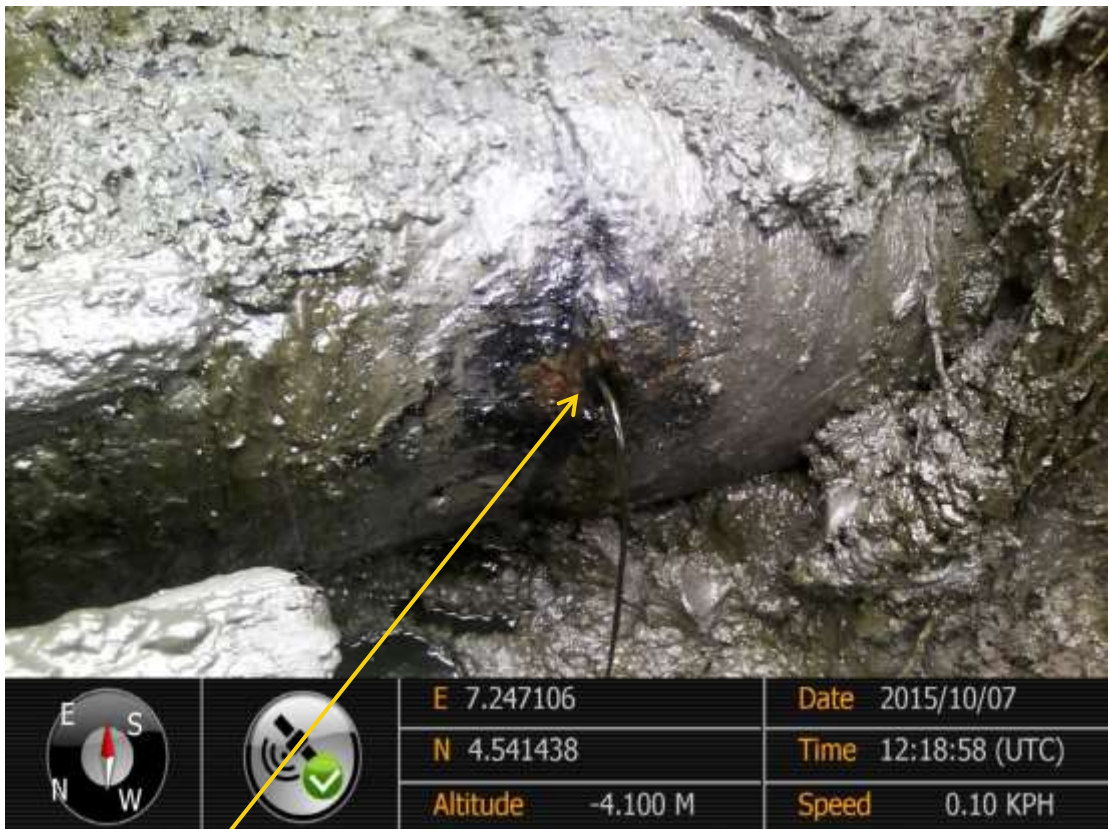
Close-up: Spill due to corrosion on 24" Bomu-Bonny Pipeline at Owokiri. Picture was taken during Joint Investigation of 7th October 2015.
