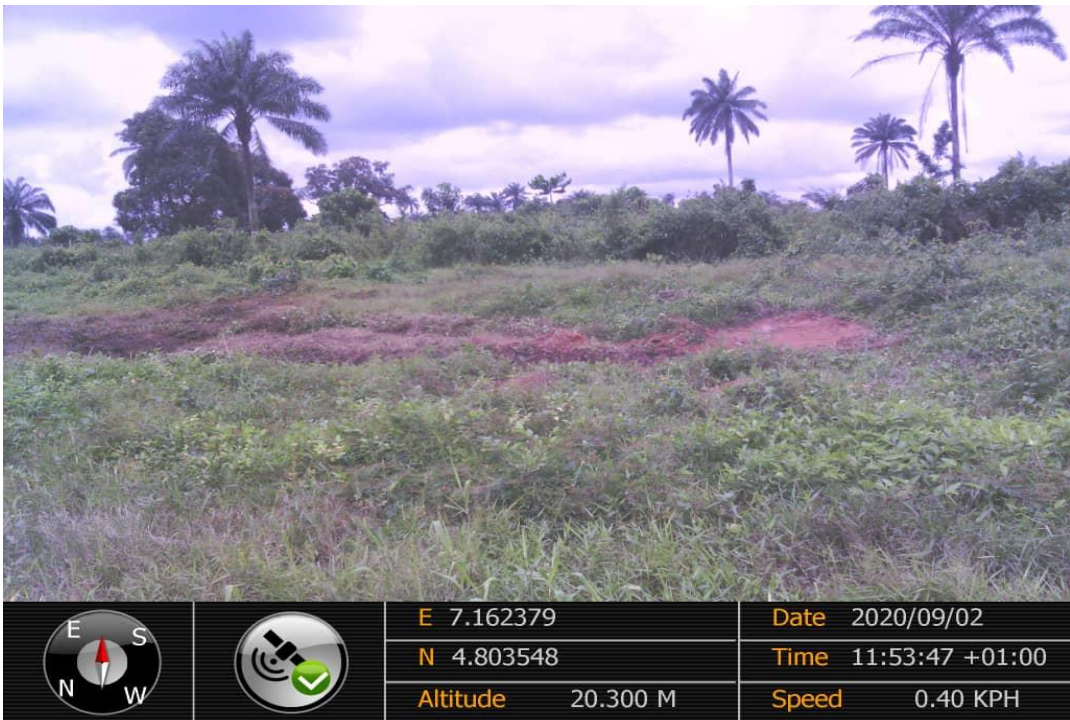
Overview: Part of spill impact on 24" Nkpoku - Bomu Pipeline at Agbeta. Picture was taken during Joint Investigation on 2nd September 2020.

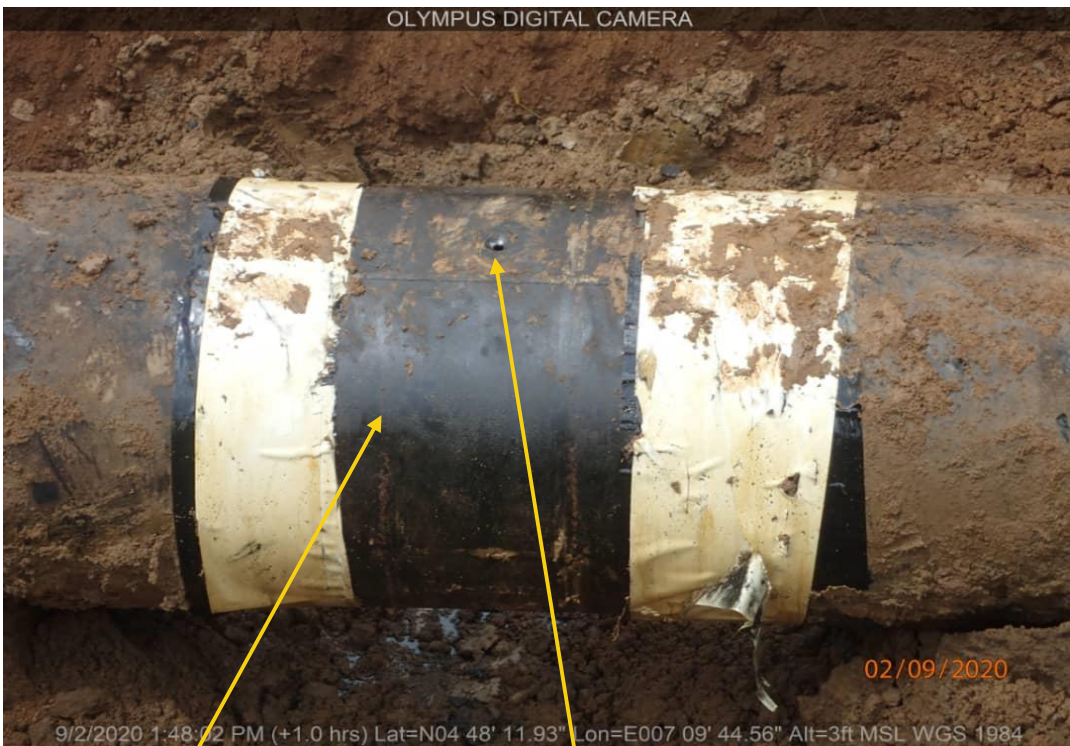
Close-up: Position of missing Clamp and drilled hole at 12 o'clock position on 24" Nkpoku - Bomu Pipeline at Agbeta. Picture was taken during Joint Investigation on 2nd September 2020.
