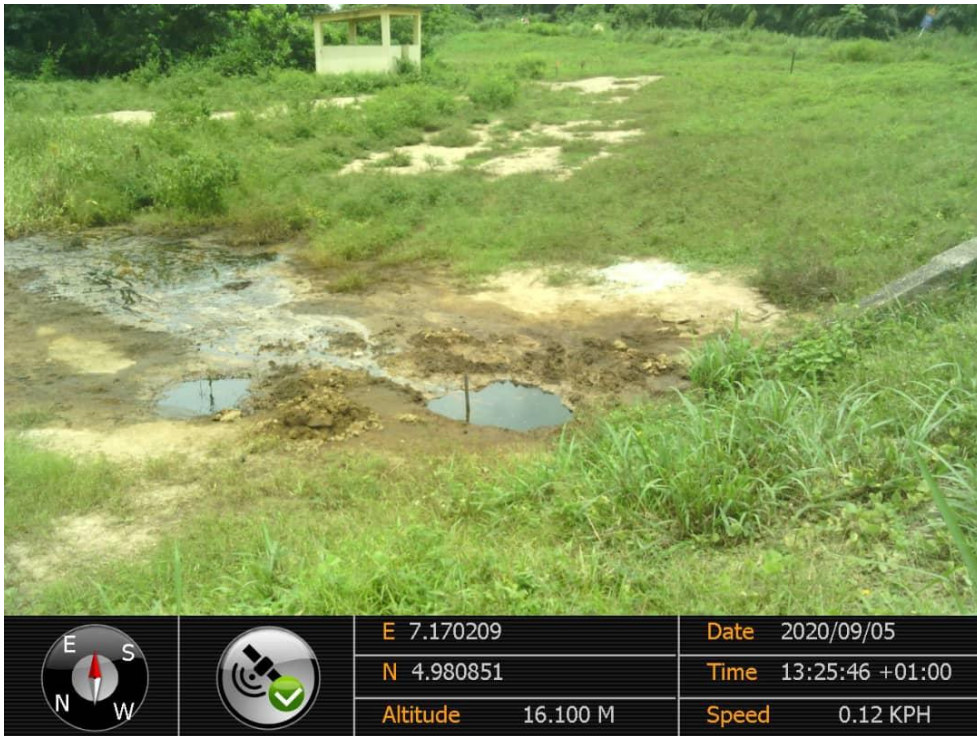
Overview: Part of spill impact on 12" Imo River 2 – Ogale Pipeline at Odagwa. Picture was taken during Joint Investigation on 5th September 2020.

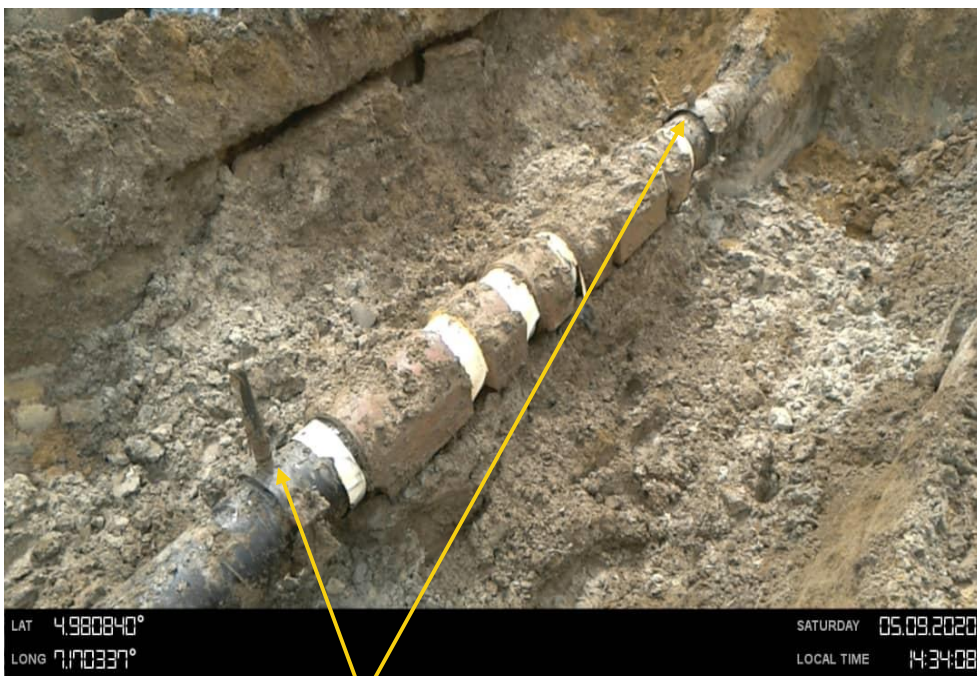
Close-up: 2 nos crude oil theft points at 12 o'clock position on 12" Imo River 2 – Ogale Pipeline at Odagwa. Picture was taken during Joint Investigation on 5th September 2020.
