Overview: Part of spill impact on 12" Imo River2 - Ogale Pipeline at Umuololo. Picture was taken during Joint Investigation on 9th September 2020.

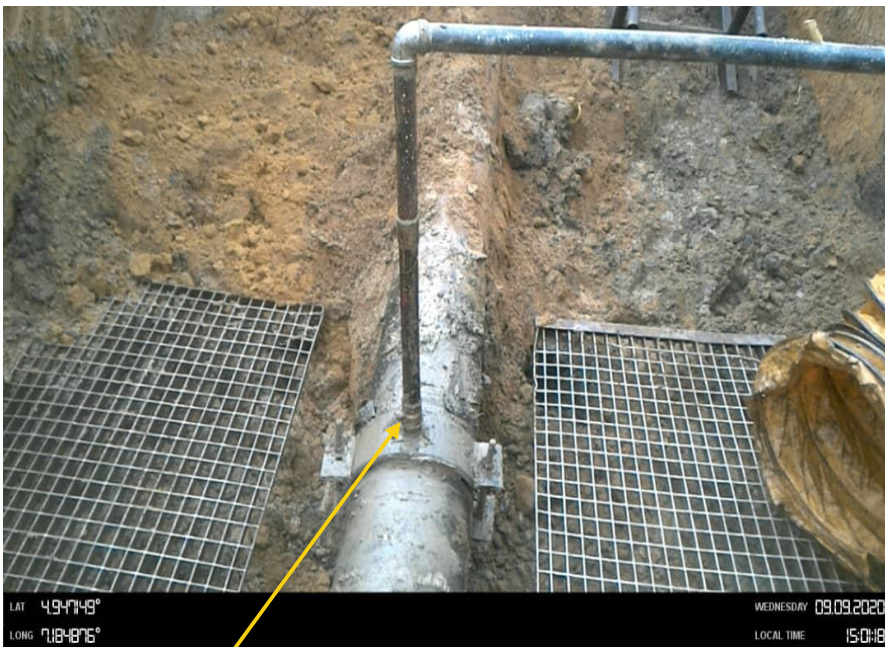
Close-up: Crude oil theft point installed at 12 o'clock position on 12" Imo River2 - Ogale Pipeline at Umuololo. Picture was taken during Joint Investigation on 9th September 2020.
