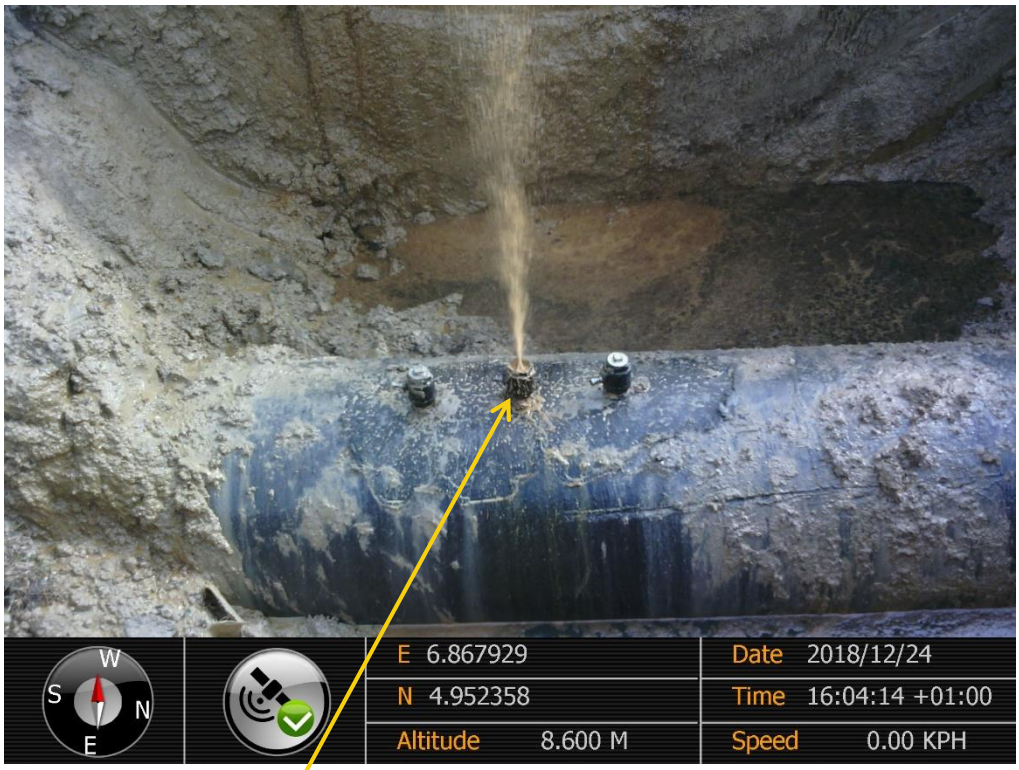
Overview: Part of spill impact on 36'' Rumuekpe - Nkpoku Pipeline Right of Way at Ogbodo-Isiokpo. Picture was taken during Joint Investigation of 24th December 2018.

Close-up: Leaking Illegal Fitting on 36'' Rumuekpe - Nkpoku Pipeline at Ogbodo-Isiokpo. Picture was taken during Joint Investigation of 24th December 2018.
