# JOINT INVESTIGATION REPORT

INCIDENT NO: 1833450 JIV report S/N: Nº 0000313

1. Spill incident Number: 1833450 2. Type of incident\* OIL SPILL  
3. Name of Location 20" OTUMARA - ESCRAVOS PIPELINE  
4. Name of nearest community UGBOEGUNGUN 5. State: DELTA 6. LGA WARRI SOUTH-WEST  
7. Type of Production facility/Installation OIL PIPELINE  
8. Asset owner/District THE SHELL PETROLEUM DEVELOPMENT COMPANY OF

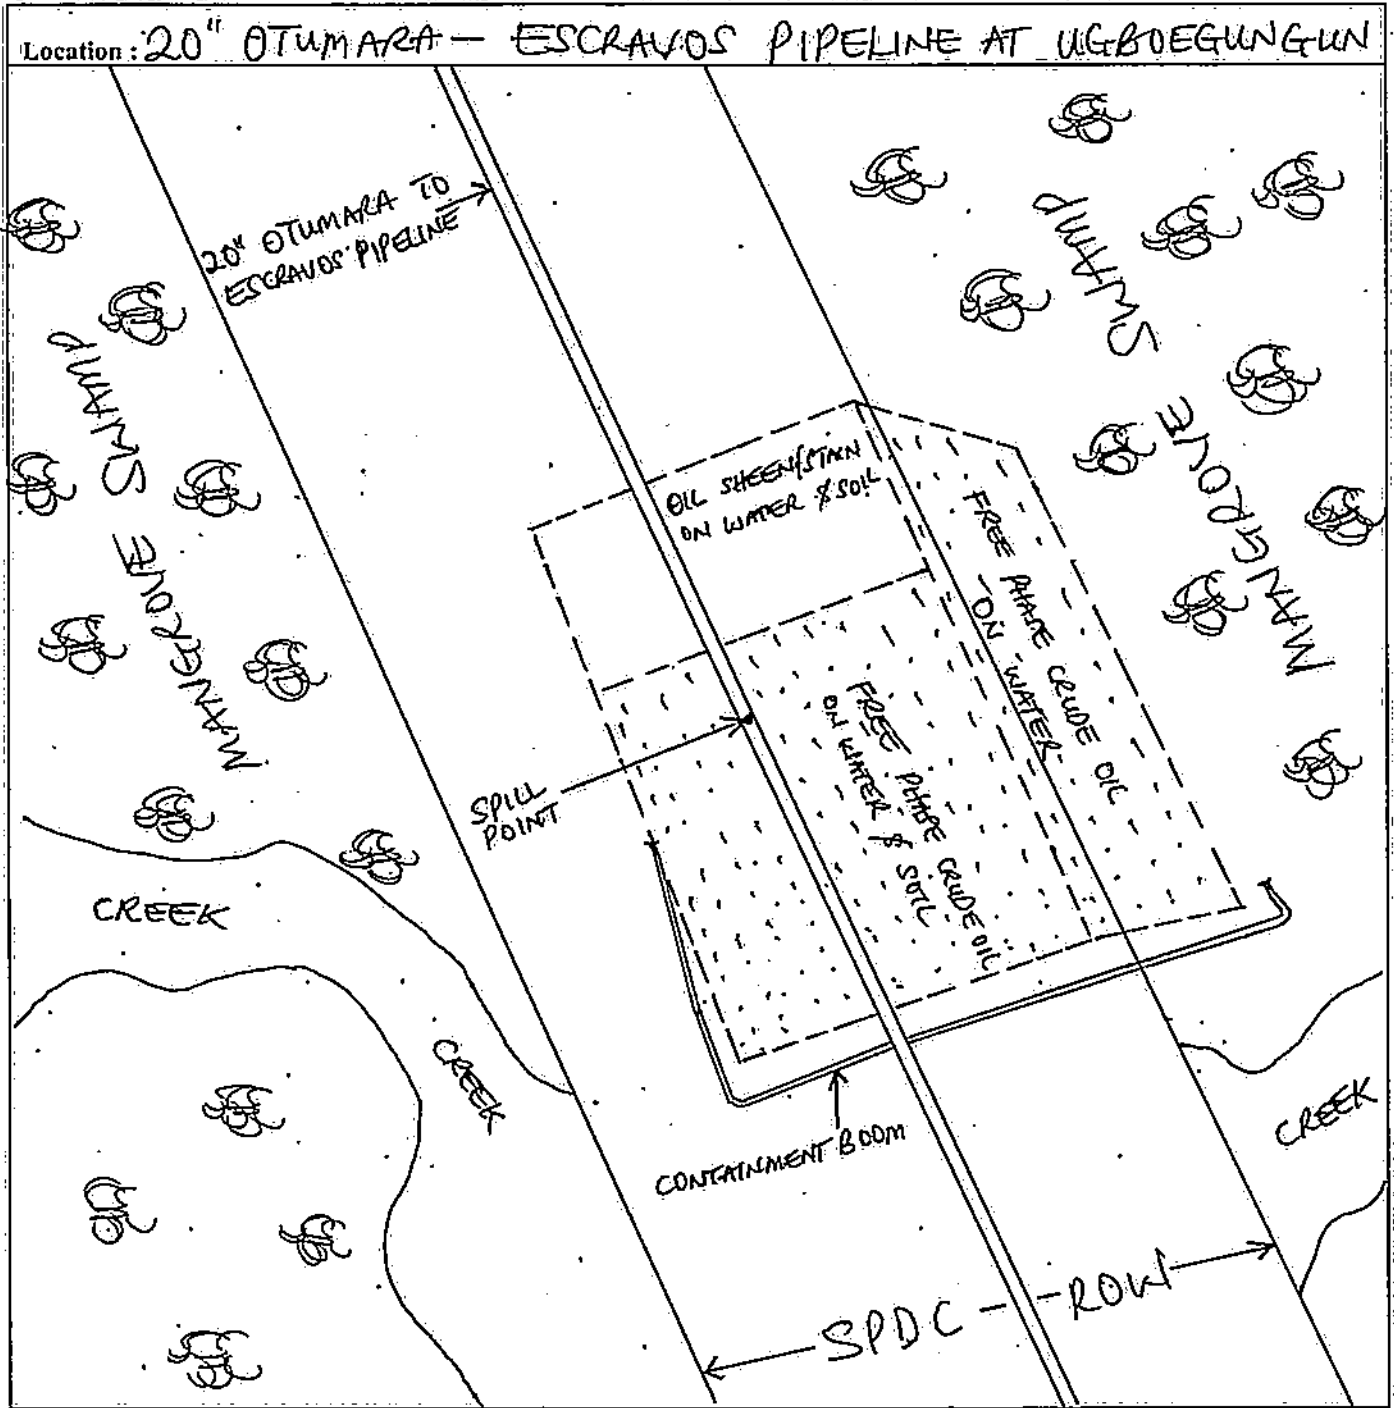
f. Appendix 1: Overview sketch of the site

ON EXCAVATION, THE JOINT INVESTIGATION TEAM OBSERVED A 3" FAILED VALVE ILLEGALLY ATTACHED TO THE 20" OTUMARA - ESCRAVOS PIPELINE AT 12 O'CLOCK POSITION.

SECTION OF 20" OTUMARA - ESCRAVOS PIPELINE AT UGBOERUNGUN SHOWING 3" FAILED VALVE ILLEGALLY ATTACHED AT 12 O' CLOCK POSITION

3" FAILED VALVE ILLEGALLY ATTACHED AT 12 O' CLOCK POSITION
