# JOINT INVESTIGATION REPORT

INCIDENT NO: 1844460 JIV report S/N: No: 0000311

1. Spill incident Number: 1844460 2. Type of incident\* OIL SPILL  
3. Name of Location BENISEDE WELL - 16T WELLHEAD  
4. Name of nearest community OJOBO 5. State: BAYELSA 6. LGA EKEREMOR  
7. Type of Production facility/Installation WELLHEAD  
8. Asset owner/District THE SHELL PETROLEUM DEVELOPMENT COMPANY OF

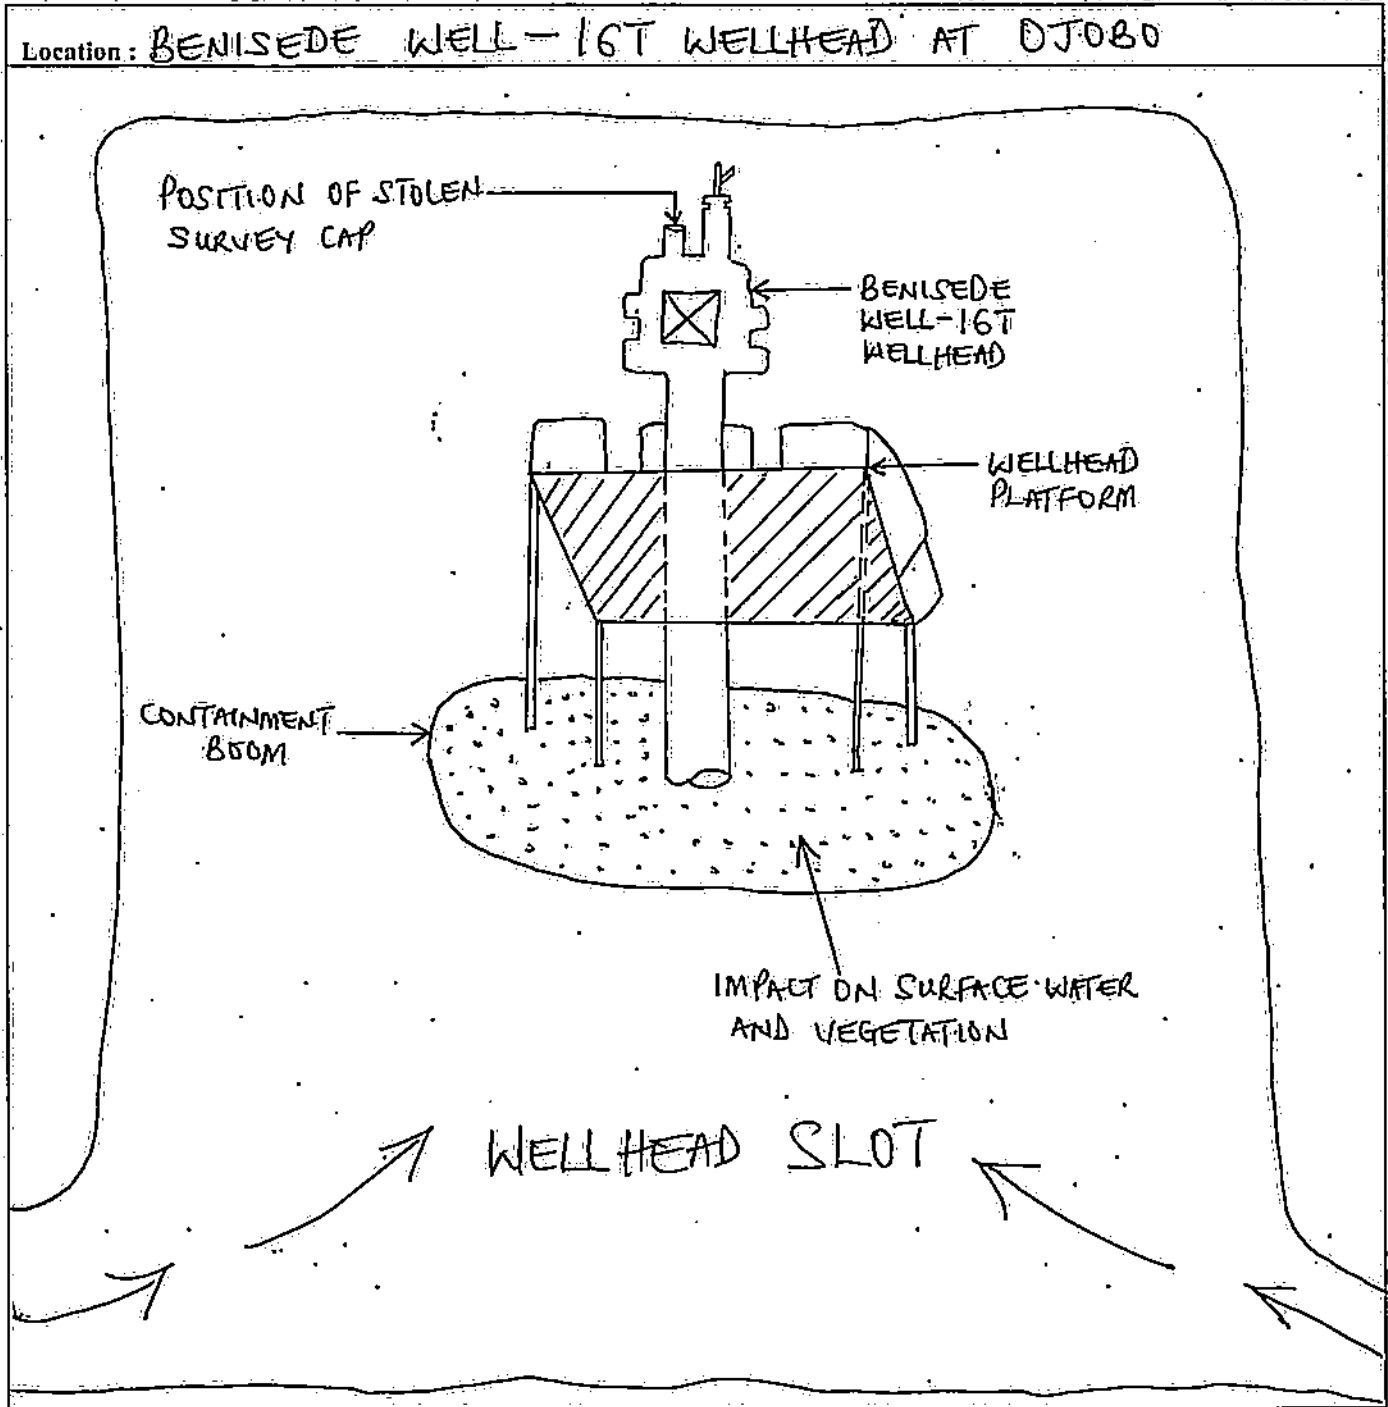
f. Appendix 1: Overview sketch of the site

Additional observations around the spill point: ON ASSESSMENT, THE JOINT INVESTIGATION TEAM OBSERVED THAT THE SURVEY CAP ON THE NON-FLOWING STRING OF BENISEDE WELL - 16T WELLHEAD HAS BEEN REMOVED BY UNKNOWN PERSONS.
