JOINT INVESTIGATION REPORT

INCIDENT NO: 1876963 JIV report S/N: No: 0000322

1. Spill incident Number: 1876963 2. Type of incident* OIL SPILL
3. Name of Location 20" OTUMARA - ESCRAVOS PIPELINE
4. Name of nearest community UGBOEGUNGUN State: DELTA 6. LGA WARRI SOUTH-WEST
7. Type of Production facility/Installation OIL PIPELINE
8. Asset owner/District THE SHELL PETROLEUM DEVELOPMENT COMPANY OF NIGERIA LIMITED / PIPELINES

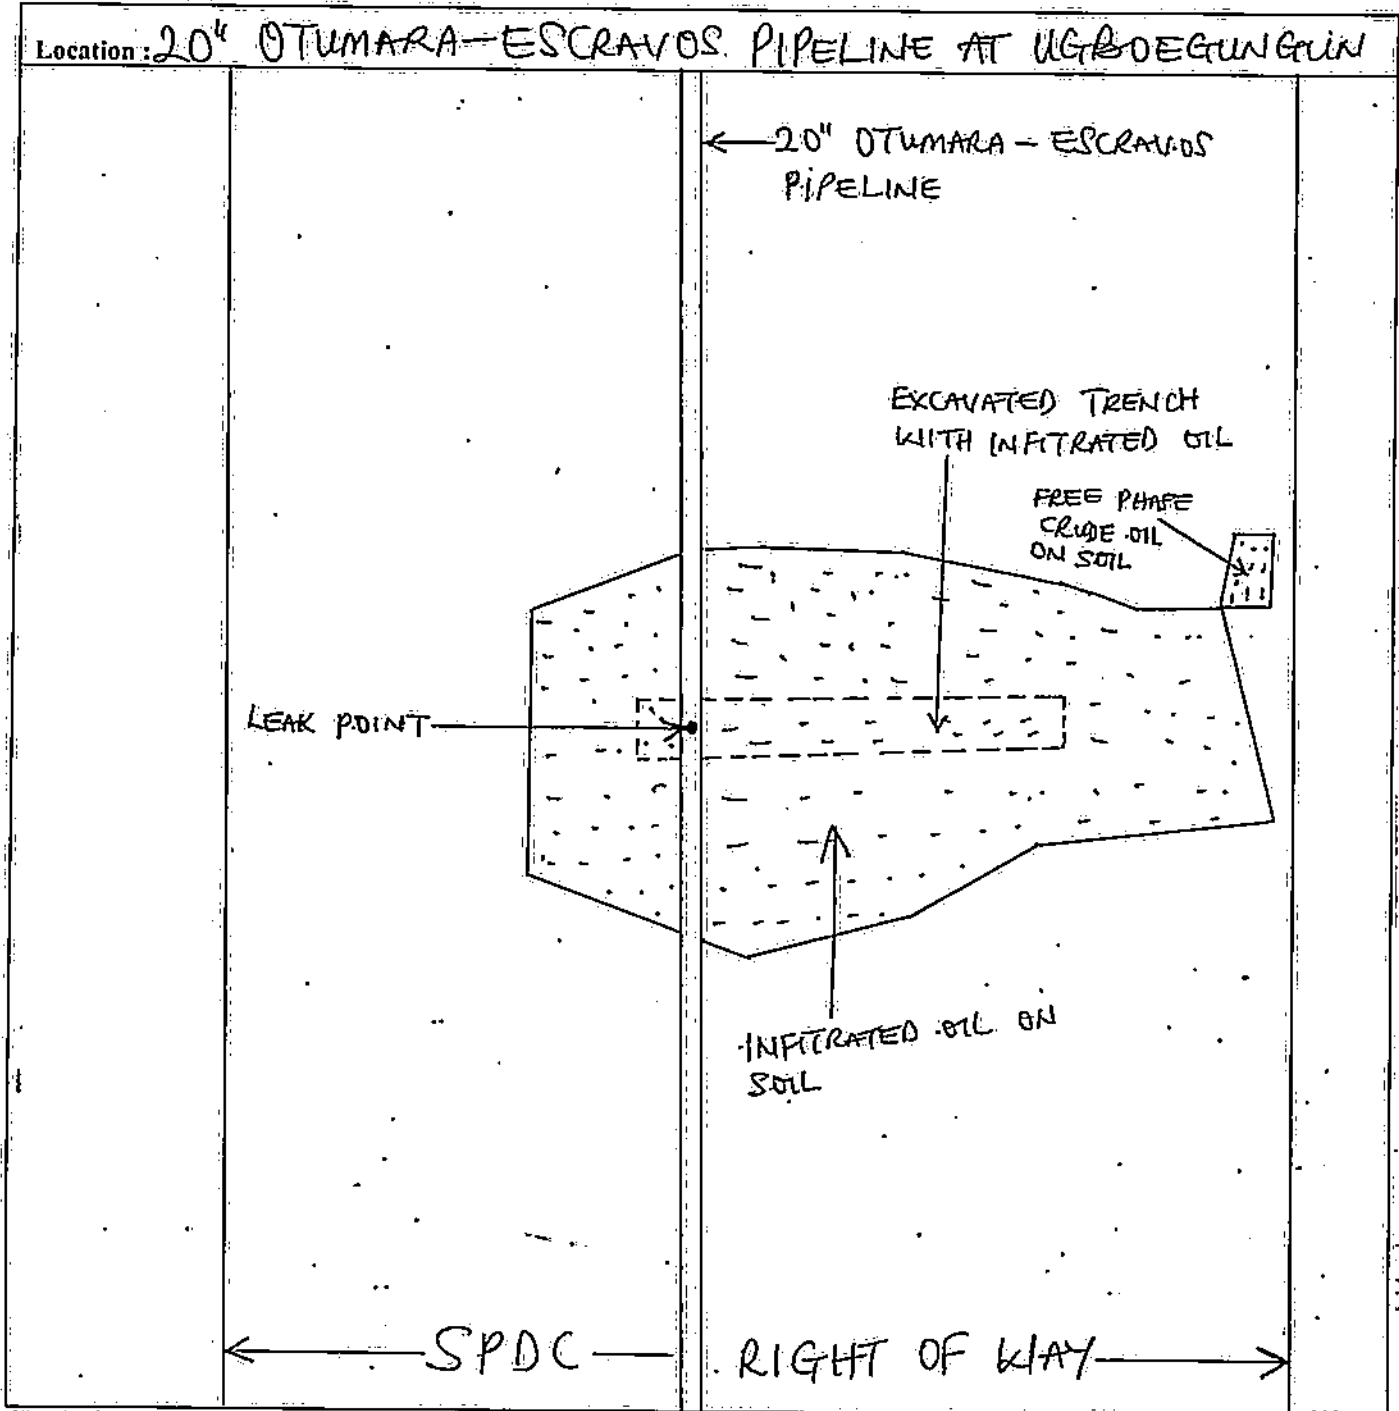
f. Appendix 1: Overview sketch of the site

ON EXCAVATION, THE JOINT INVESTIGATION TEAM OBSERVED A FAILED 4" HOT TAP VALVE, ILLEGALLY ATTACHED TO THE 20" OTUMARA-ESCAVOS PIPELINE AT 12 O' CLOCK POSITION.

SECTION OF 20" OTUMARA-ESCRAVOS PIPELINE AT UGBOEGUNGUN SHOWING; FAILED 4" HOT TAP VALVE AT 12 O' CLOCK POSITION
