JOINT INVESTIGATION REPORT

INCIDENT NO: 1864496 JIV report S/N: Nº 0000287

1. Spill incident Number: 1864496 2. Type of incident* OIL SPILL
3. Name of Location 12" IMDRIVER - OSALE PIPELINE
4. Name of nearest community OKOHIA - ASA AIZUAKU 5. State: ABIA 6. LGA UKWA WEST
7. Type of Production facility/Installation OIL PIPELINE
8. Asset owner/District THE SHELL PETROLEUM DEVELOPMENT COMPANY OF NIGERIA LTD
(SPDC)

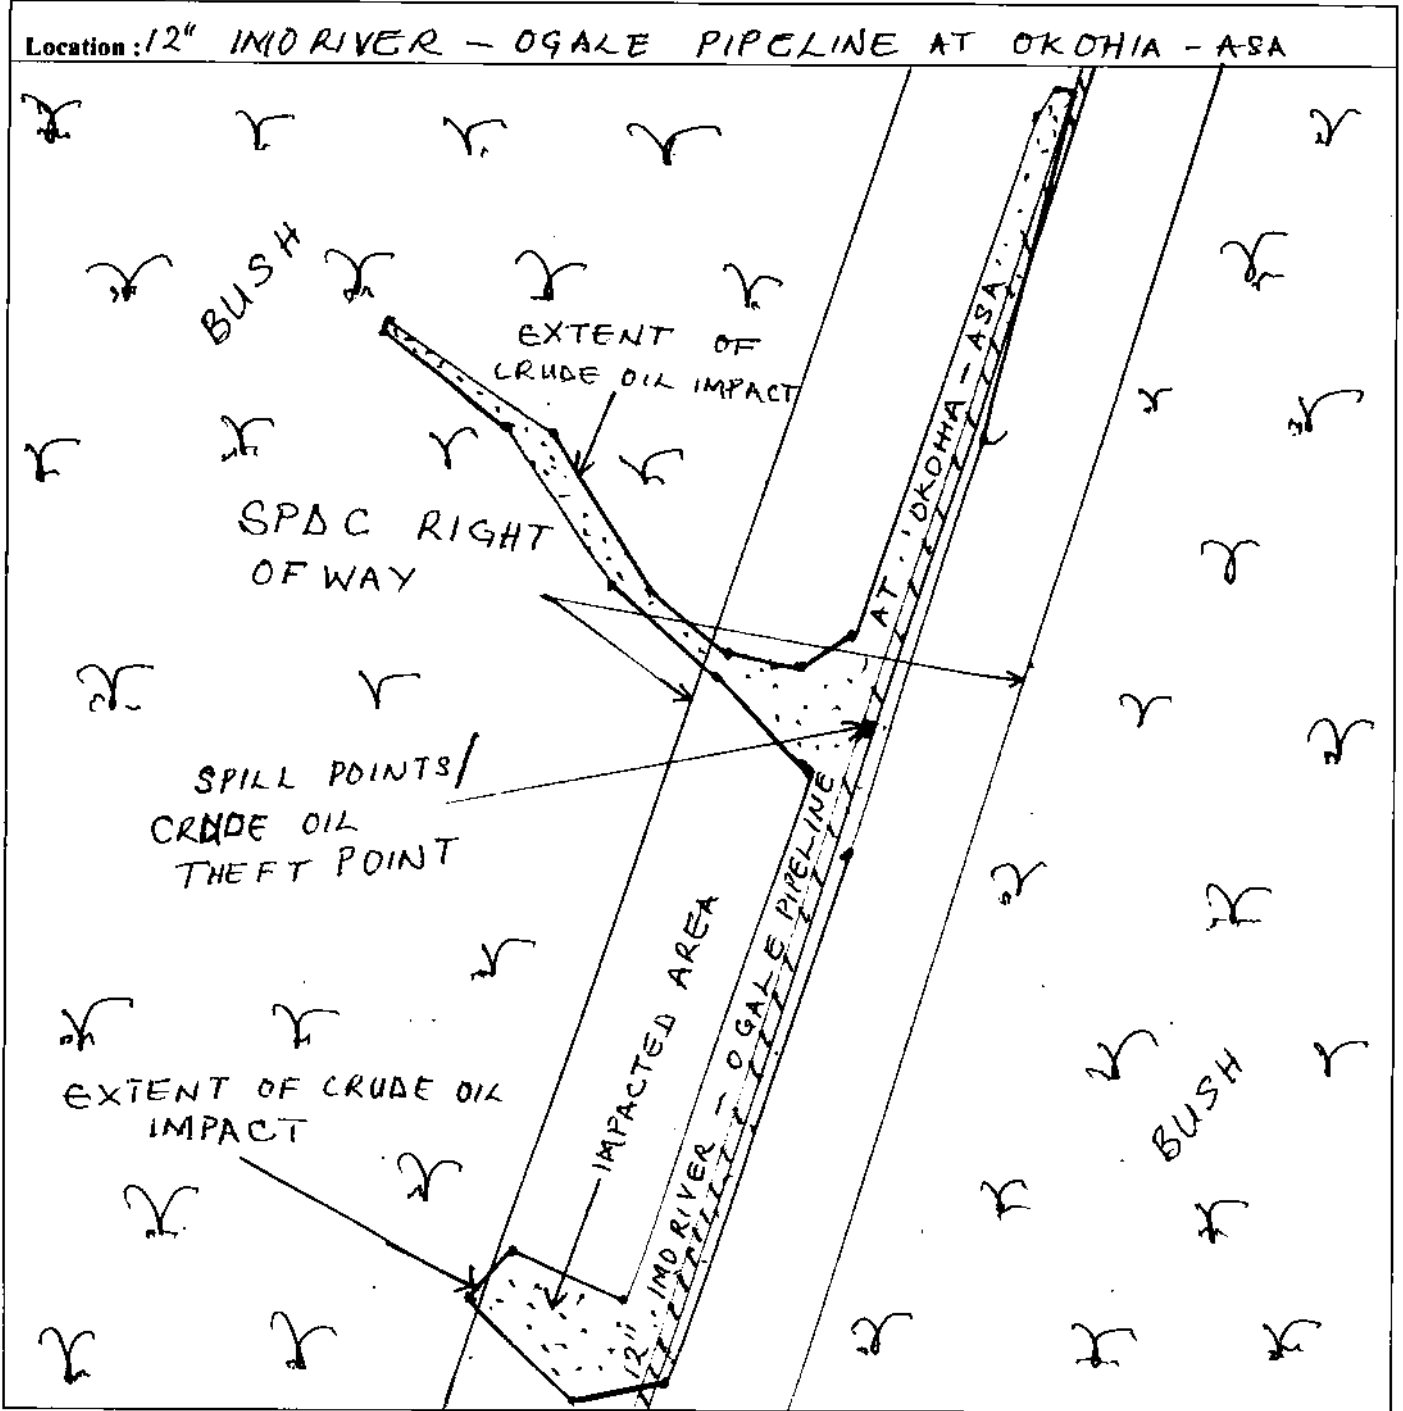
f. Appendix 1: Overview sketch of the site

Additional observations around the spill point: THE JOINT INVESTIGATION TEAM SAW CRUDE OIL THEFT POINTS CONNECTED TO THE PIPELINE AT 12 O'CLOCK POSITIONS

the leak report, overview sketch of the site should be added as an appendix 1) A SECTION OF 12" (MDRIVER - OGALE PIPELINE AT OKOHIA-ASA SHOWING 3 (NO) 3" CRUDE THEFT POINT VALVES INSTALLED AT 12 O'CLOCK POSITIONS BY UNKNOWN PERSONS.

REPAIR BY CLAMPING
