JOINT INVESTIGATION REPORT

INCIDENT NO: 1461320 JIV report S/N: N^o 0000071

1. Spill incident Number: 1461320 2. Type of incident* OIL SPILL
3. Name of Location 12" ADIBAWA - OKORDIA PIPELINE
4. Name of nearest community IKARAMA 5. State: BAYELSA 6. LGA YENAGOA
7. Type of Production facility/Installation OIL PIPELINE
8. Asset owner/District THE SHELL PETROLEUM DEVELOPMENT COMPANY OF NIGERIA LIMITED / PIPELINE

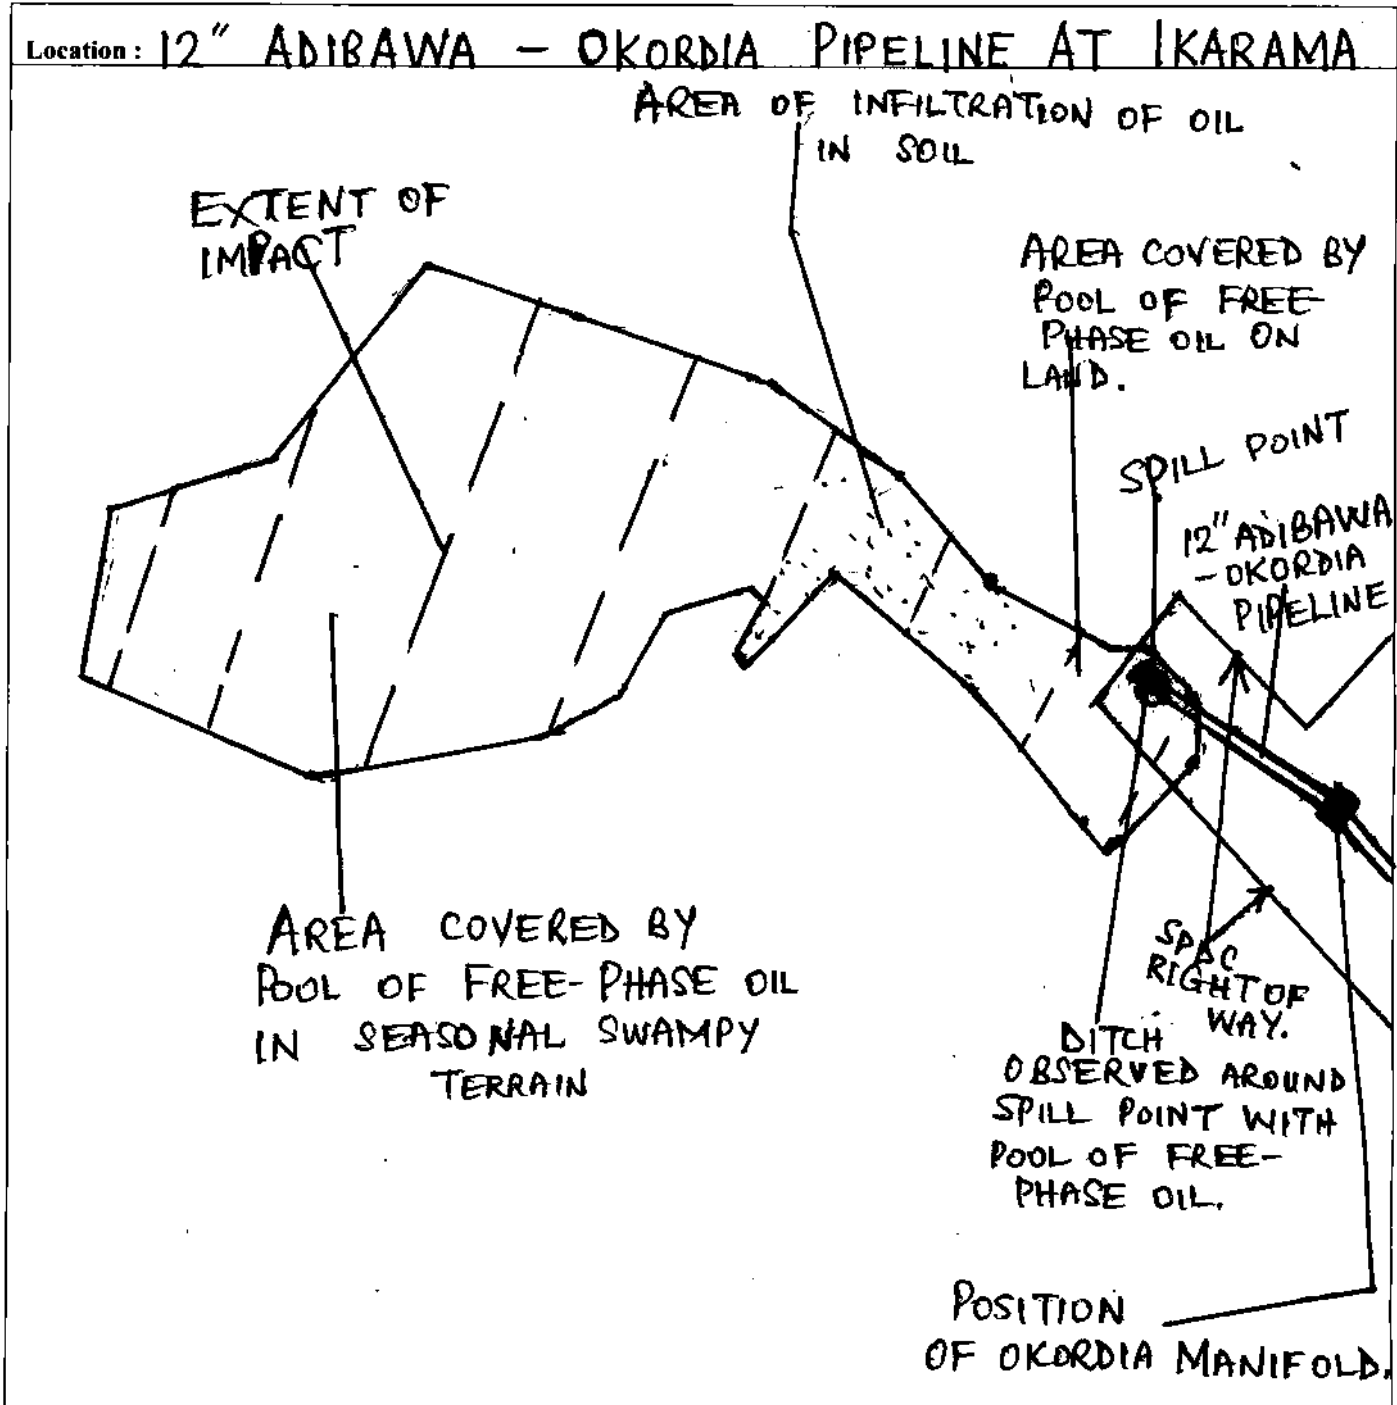
f. Appendix 1: Overview sketch of the site

Additional observations around the spill point: A DITCH DIG BY UNKNOWN PERSON(S) WAS OBSERVED AROUND THE SPILL POINT WHEN THE JOINT INVESTIGATION TEAM ARRIVED AT SITE. UPON EXCAVATION DURING JIV TO ASCERTAIN LEAK CAUSE, A SECTION OF THE CONCRETE COATING AROUND THE SPILL POINT WAS NOTICED REMOVED, OFF THE PIPELINE, BY UNKNOWN PERSON(S).

SOURCE OF LEAK WAS STOPPED AND THEREAFTER REPAIRS WERE EFFECTED ON THE AFFECTED SECTION OF PIPELINE BY CLAMPING.
