JOINT INVESTIGATION REPORT

INCIDENT NO: 1473411 JIV report S/N:

1. Spill incident Number: 1473411 2. Type of incident* OIL SPILL
3. Name of Location 6" SEIBOU BULKLINE - 4
4. Name of nearest community AZAGBENE 5. State: BAYELSA 6. LGA EKEREMOR
7. Type of Production facility/Installation FLOWLINE
8. Asset owner/District THE SHELL PETROLEUM DEVELOPMENT COMPANY OF

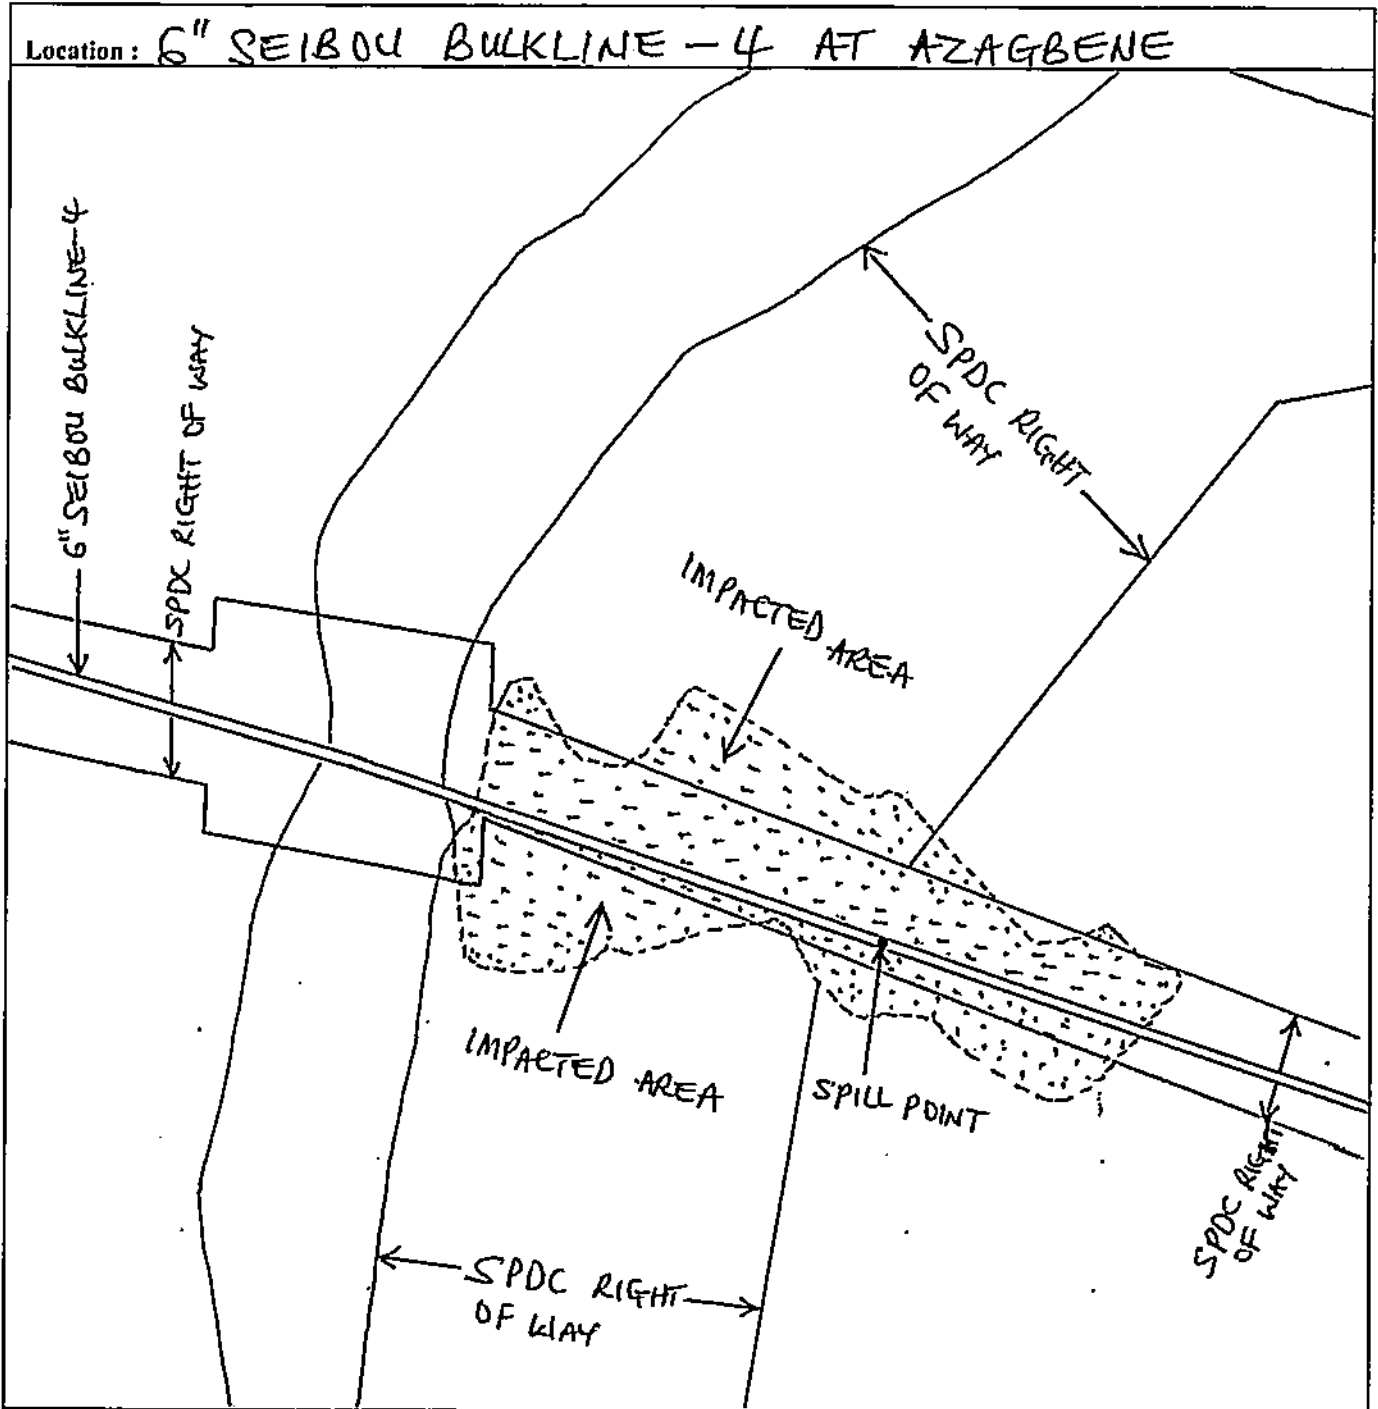
f. Appendix 1: Overview sketch of the site

Additional observations around the spill point: UPON EXCAVATION, THE JOINT INVESTIGATION TEAM OBSERVED A HACK-SAW CUT (ABOUT 10CM LONG) ON SEIBOU BULKLINE - 4 AT 2 O' CLOCK POSITION.
