JOINT INVESTIGATION REPORT

INCIDENT NO: 1350803 JIV report S/N: Nº 0000344

1. Spill incident Number: 1350803 2. Type of incident* OIL SPILL
3. Name of Location TUNU WELL-6T FLOWLINE
4. Name of nearest community AGBIDIAMA 5. State: BAYELSA 6. LGA EKEREMOR
7. Type of Production facility/Installation FLOWLINE
8. Asset owner/District THE SHELL PETROLEUM DEVELOPMENT COMPANY OF NIG. LIMITED

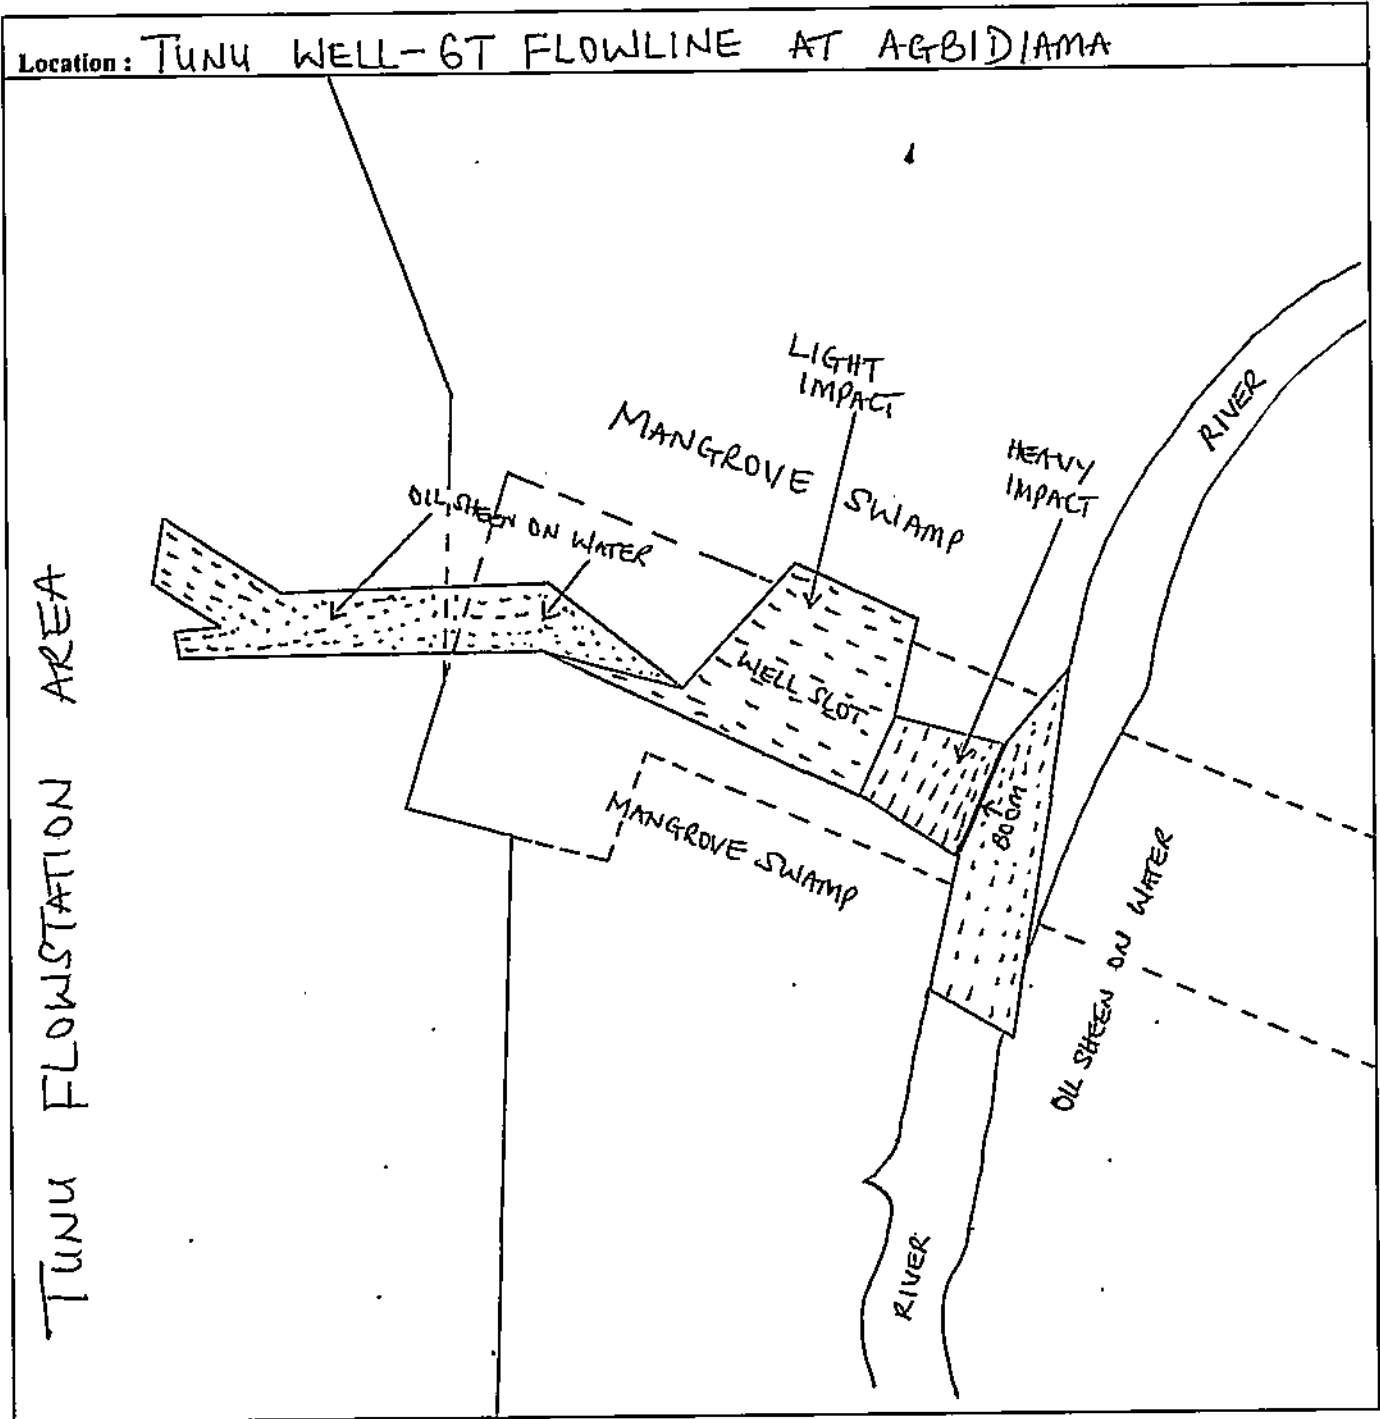
f. Appendix 1: Overview sketch of the site

APPENDIX 1 FID: 1350803

NAME	EAST	NORTH	DESCRIPTION
1	354506.63	97527.405	SHEEN
2	354512.71	97554.921	SHEEN
3	354643.15	97537.194	SHEEN
4	354901.12	97665.517	SHEEN
5	355095.59	97611.278	SHEEN
6	354949.41	97623.184	SHEEN
7	354748.46	97544.073	SHEEN
8	354596.85	97477.663	SHEEN
9	354585.47	97490.627	SHEEN
10	354611.4	97508.09	SHEEN
11	354506.63	97527.405	SHEEN
12	354949.41	97623.184	LIGHT
13	355095.59	97611.278	LIGHT
14	355095.59	97698.326	LIGHT
15	355198.78	97681.392	LIGHT
16	355229.21	97564.975	LIGHT
17	355219.94	97525.288	LIGHT
18	354949.41	97623.184	LIGHT
19	355219.94	97525.288	HEAVY
20	355229.21	97564.975	HEAVY
21	355308.58	97538.517	HEAVY
22	355291.38	97482.954	HEAVY
23	355291.38	97482.954	BOOM
24	355308.58	97538.517	BOOM
25	355348.27	97616.569	SHEEN
26	355327.63	97442.473	SHEEN
27	355291.65	97271.023	SHEEN
28	355262.28	97353.308	SHEEN
29	355291.38	97482.954	SHEEN
30	355308.58	97538.517	SHEEN
31	355348.27	97616.569	SHEEN
