JOINT INVESTIGATION REPORT

INCIDENT NO: 1489792 JIV report S/N: Nº 0000072

1. Spill incident Number: 1489792 2. Type of incident* OIL SPILL
3. Name of Location 12" ADIBAWA - OKORDIA PIPELINE
4. Name of nearest community IKARAMA 5. State: BAYELSA 6. LGA YENAGOA
7. Type of Production facility/Installation OIL PIPELINE
8. Asset owner/District THE SHELL PETROLEUM DEVELOPMENT COMPANY OF NIGERIA LIMITED / PIPELINE

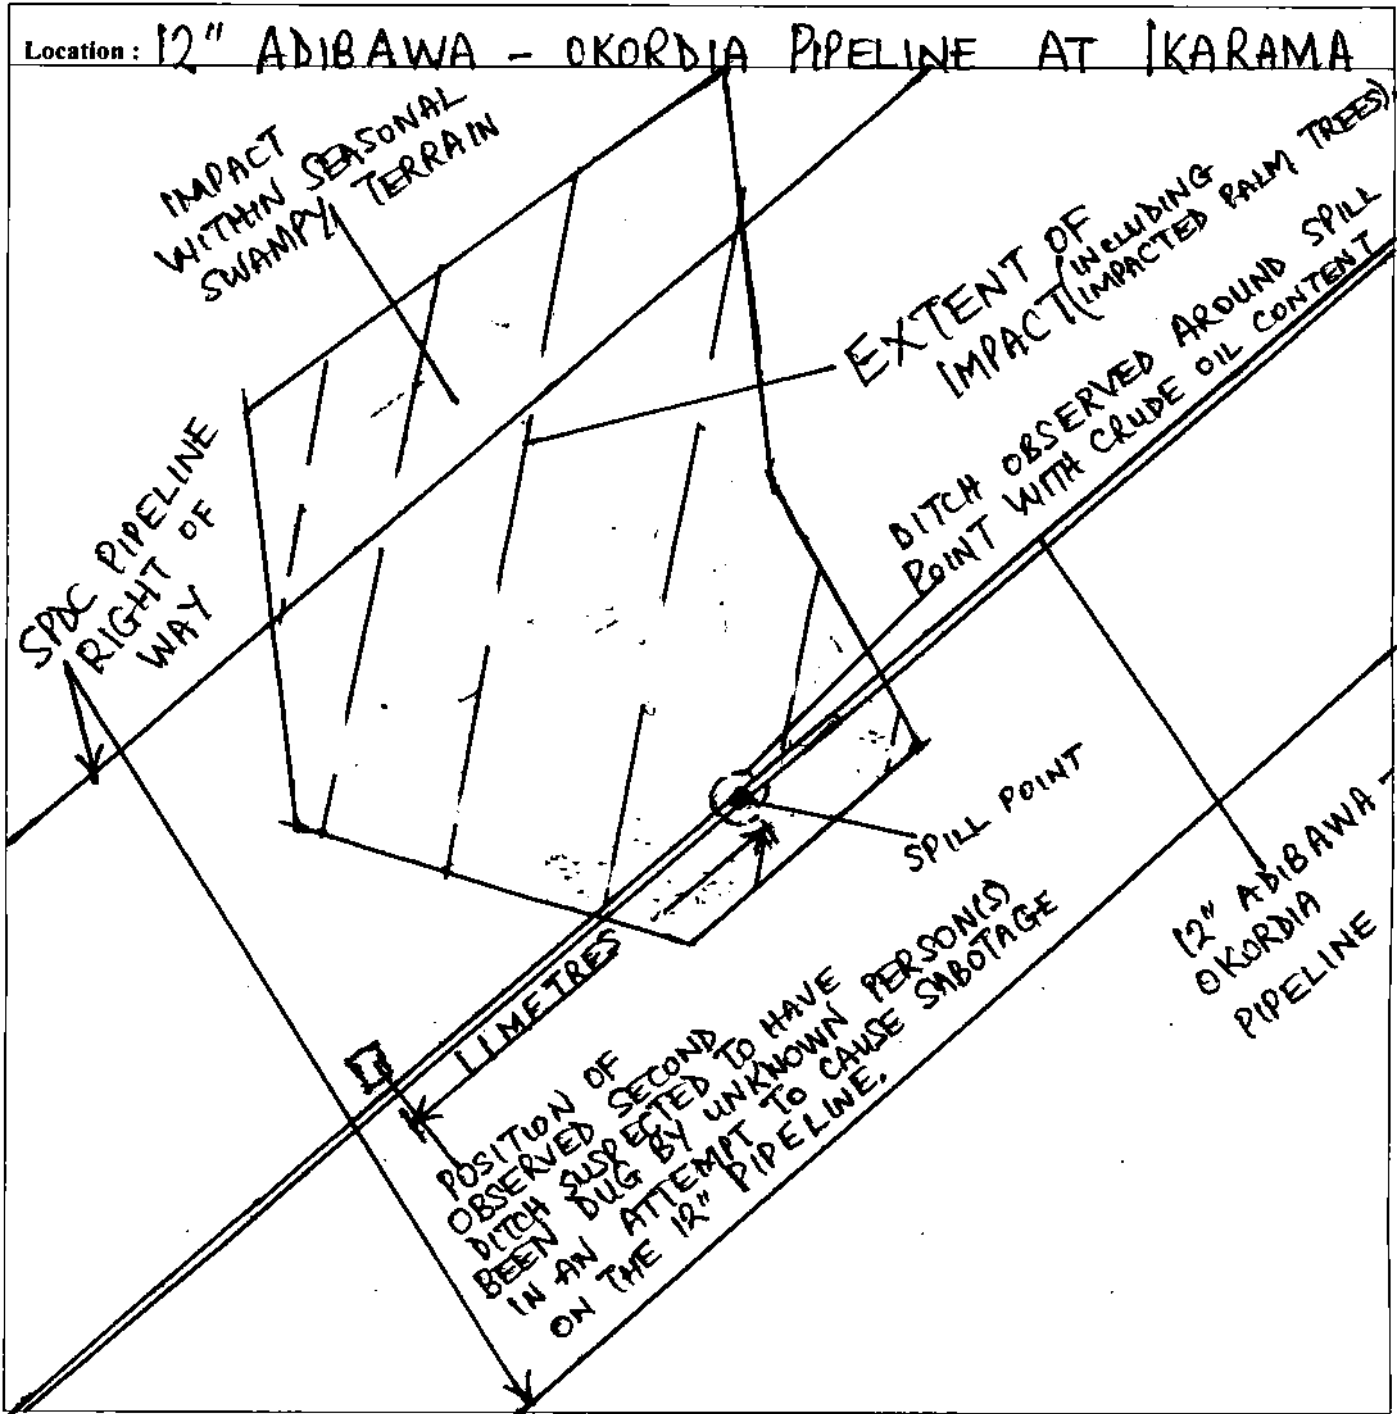
f. Appendix 1: Overview sketch of the site

Additional observations around the spill point: A DITCH DUG BY UNKNOWN PERSON(S) WAS OBSERVED AROUND THE SPILL POINT WITH SOME CRUDE OIL CONTENT. ALSO, THE JOINT INVESTIGATION TEAM OBSERVED, APPROXIMATELY 5 METRES FROM THE SPILL POINT, A SECOND DITCH SUSPECTED TO HAVE BEEN DUG BY UNKNOWN PERSON(S) IN AN ATTEMPT TO CAUSE SABOTAGE ON THE 12" PIPELINE.

SOURCE OF SPILL WAS STOPPED AND REPAIRS WERE EFFECTED ON THE AFFECTED PIPELINE SECTION BY CLAMPING.
