JOINT INVESTIGATION REPORT

INCIDENT NO: 1675064 JIV report S/N: NO: 0000179

1. Spill incident Number: 1675064 2. Type of incident* OIL SPILL
3. Name of Location OBIGBO NORTH WELL 2ST, 18S, 20T AND THREE (3) OTHER DISUSED FLOWLINES.
4. Name of nearest community UMUWALIA 5. State: RIVERS 6. LGA OYIGBO
7. Type of Production facility/Installation OIL FLOWLINE
8. Asset owner/District SPDC / LAND 1

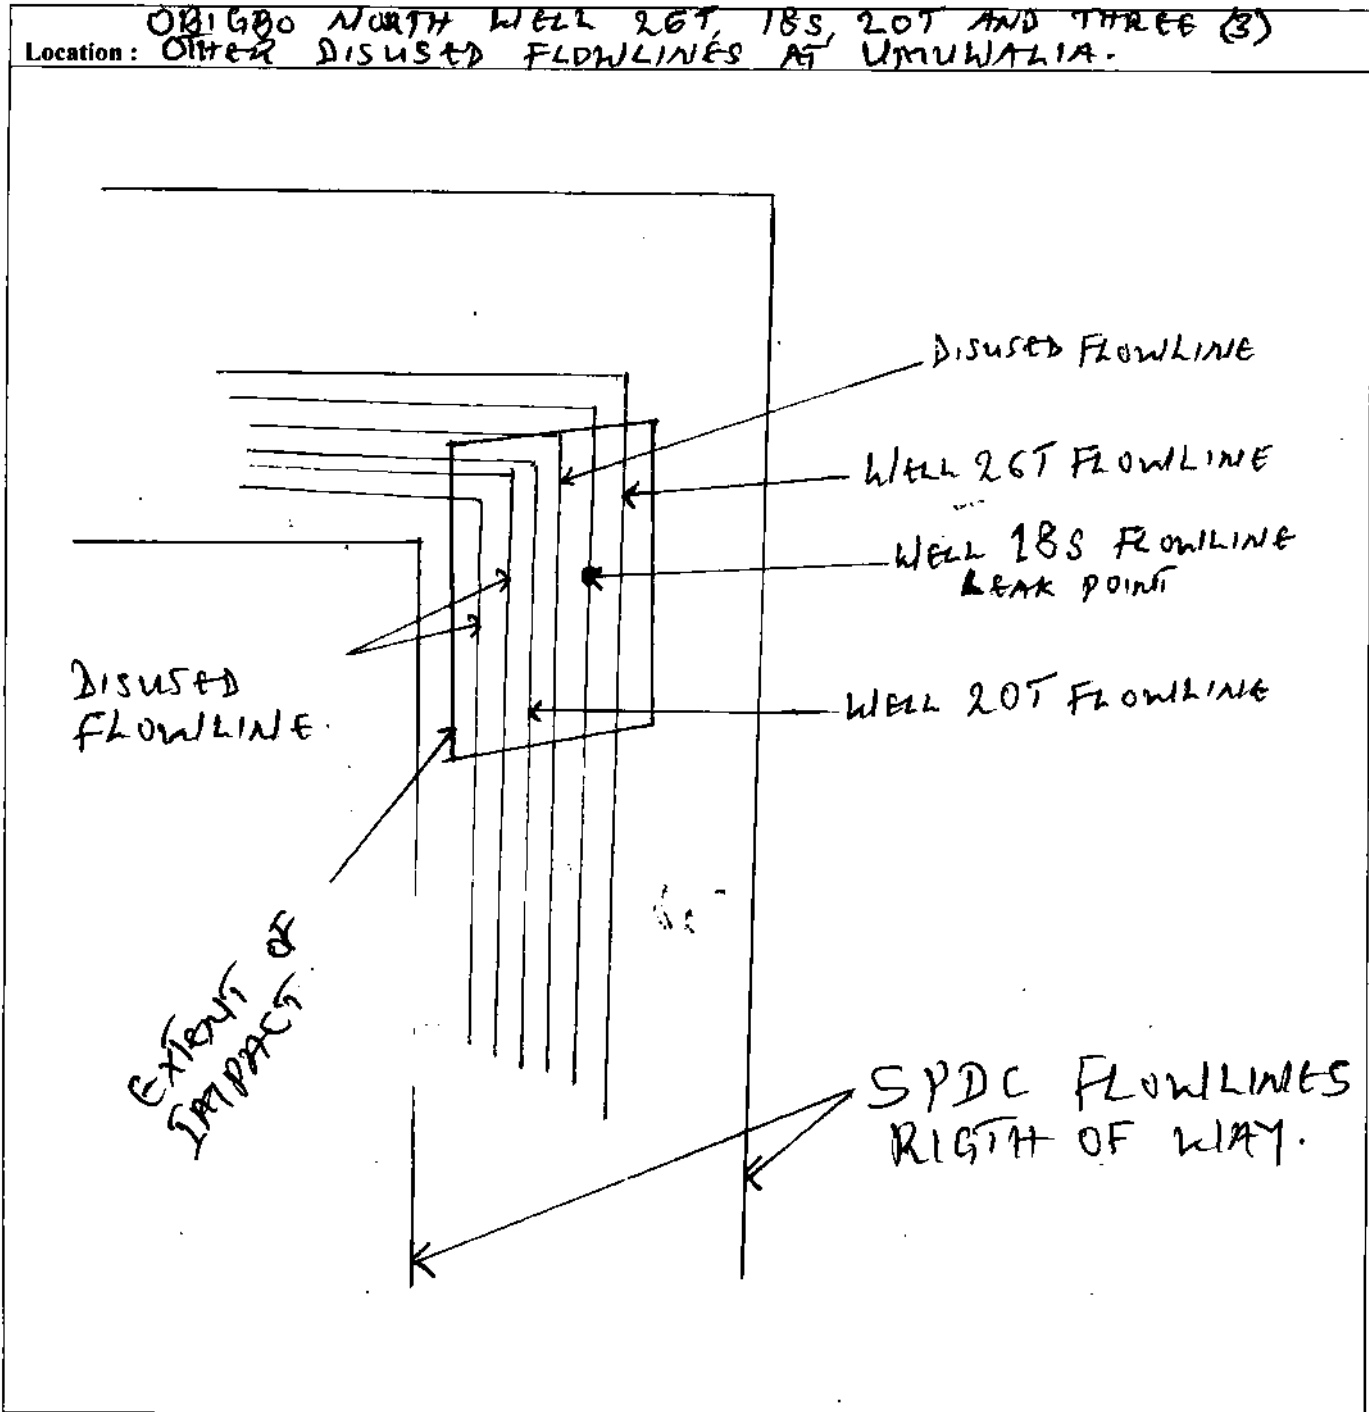
f. Appendix 1: Overview sketch of the site

Additional observations around the spill point: ON ARRIVAL AT SITE, THE JOINT INVESTIGATION AND TEAM OBSERVED PIECES OF CONCRETE AND RUBBER BELT SUSPECTED TO HAVE BEEN USED BY UNKNOWN PERSON(S) TO SECURE EXPLOSIVE MATERIAL WHICH CAUSED IMPACT (IRREGULAR HOLES, INWARD DENT, AND MARKS) TO THE OBIGBO NORTH WELL FLOWLINES.
