# JOINT INVESTIGATION REPORT

INCIDENT NO: 1749924 JIV report S/N: 0981

1. Spill incident Number: 1749924 2. Type of incident\* OIL SPILL  
3. Name of Location 16" NUNRIVER - KOLOCREEK PIPELINE  
AGBURA  
4. Name of nearest community OTUOKPOTI 5. State: BAYELSA LGA TENAGOA/OGBIA  
7. Type of Production facility/Installation OIL PIPELINE  
8. Asset owner/District SPDC / PIPELINE

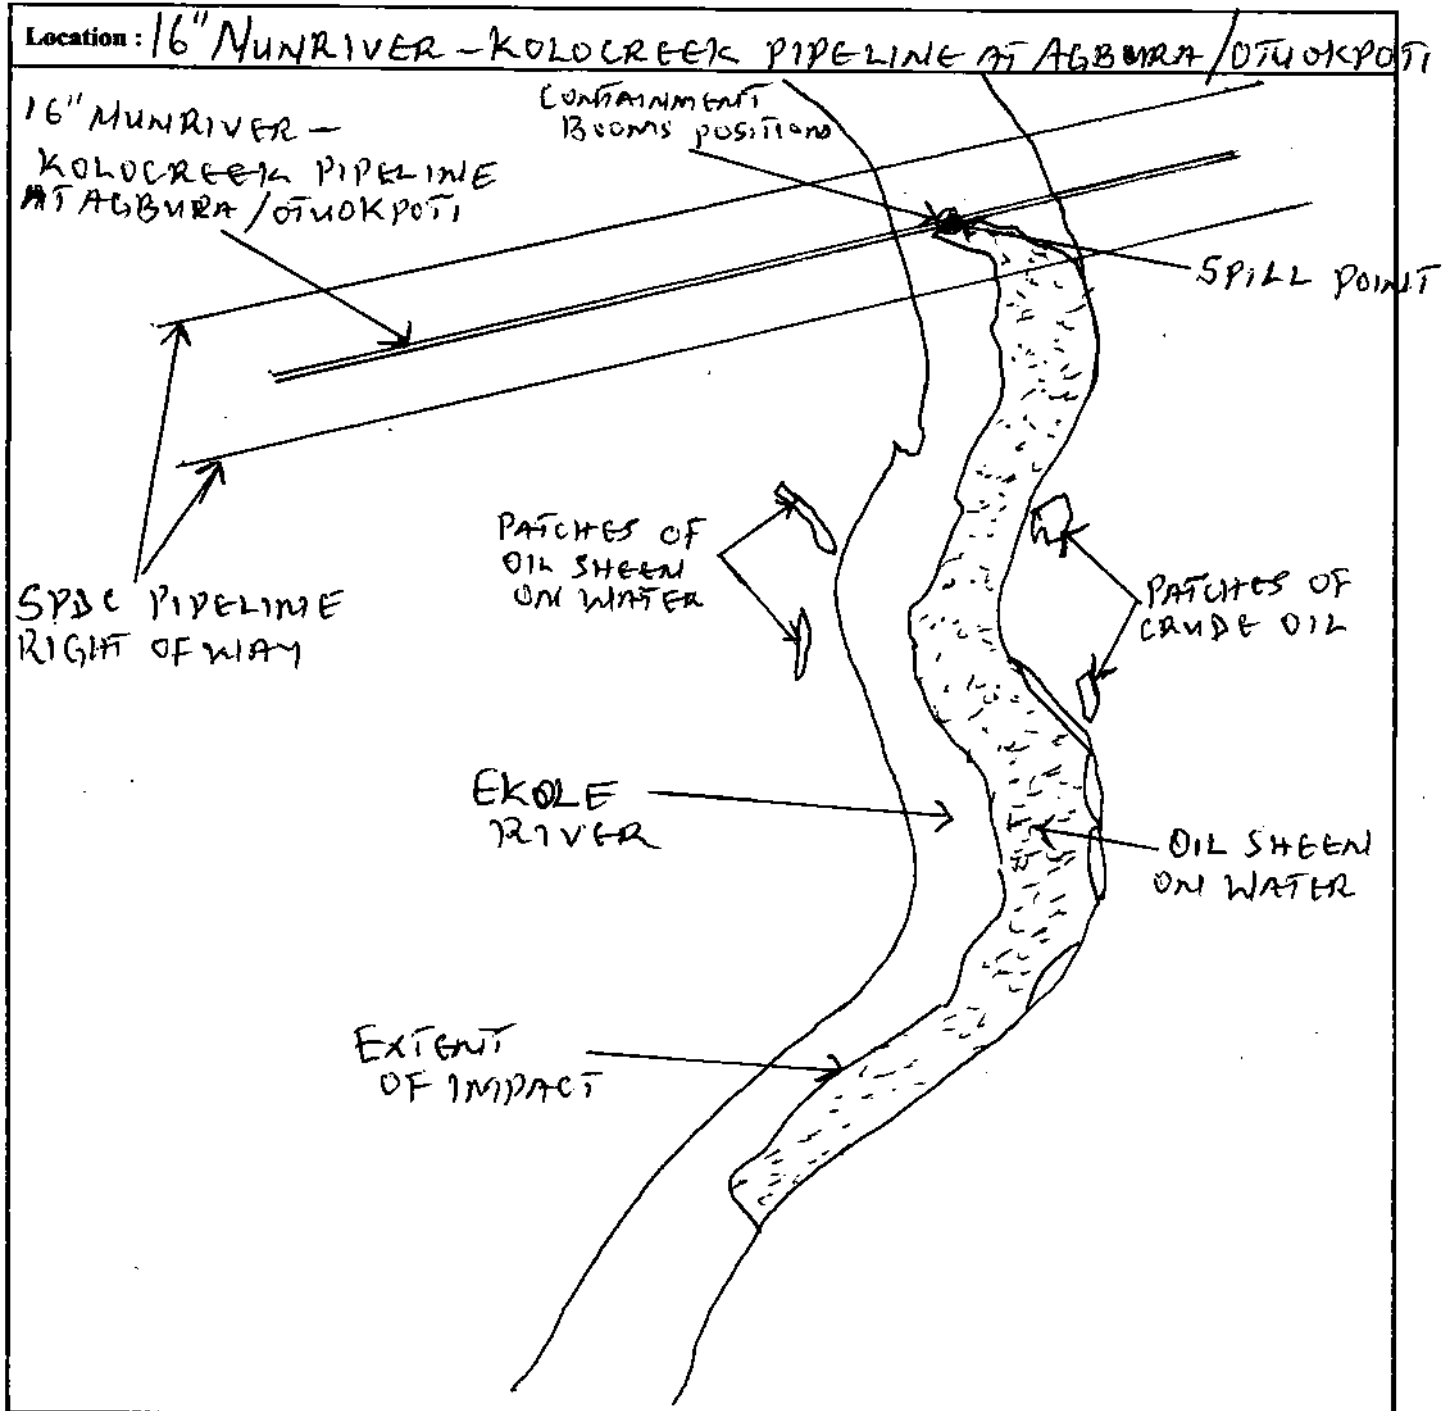
## f. Appendix 1: Overview sketch of the site

Additional observations around the spill point: JOINT INVESTIGATION TEAM (JIT) OBSERVED THAT THE INCIDENT OCCURED AT A RIVER CROSSING AND TOOK MORE THAN A YEAR TO ACCESS THE LEAK POINT. JIT ALSO OBSERVED THAT THE PIPELINE WAS TOTALLY SUBMERGED IN WATER. A SECTION OF COMPLETELY BROKEN OF THE PIPELINE WAS SUSPENDED.

SECTION OF 16" MUNRIVER - KOLOCREEK PIPELINE AT AGBURA / OTUOKPOT SHOWING POSITION OF COMPLETELY BROKEN POINT.
