# JOINT INVESTIGATION REPORT

INCIDENT NO: 1707836 JIV report S/N: Nº 0000090

1. Spill incident Number: 1707836 2. Type of incident\* OIL SPILL  
3. Name of Location 8" NKALI - IMO RIVER 2 PIPELINE (BREATHING TUBE BOX)  
4. Name of nearest community UMURU-OKHARA State: RIVERS 6. LGA ETCHE  
7. Type of Production facility/Installation 8" PIPELINE BREATHING TUBE BOX  
8. Asset owner/District THE SHELL PETROLEUM DEVELOPMENT COMPANY OF NIGERIA LIMITED | PIPELINE

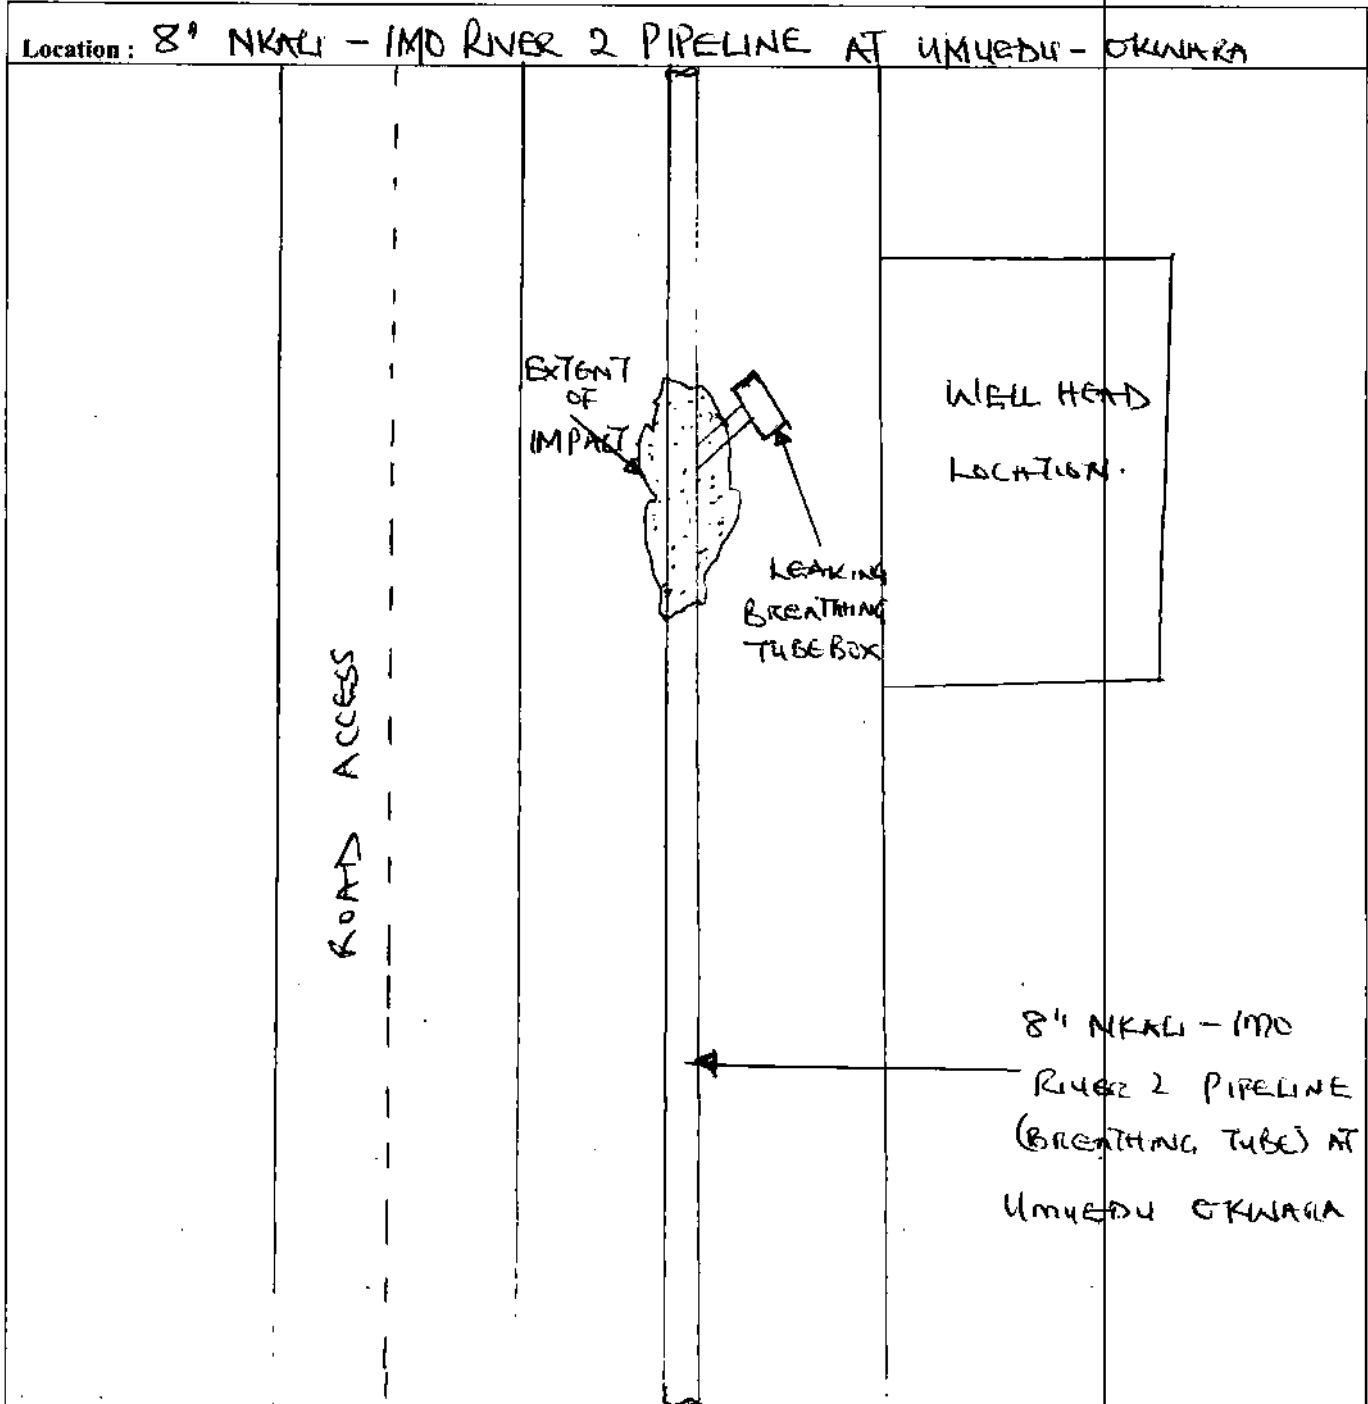
f. Appendix 1: Overview sketch of the site

Additional observations around the spill point: ON ARRIVAL AT THE INCIDENT SCENE, THE JOINT INVESTIGATION TEAM OBSERVED THAT THE KEROTEST VALVE WAS LEAKING AND LEFT IN AN OPEN POSITION BY UNKNOWN PERSON(S). ON TURNING OFF THE KEROTEST VALVE, THE LEAK STOPPED.

MOPPING OF N&N - RECOVERABLE AND REPAIR WORK INITIATED AND COMPLETED.
