JOINT INVESTIGATION REPORT

INCIDENT NO: 1911557 JIV report S/N: NO: 0000324

1. Spill incident Number: 1911557 2. Type of incident* OIL SPILL
3. Name of Location 20" OTUMARA - ESCRAVOS PIPELINE
4. Name of nearest community UGBOEGUNGUN 5. State: DELTA 6. LGA WARRI SOUTH-WEST
7. Type of Production facility/Installation OIL PIPELINE
8. Asset owner/District THE SHELL PETROLEUM DEVELOPMENT COMPANY OF NIGERIA LIMITED / PIPELINES

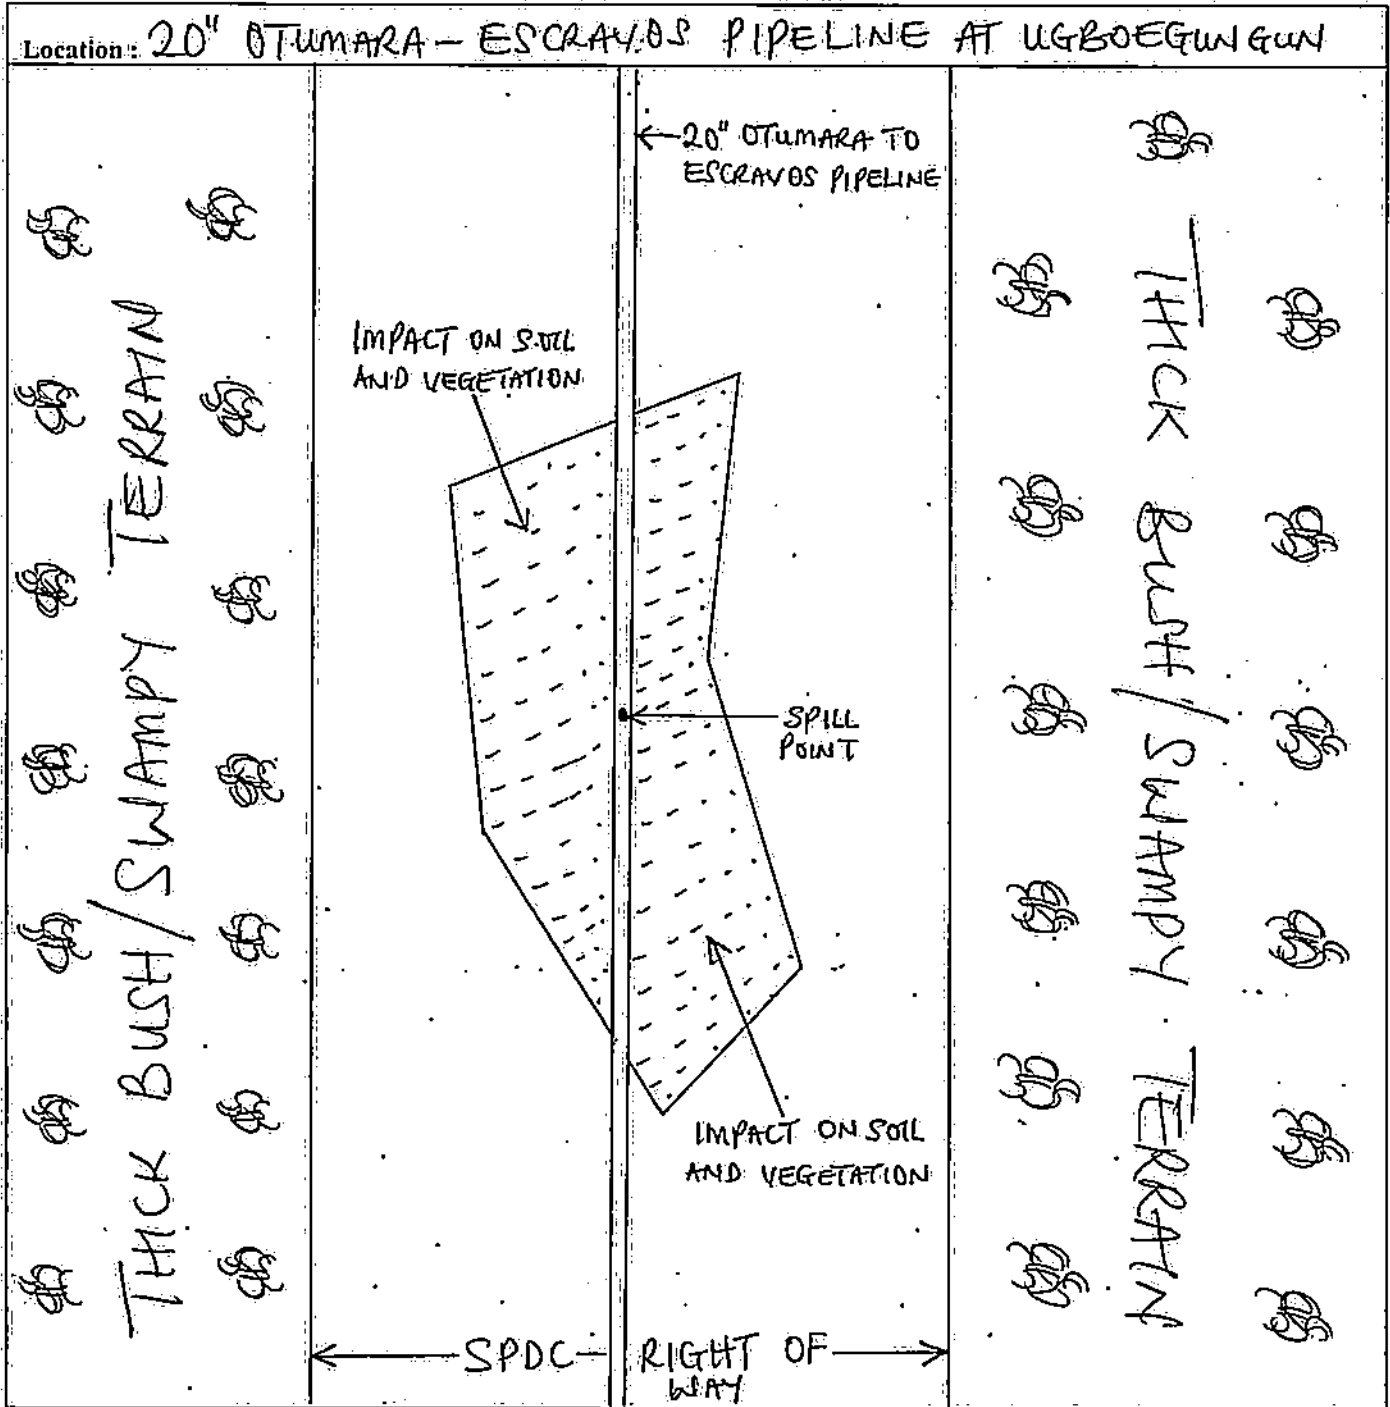
f. Appendix 1: Overview sketch of the site

ON EXCAVATION, THE JOINT INVESTIGATION TEAM OBSERVED A FAILED 4" VALVE ILLEGALLY ATTACHED TO THE 20" OTUMARA-ESCRAVOS PIPELINE AT 12 O' CLOCK POSITION. THE LEAK HAS STOPPED AS AT THE TIME OF THIS INVESTIGATION.

SECTION OF 20" OTUMARA-ESCRAVOS PIPELINE AT URBDEGUNGUW AXIS
SHOWING: A FAILED 4" VALVE ILLEGALLY ATTACHED AT 12 O' CLOCK POSITION
