# JOINT INVESTIGATION REPORT

INCIDENT NO: 1899560 JIV report S/N: Nº 0000329

1. Spill incident Number: 1899560 2. Type of incident\* OIL SPILL  
3. Name of Location BELEMA FLOW STATION  
4. Name of nearest community BELEMA 5. State: RIVERS 6. LGA AKUKU-TORU  
7. Type of Production facility/Installation FLOW STATION  
8. Asset owner/District THE SHELL PETROLEUM DEVELOPMENT COMPANY OF NIGERIA LIMITED / SWAMP EAST HUB

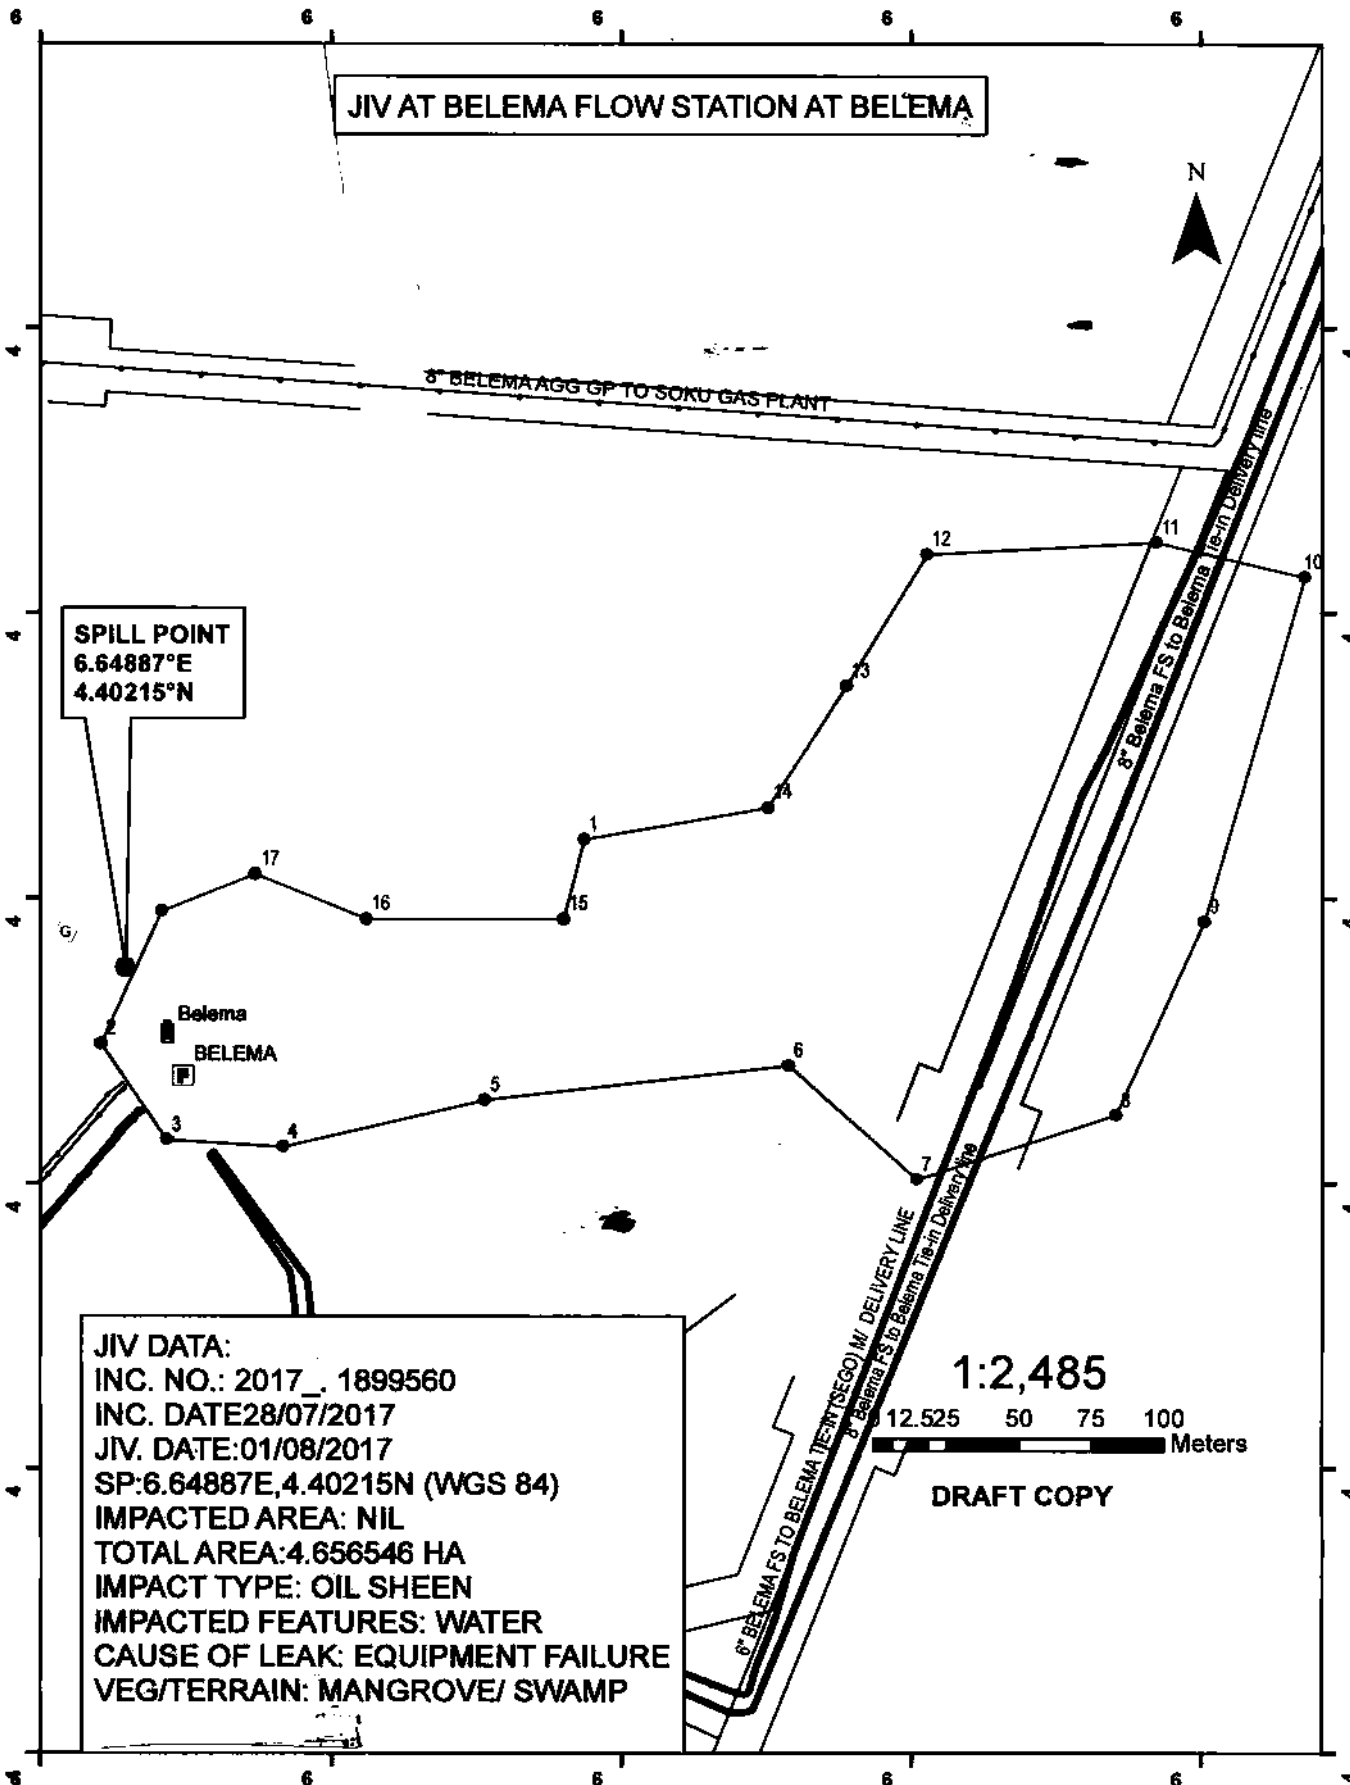
JIV AT BELEMA FLOW STATION AT BELEMA

SPILL POINT  
6.64887°E  
4.40215°N

JIV DATA:  
 INC. NO.: 2017\_ 1899560  
 INC. DATE: 28/07/2017  
 JIV. DATE: 01/08/2017  
 SP: 6.64887E, 4.40215N (WGS 84)  
 IMPACTED AREA: NIL  
 TOTAL AREA: 4.656546 HA  
 IMPACT TYPE: OIL SHEEN  
 IMPACTED FEATURES: WATER  
 CAUSE OF LEAK: EQUIPMENT FAILURE  
 VEG/TERRAIN: MANGROVE/ SWAMP
