JOINT INVESTIGATION REPORT

INCIDENT NO: 1955746 JIV report S/N: 1105

- 1. Spill incident Number: 1955746 2. Type of incident* OIL SPILL
- 3. Name of Location 20" OTUMARA - ESCRAVOS PIPELINE
- 4. Name of nearest community UGBOEGUNGUN, State: DELTA 6. LGA WARRI SOUTH-WEST
- 7. Type of Production facility/Installation OIL PIPELINE
- 8. Asset owner/District THE SHELL PETROLEUM DEVELOPMENT COMPANY OF NIGERIA LIMITED / PIPELINES

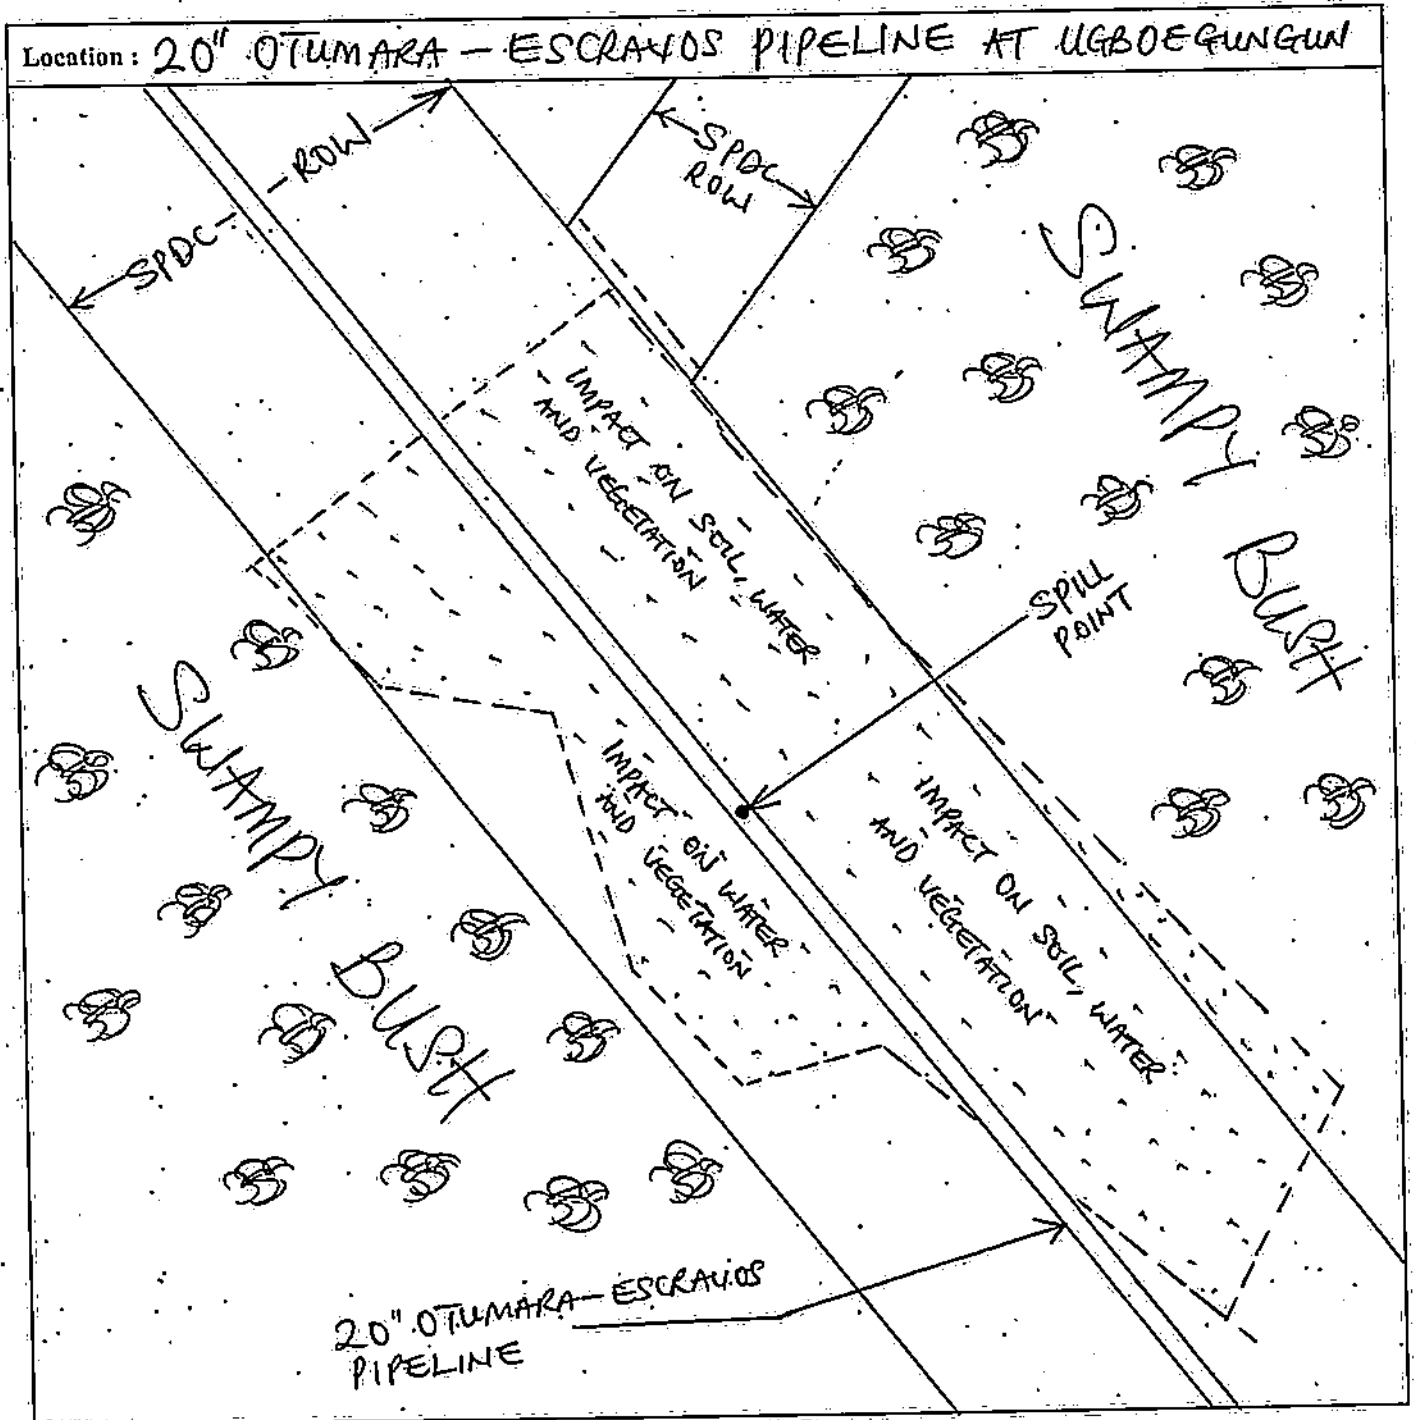
f. Appendix 1: Overview sketch of the site

Additional observations around the spill point: ON EXCAVATION, THE JOINT INVESTIGATION TEAM OBSERVED A FAILED 3" VALVE, ILLEGALLY ATTACHED TO THE 20" OTUMARA - ESCRAVOS PIPELINE AT 12 O' CLOCK POSITION.

E. GRAPHIC DESCRIPTION OF LEAK POINT (While detail report of the leak point should be contained in the leak report, overview sketch of the site should be added as an appendix I)
SECTION OF 20" OTUMARA - ESCRAVOP PIPELINE AT UGBOEGUNGUN
SHOWING POSITION OF 3" FAILED VALVE AT 12 O' CLOCK

FAILED 3" VALVE ILLEGALLY ATTACHED AT 12 O' CLOCK POSITION
