JOINT INVESTIGATION REPORT

INCIDENT NO: 2054409 JIV report S/N: 1042

1. Spill incident Number: 2054409 2. Type of incident* OIL SPILL
3. Name of Location 28" BOMU - BONNY TRANS NIGER PIPELINE
4. Name of nearest community PATRICK WATER SIDE 5. State: RIVERS 6. LGA GOKANA
7. Type of Production facility/Installation OIL PIPELINE
8. Asset owner/District THE SHELL PETROLEUM DEVELOPMENT COMPANY OF NIGERIA LIMITED PIPELINE

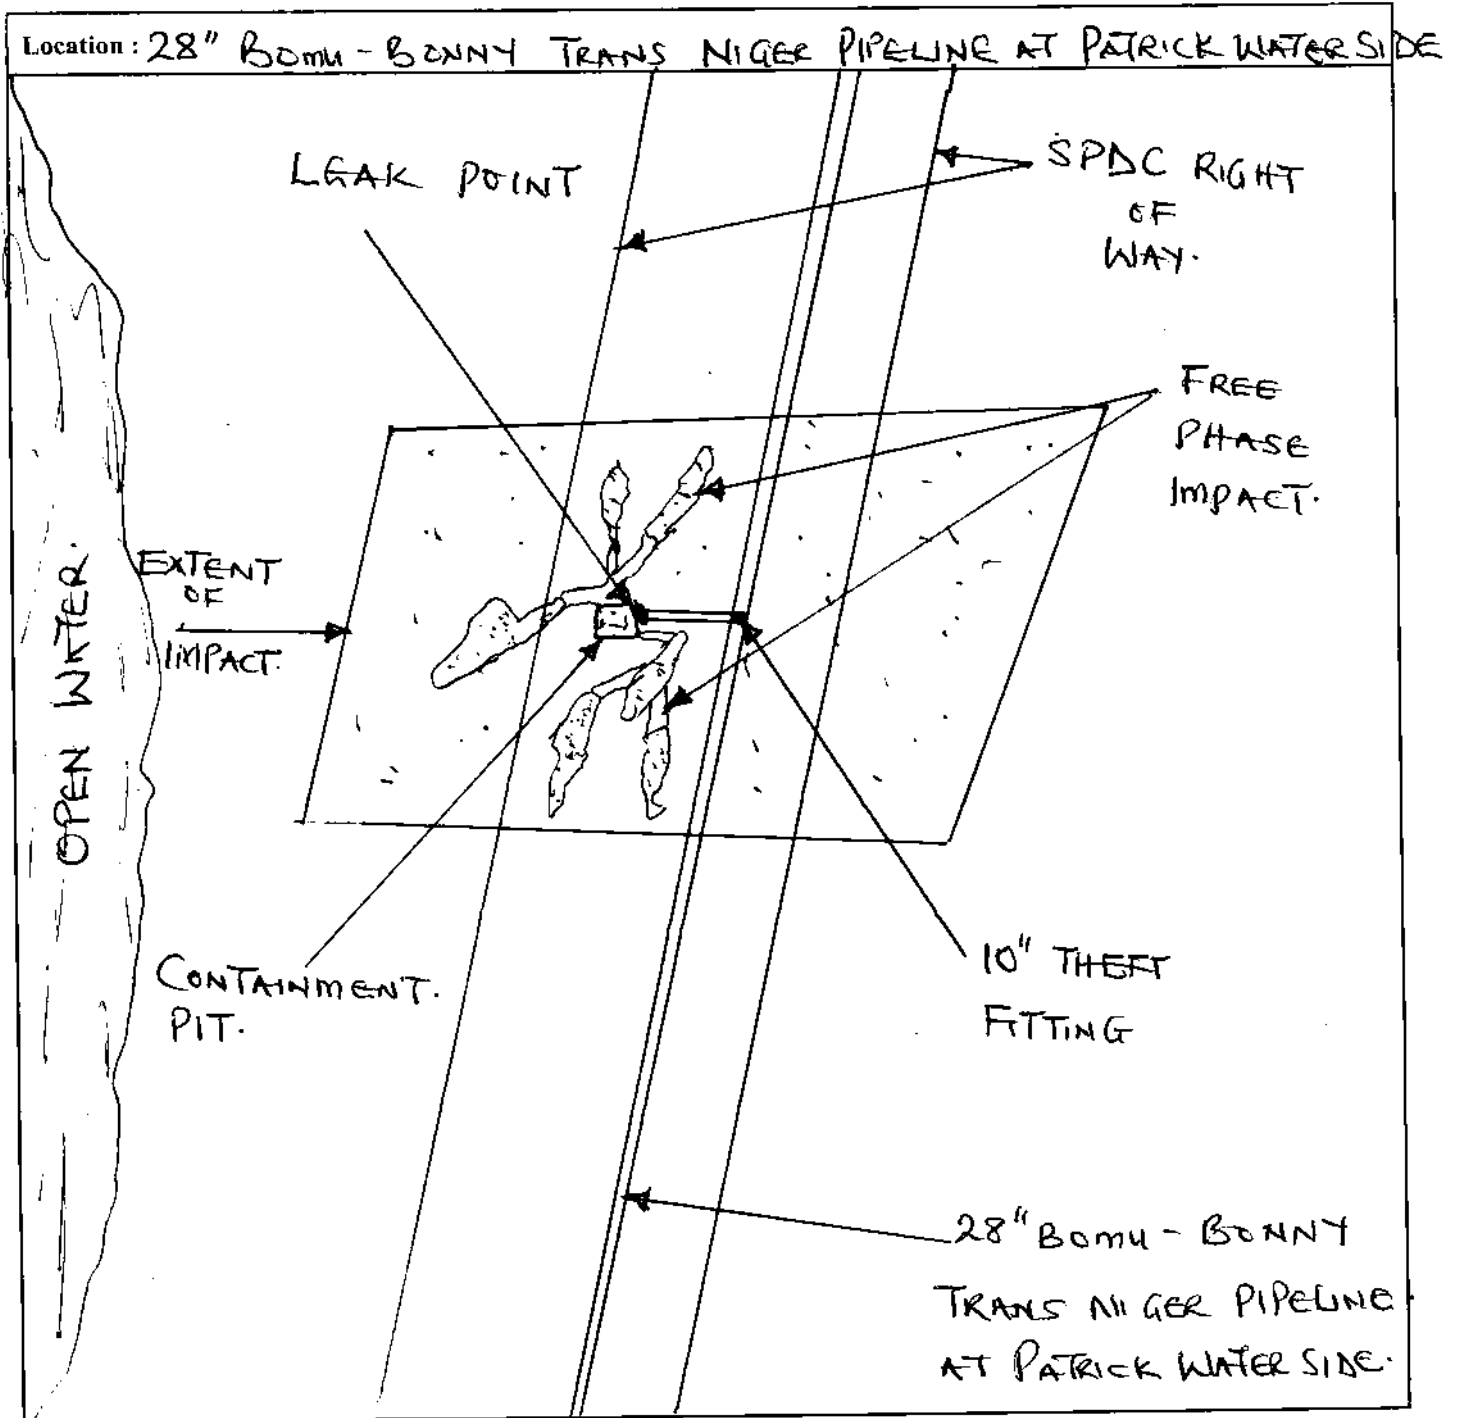
f. Appendix 1: Overview sketch of the site

Additional observations around the spill point: THE JOINT INVESTIGATION TEAM OBSERVED AN 8" PIPE EXTENSION CONNECTED TO THE 10" THEFT FITTING WITH A LEAK POINT 6 METERS AWAY FROM THE 28" BOMU - BONNY TRANS NIGER PIPELINE AT PATRICK WATER SIDE.

WATER SIDE SHOWING: LEAKING 10" BALL VALVE ILLEGAL THEFT FITTING INSTALLED AT 12 O'CLOCK POSITION.

RECOVERY WORK ONGOING WHILE REPAIR WORK BY BLIND
FLAYGONG COMPLETED.
