JOINT INVESTIGATION REPORT

INCIDENT NO: 2068083 JIV report S/N: 1036

1. Spill incident Number: 2068083 2. Type of incident* OIL SPILL
3. Name of Location 16" EGBEMA - ASSA PIPELINE
4. Name of nearest community EKUGBA 5. State: IMO 6. LGA OHAJI/ESBEMA
7. Type of Production facility/Installation OIL PIPELINE
8. Asset owner/District THE SHELL PETROLEUM DEVELOPMENT COMPANY OF NIGERIA
KTD (S PDC)/PIPELINE

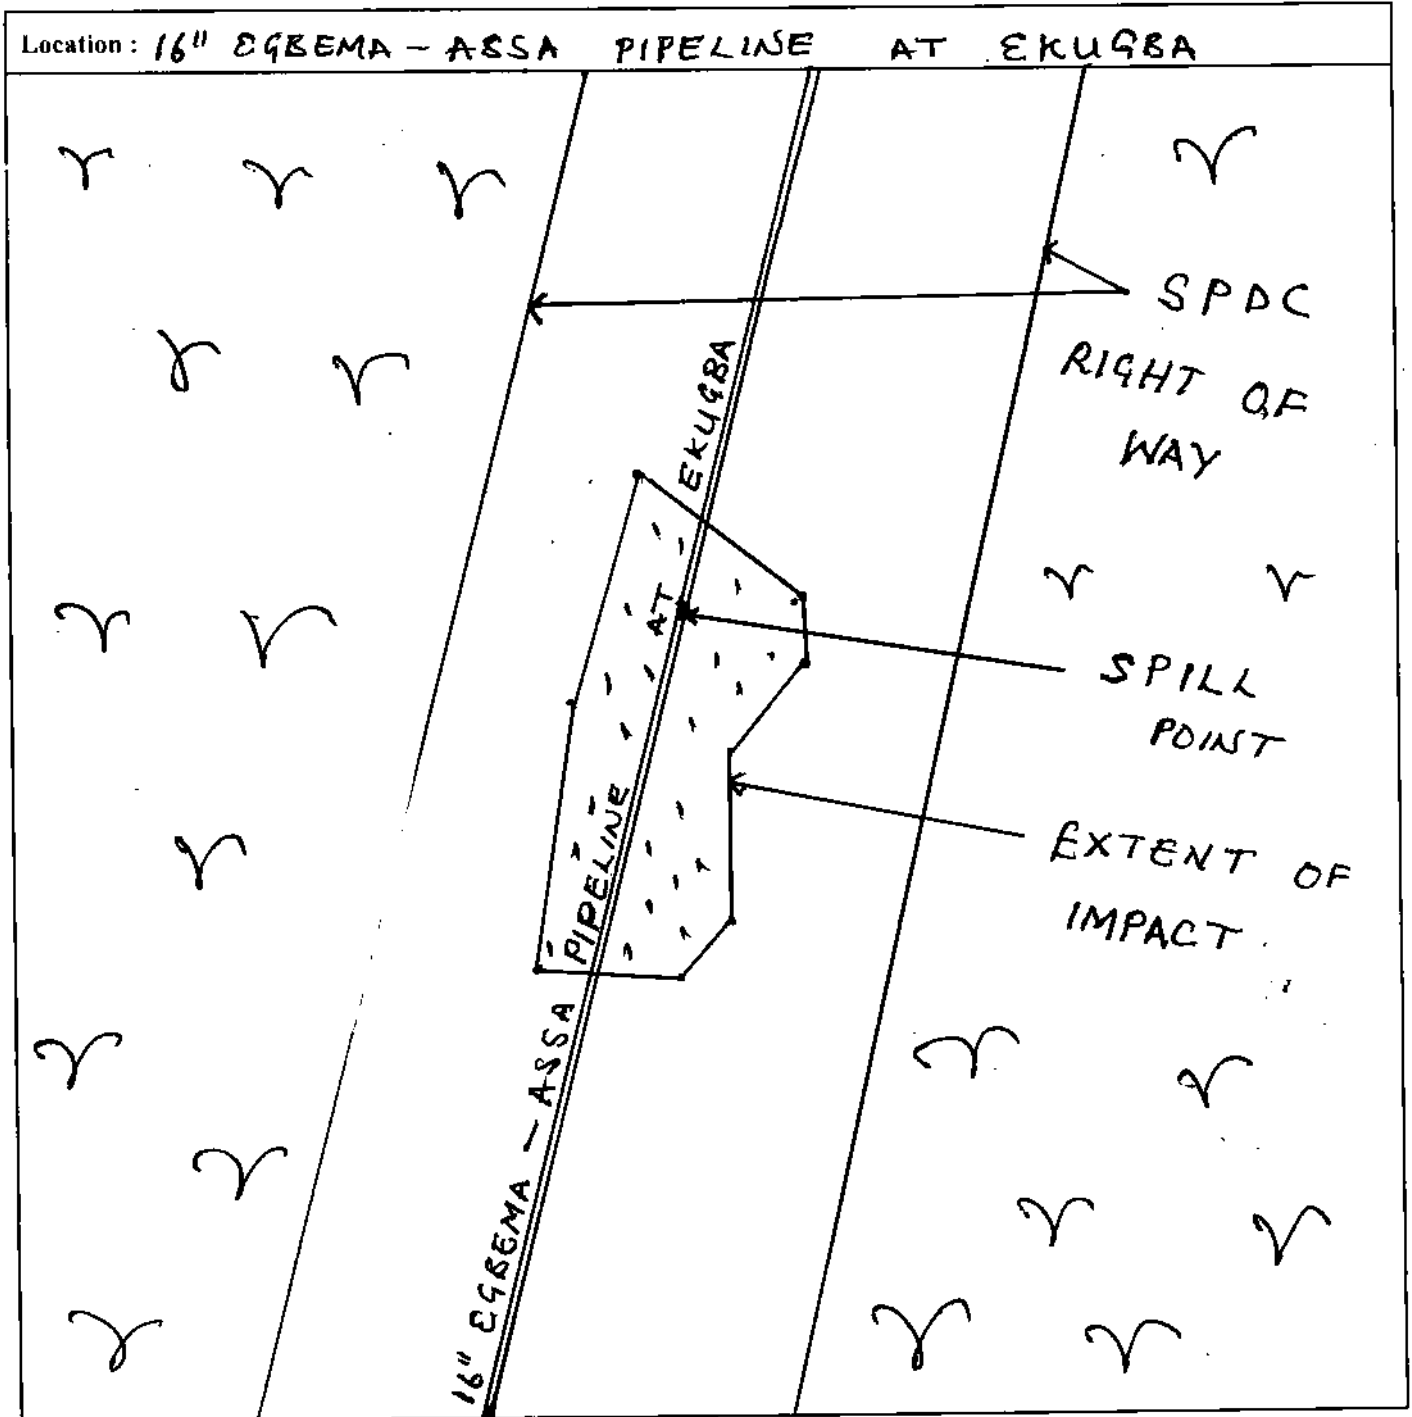
f. Appendix 1: Overview sketch of the site

Additional observations around the spill point: THE TEAM OBSERVED A 3" VALVE
CRUDE THEFT POINT INSTALLED AT 12 O'CLOCK
POSITIONS.

REPAIR BY CLAMPING
