# JOINT INVESTIGATION REPORT

INCIDENT NO: 2224449 JIV report S/N: 0192

1. Spill incident Number: 2224449 2. Type of incident\* OIL SPILL  
3. Name of Location 6" MININTA - AHIA BULKLINE  
4. Name of nearest community AKPARU 5. State: RIVERS 6. LGA EMOHUA  
7. Type of Production facility/Installation FLOWLINE  
8. Asset owner/District THE SHELL PETROLEUM DEVELOPMENT COMPANY OF NIGERIA LTD (SPDC) /

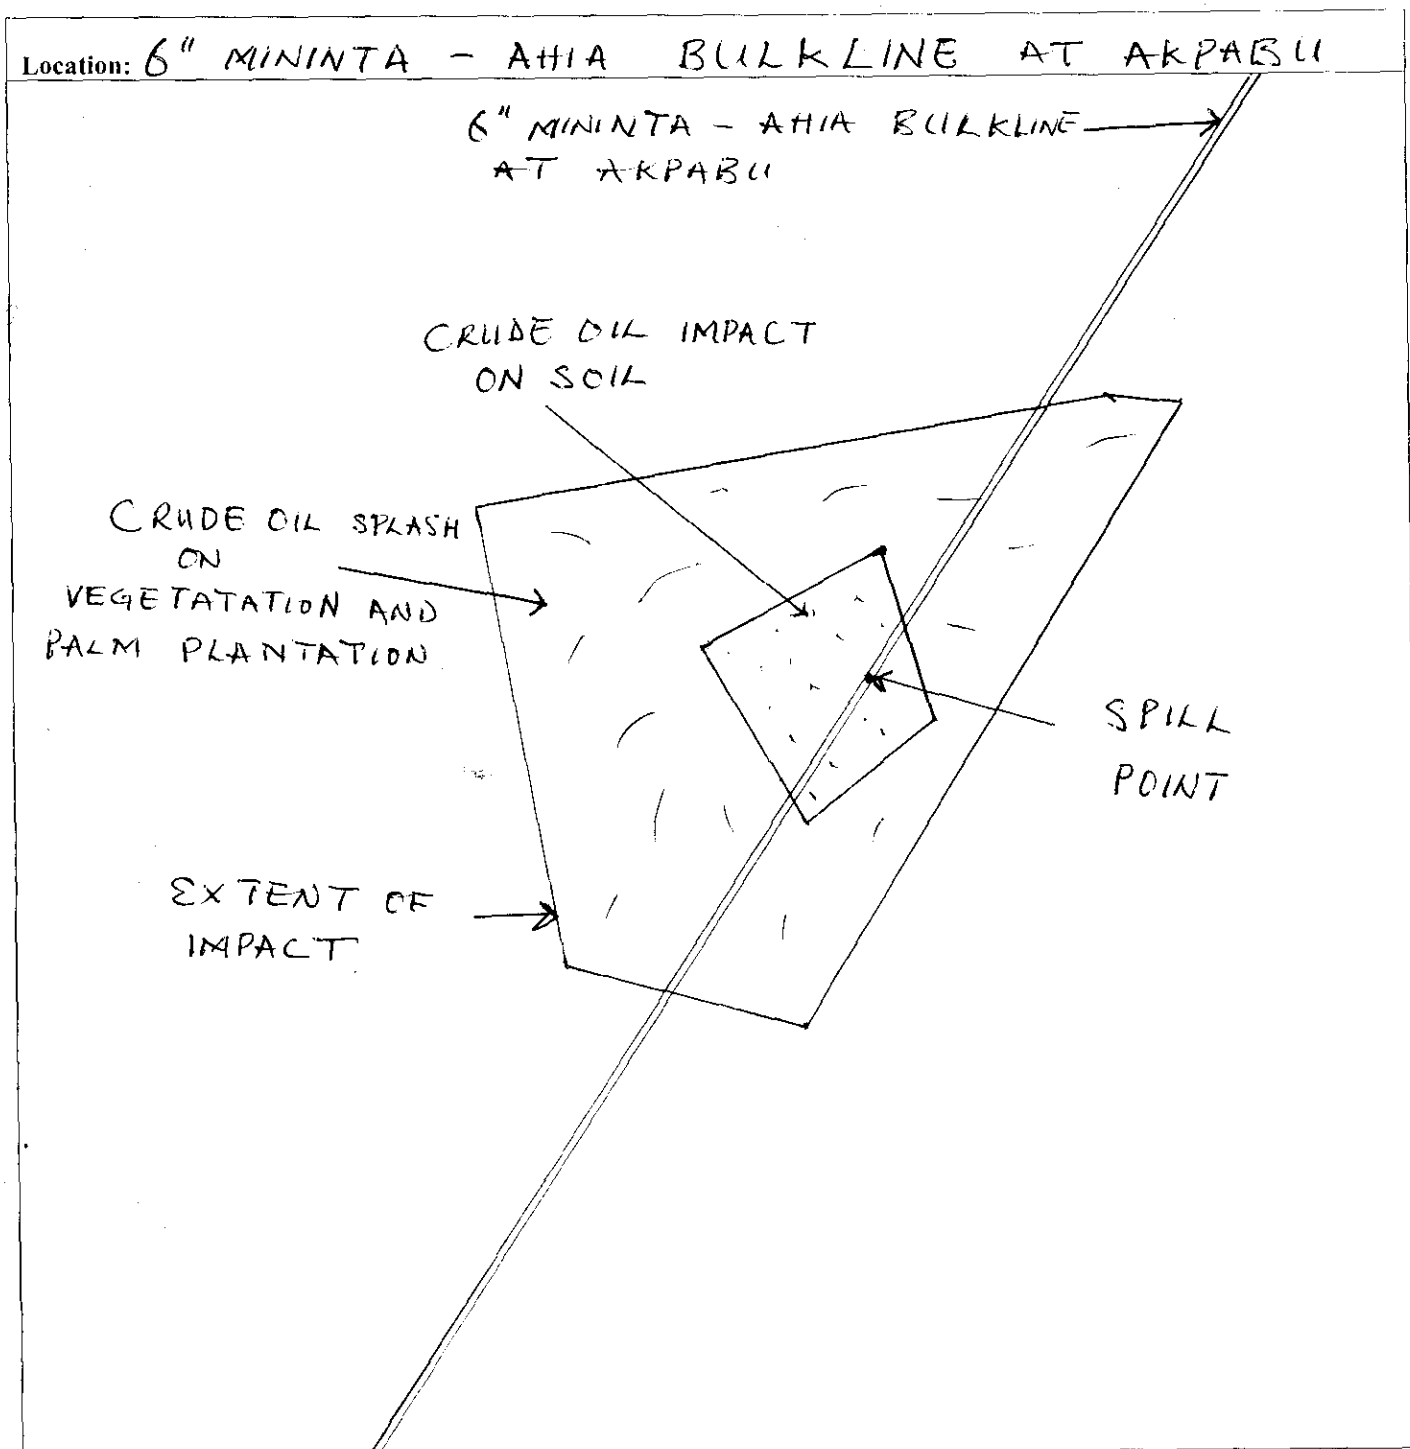
f. Appendix 1: Overview sketch of the site

E. GRAPHIC DESCRIPTION OF LEAK POINT (while detailed report of the leak point should be contained in the leak report, overview sketch of the site should be added as an appendix I) A SECTION OF 6" MININTA — AHIA BULKLINE AT ARPARU SHOWING 5mm DRILLED HOLE AT 11 O'CLOCK POSITION BY UNKNOWN PERSONS.
