JOINT INVESTIGATION REPORT

INCIDENT NO: 2018653 JIV report S/N: 1018

1. Spill incident Number: 2018653 2. Type of incident* OIL SPILL/FIRE
3. Name of Location 20" RUMUEKPE - NKPOKU PIPELINE
4. Name of nearest community OMUIGWE-ALUU 5. State: RIVERS 6. LGA IKWERRE
7. Type of Production facility/Installation OIL PIPELINE
8. Asset owner/District THE SHELL PETROLEUM DEVELOPMENT COMPANY OF NIGERIA LTD (SPDC) / PIPELINE

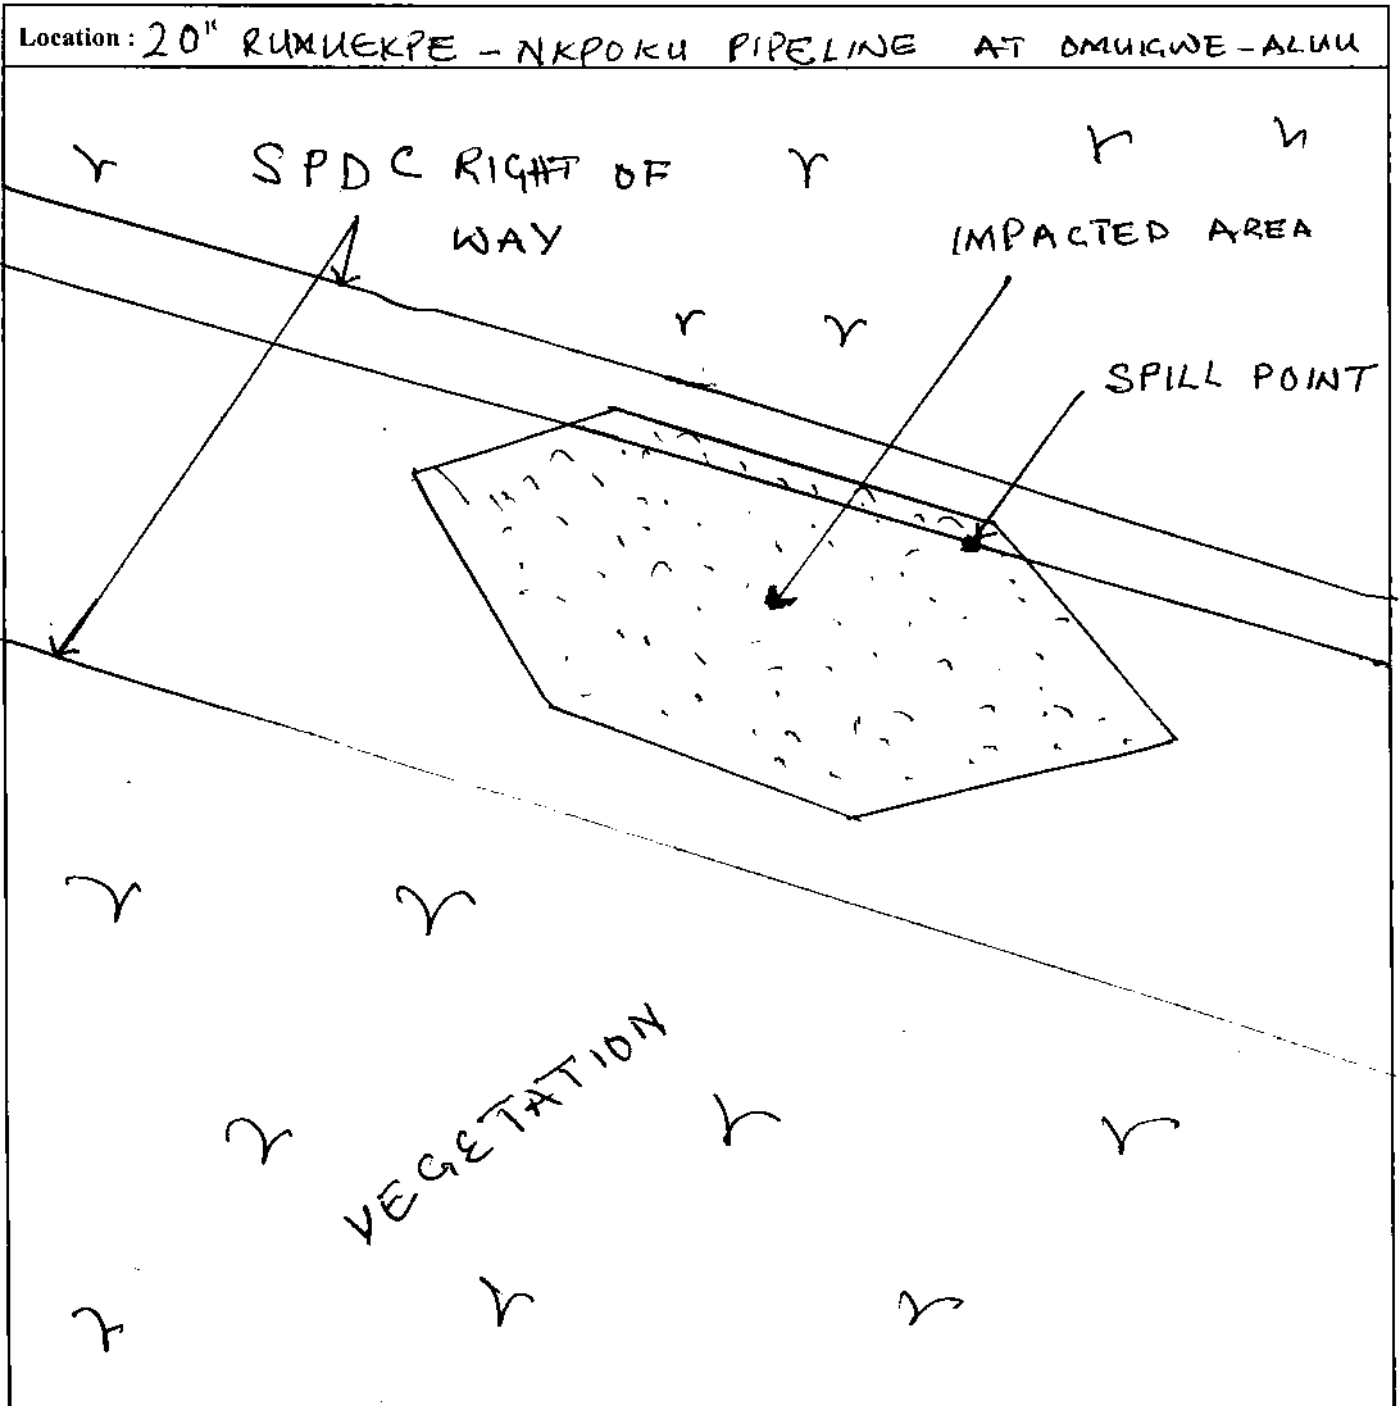
f. Appendix 1: Overview sketch of the site

Additional observations around the spill point: THE JOINT INVESTIGATION TEAM OBSERVED THAT THE SPILL SITE WAS ALREADY BURNT, BY FIRE.

① FIRE BURNT THE OIL.
 ② THE INCIDENT WAS ACCOMPANIED ~~WITH~~ BY FIRE.
for

REPAIR BY CLAMPING
