# JOINT INVESTIGATION REPORT

INCIDENT NO: 2000229 JIV report S/N: 0917

1. Spill incident Number: 2000229 2. Type of incident\* OIL SPILL  
3. Name of Location AGBADA WELL 18 T FLOWLINE  
4. Name of nearest community OMUNIKE (OMUNOBO) 5. State: RIVERS 6. LGA IKWERRE  
7. Type of Production facility/Installation OIL FLOWLINE  
8. Asset owner/District THE SHELL PETROLEUM DEVELOPMENT COMPANY OF NIGERIA LIMITED / LAND EAST HUB

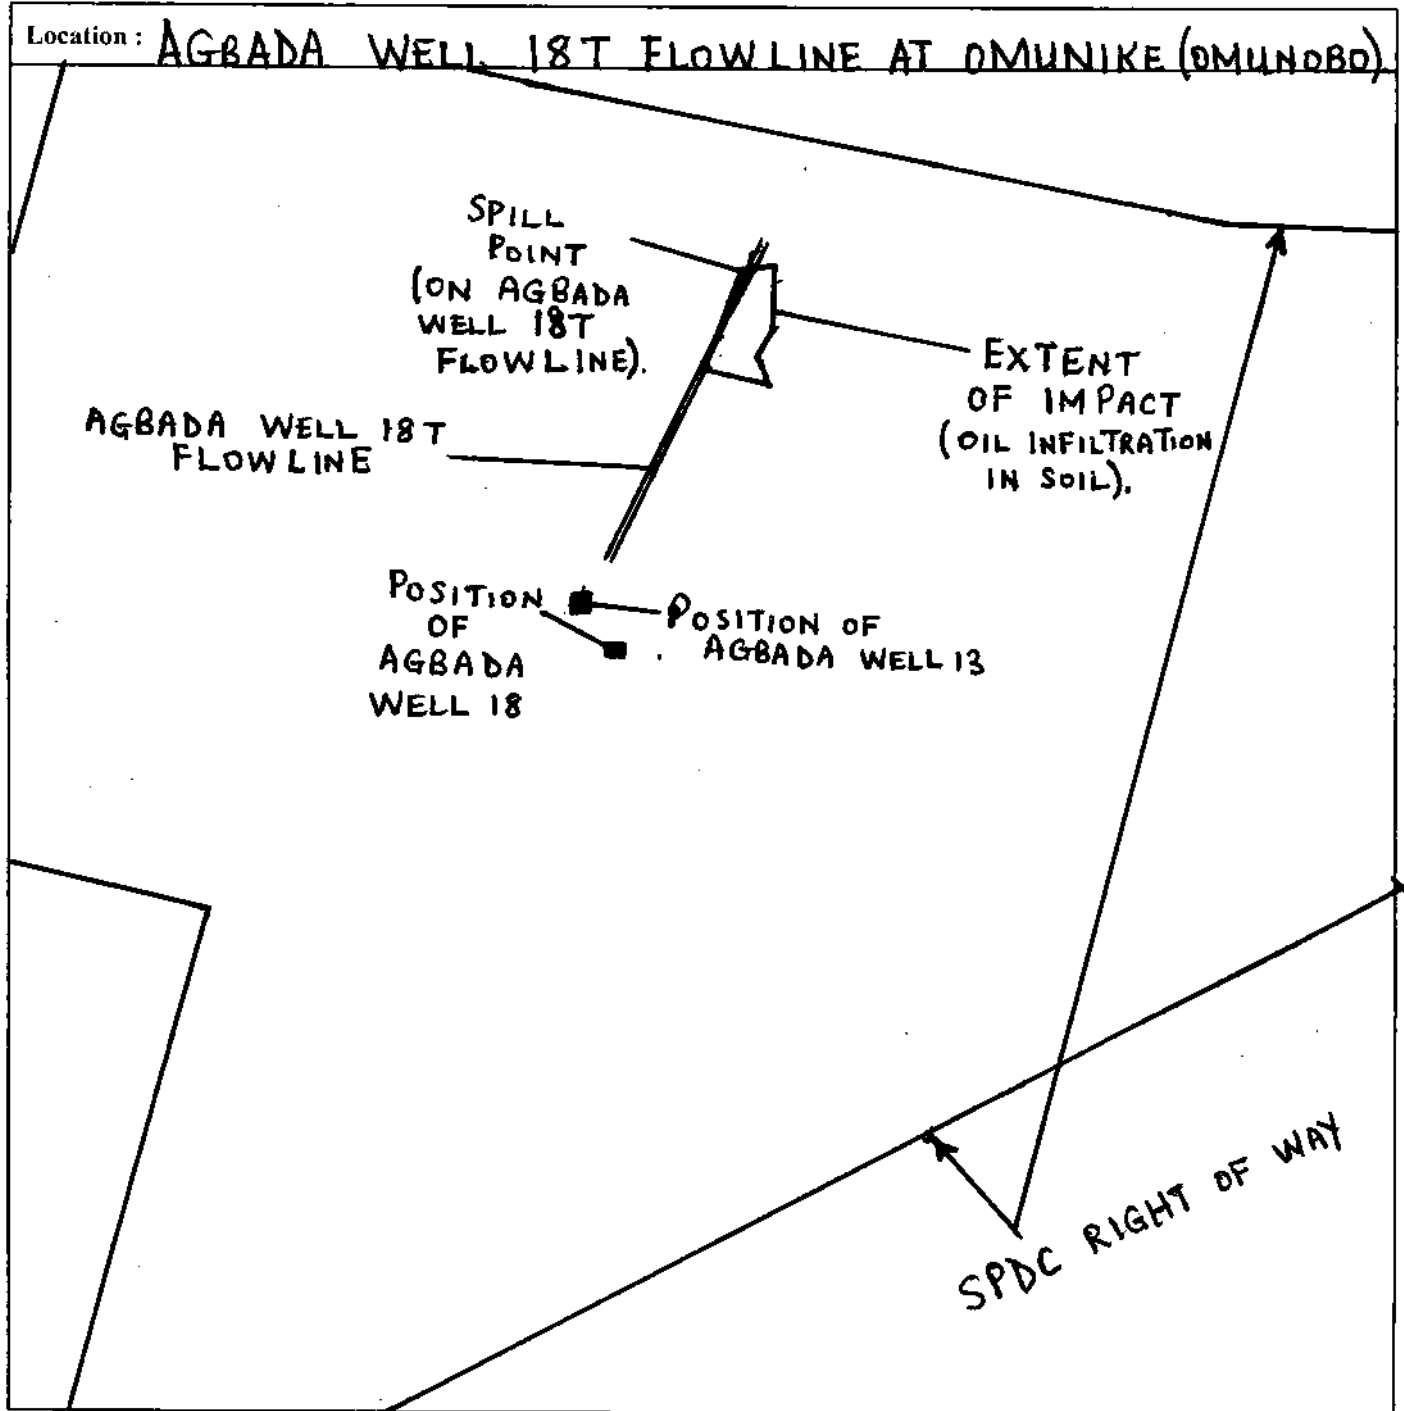
f. Appendix 1: Overview sketch of the site

Additional observations around the spill point: **SPILL WAS OBSERVED WITHIN AN ONGOING REMEDIATED SITE. THE JOINT INVESTIGATION TEAM, ON ARRIVAL AT SITE, NOTICED THAT THE SPILL POINT (OCCASIONED BY THE MISSING FLOWLINE VALVE ON AGBADA WELL 18 T FLOWLINE) HAD BEEN BLIND-FLANGED BY THE ASSET OWNER AS A MEANS OF POSITIVE ISOLATION. THE ADJACENT AGBADA WELL 13 FLOWLINE HAD ITS VALVE STILL IN PLACE.**

SECTION OF AGBADA WELL 18T FLOW LINE AT SOKU SHOWING EVIDENCE OF MISSING FLOW LINE VALVE REMOVED BY UNKNOWN PERSON(S).
