JOINT INVESTIGATION REPORT

INCIDENT NO: 2119145 JIV report S/N: 1095

1. Spill incident Number: 2119145 2. Type of incident* OIL SPILL
3. Name of Location 16" NUN RIVER - KOLD CREEK PIPELINE
4. Name of nearest community OPOROMA 5. State: BAYELSA 6. LGA SOUTHERN IJAW
7. Type of Production facility/Installation OIL PIPELINE
8. Asset owner/District THE SHELL PETROLEUM DEVELOPMENT COMPANY OF NIGERIA LTD (SPDC) / PIPELINE

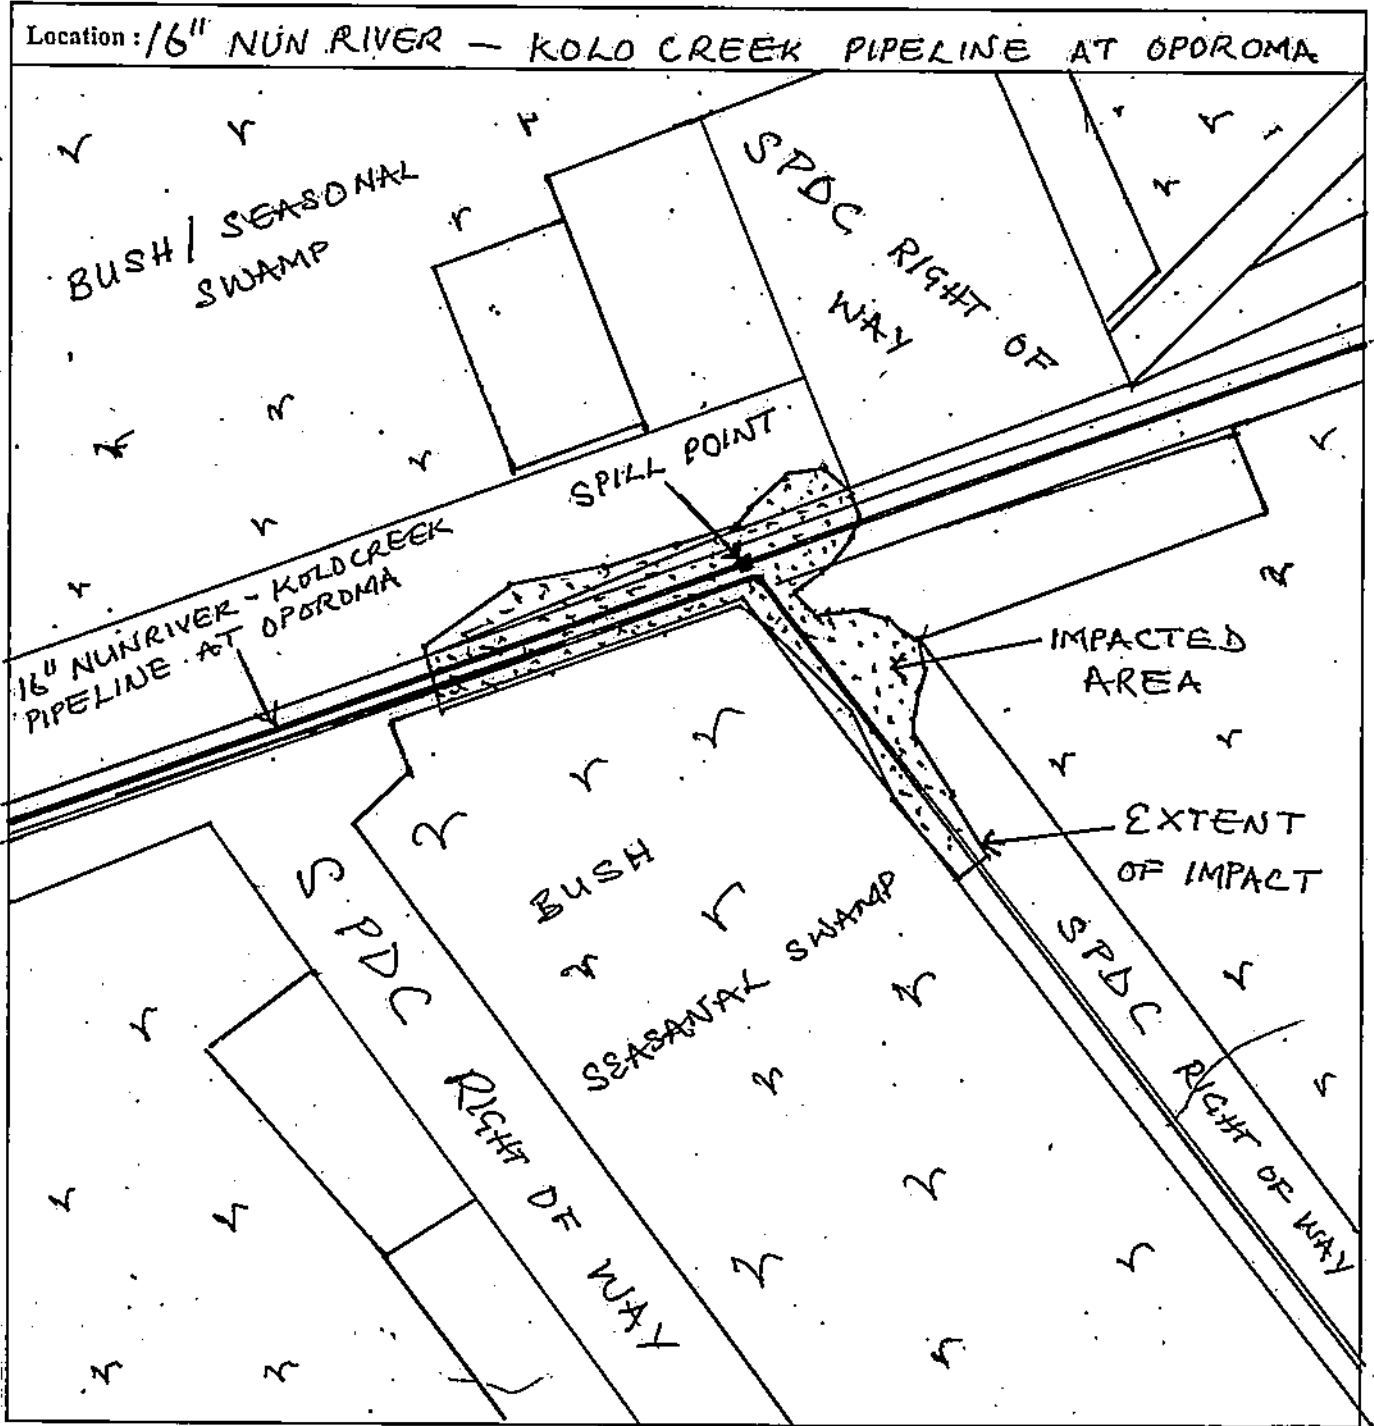
f. Appendix 1: Overview sketch of the site

Additional observations around the spill point: THE TEAM OBSERVED AN IRREGULAR HOLE AT 6 O'CLOCK POSITION.

E. GRAPHIC DESCRIPTION OF LEAK POINT (While detail report of the leak point should be contained in the leak report, overview sketch of the site should be added as an appendix.) A SECTION OF 16" NUN RIVER - KOLO CREEK PIPELINE AT OPOROMA SHOWING AN IRREGULAR HOLE AT 6 O'CLOCK POSITION DUE TO CORROSION.
