JOINT INVESTIGATION REPORT

INCIDENT NO: 2129948 JIV report S/N: 0028

1. Spill incident Number: 2129948 2. Type of incident* DIL SPILL
 3. Name of Location: 12" INDIAN RIVER - OGALE PIPELINE
 4. Name of nearest community OGALE 5. State: RIVERS 6. LGA ELEME
 7. Type of Production facility/Installation DIL PIPELINE
 8. Asset owner/District THE SHELL PETROLEUM DEVELOPMENT COMPANY OF NIGERIA LIMITED PIPELINE

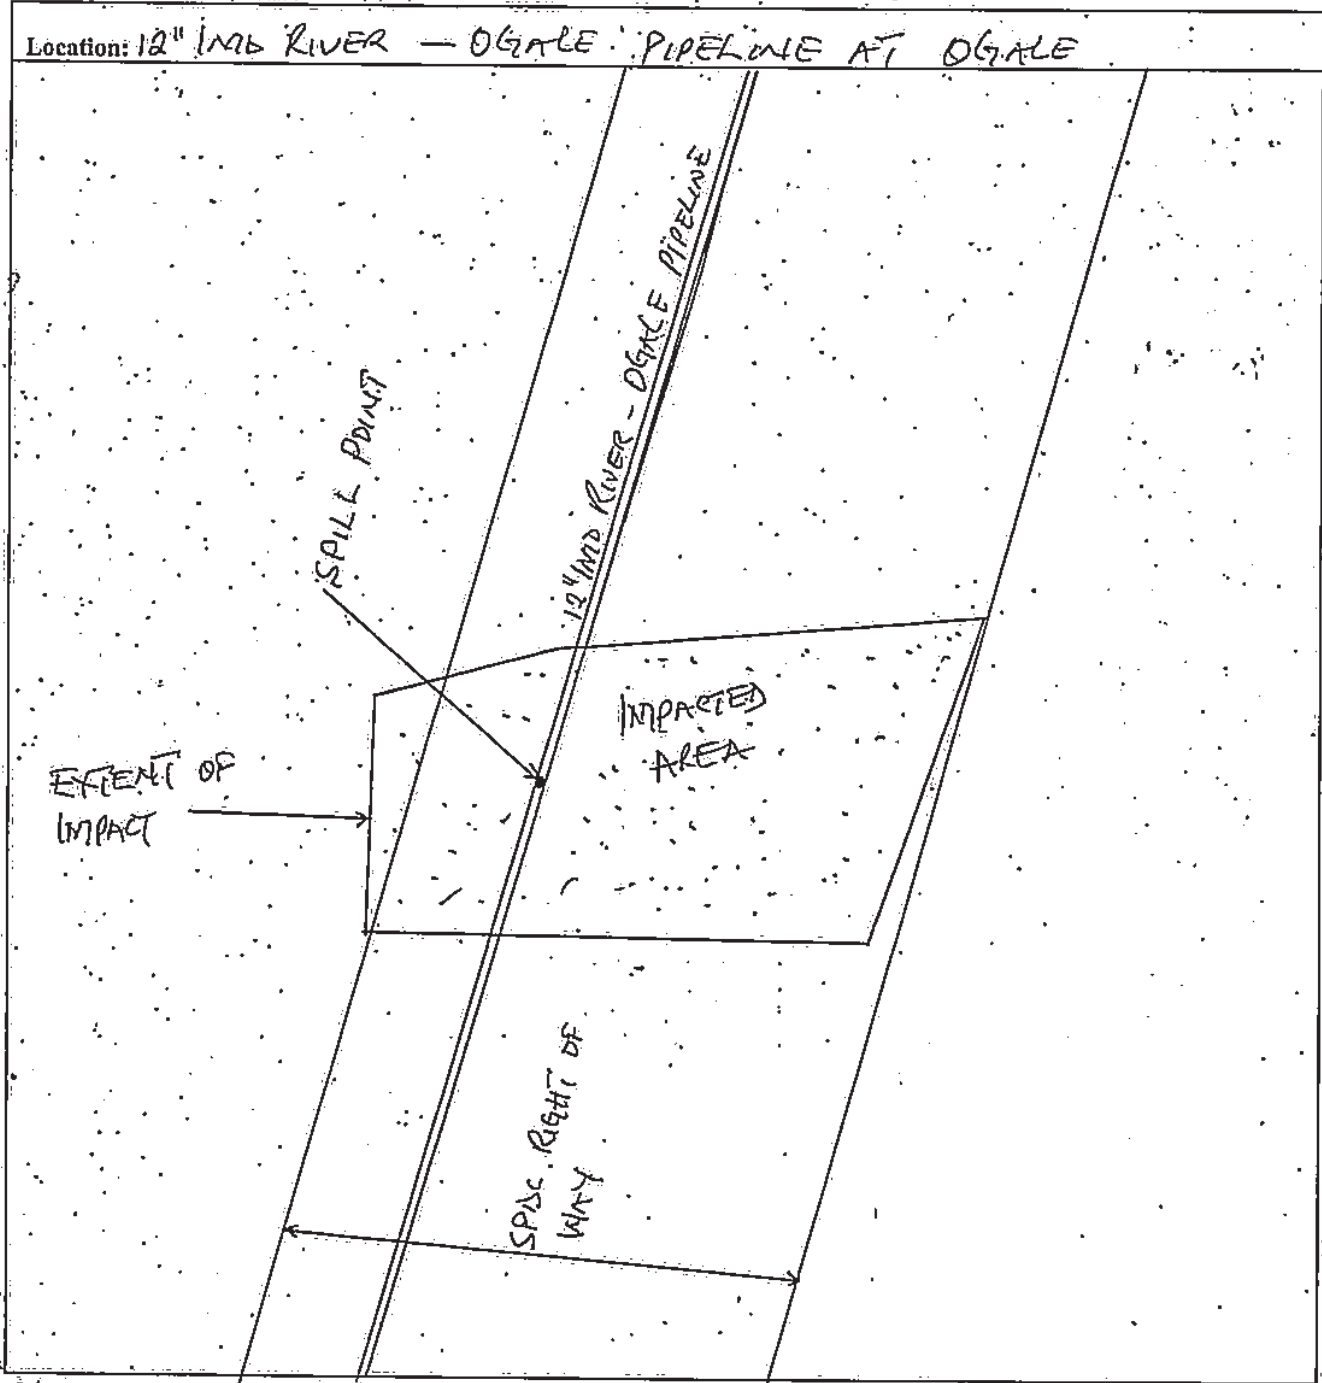
f. Appendix 1: Overview sketch of the site

Additional observations around the spill point: THE JOINT INVESTIGATION TEAM OBSERVED A DRILLED HOLE AND A LOCALLY FABRICATED CLAMP WITH 1" VALVE INSTALLED BOTH AT 12 O'CLOCK POSITION BY UNKNOWN PERSONS. THE JOINT INVESTIGATION TEAM ALSO OBSERVED BURNT SOIL WITHIN THE LEAK POINT AREA.

E. GRAPHIC DESCRIPTION OF LEAK POINT (while detailed report of the leak point should be contained in the leak report, overview sketch of the site should be added as an appendix 1) A SECTION OF 12" INDIAN RIVER - OGALÉ PIPELINE AT OGALÉ SHOWING A DRILLED HOLE AT 12 O'CLOCK POSITION AND A LOCALLY FABRICATED CLAMP WITH 1" VALVE INSTALLED BY UNKNOWN PERSON(S).

REPAIR BY CLAMPING ONGONG.
