JOINT INVESTIGATION REPORT

INCIDENT NO: 2130768 JIV report S/N: 0018

1. Spill incident Number: 2130768 2. Type of incident* OIL SPILL
3. Name of Location 16" NUN RIVER - KOLOCREEK PIPELINE
4. Name of nearest community OTUEGWE IS. State: BAYELSA. LGA OGBIA
7. Type of Production facility/Installation OIL PIPELINE
8. Asset owner/District THE SHELL PETROLEUM DEVELOPMENT COMPANY OF NIGERIA LTD (SPDC) / PIPELINE

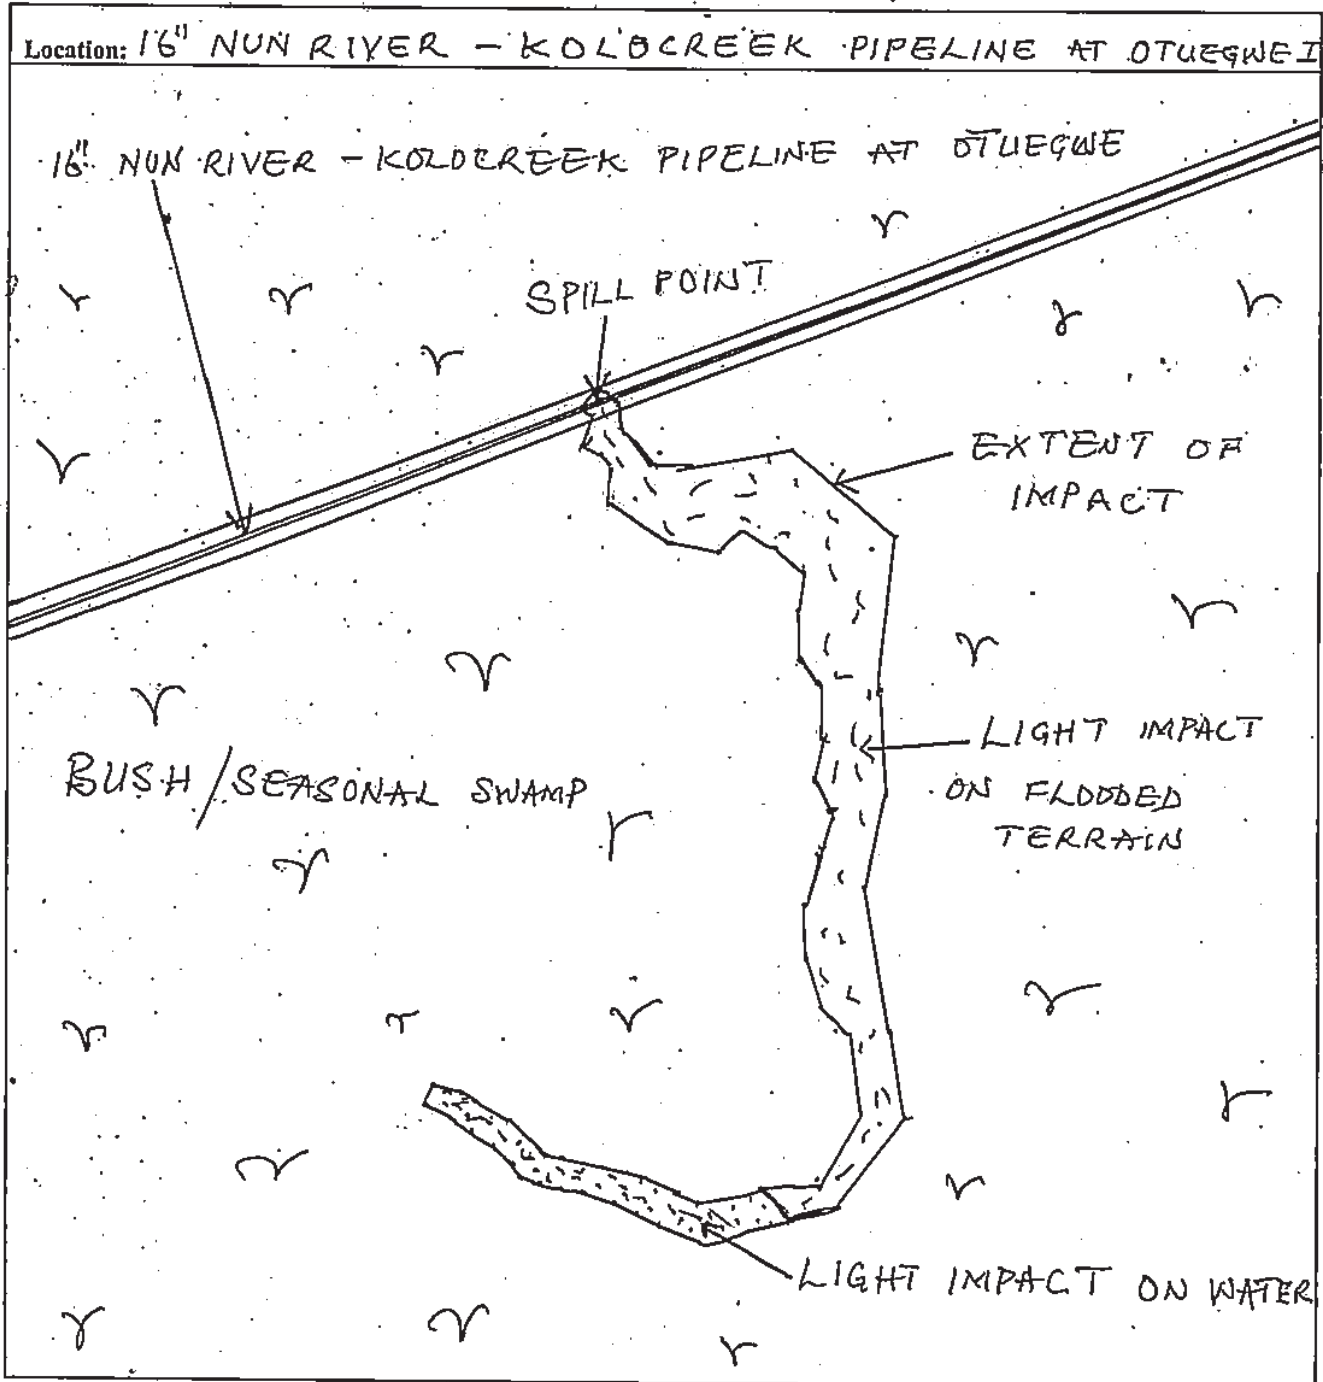
f. Appendix 1: Overview sketch of the site

Additional observations around the spill point: THE JOINT INVESTIGATION TEAM SAW 3" VALVE CRUDE THEFT POINT INSTALLED AT 12 O'CLOCK POSITION.

E. GRAPHIC DESCRIPTION OF LEAK POINT (while detailed report of the leak point should be contained in the leak report, overview sketch of the site should be added as an appendix 1) A SECTION OF 16" NUN RIVER - KOLOCREEK PIPELINE AT OTUEGWEI SHOWING 3" VALVE CRUDE THEFT POINT INSTALLED AT 12 O'CLOCK POSITION BY UNKNOWN PERSONS

i. Joint investigation of the incident site found that there is no residual impact after the initial response and JIT therefore recommend that the site be closed out
