JOINT INVESTIGATION REPORT

INCIDENT NO: 2097259 JIV report S/N 1084

1. Spill incident Number: 2097259 2. Type of incident* OIL SPILL
3. Name of Location UBIE WELL 5 L/S WELL HEAD
4. Name of nearest community IDU-EKPEYE 5. State: RIVERS 6. LGA MBADA WEST
7. Type of Production facility/Installation WELL HEAD
8. Asset owner/District THE SHELL PETROLEUM DEVELOPMENT COMPANY OF NIGERIA

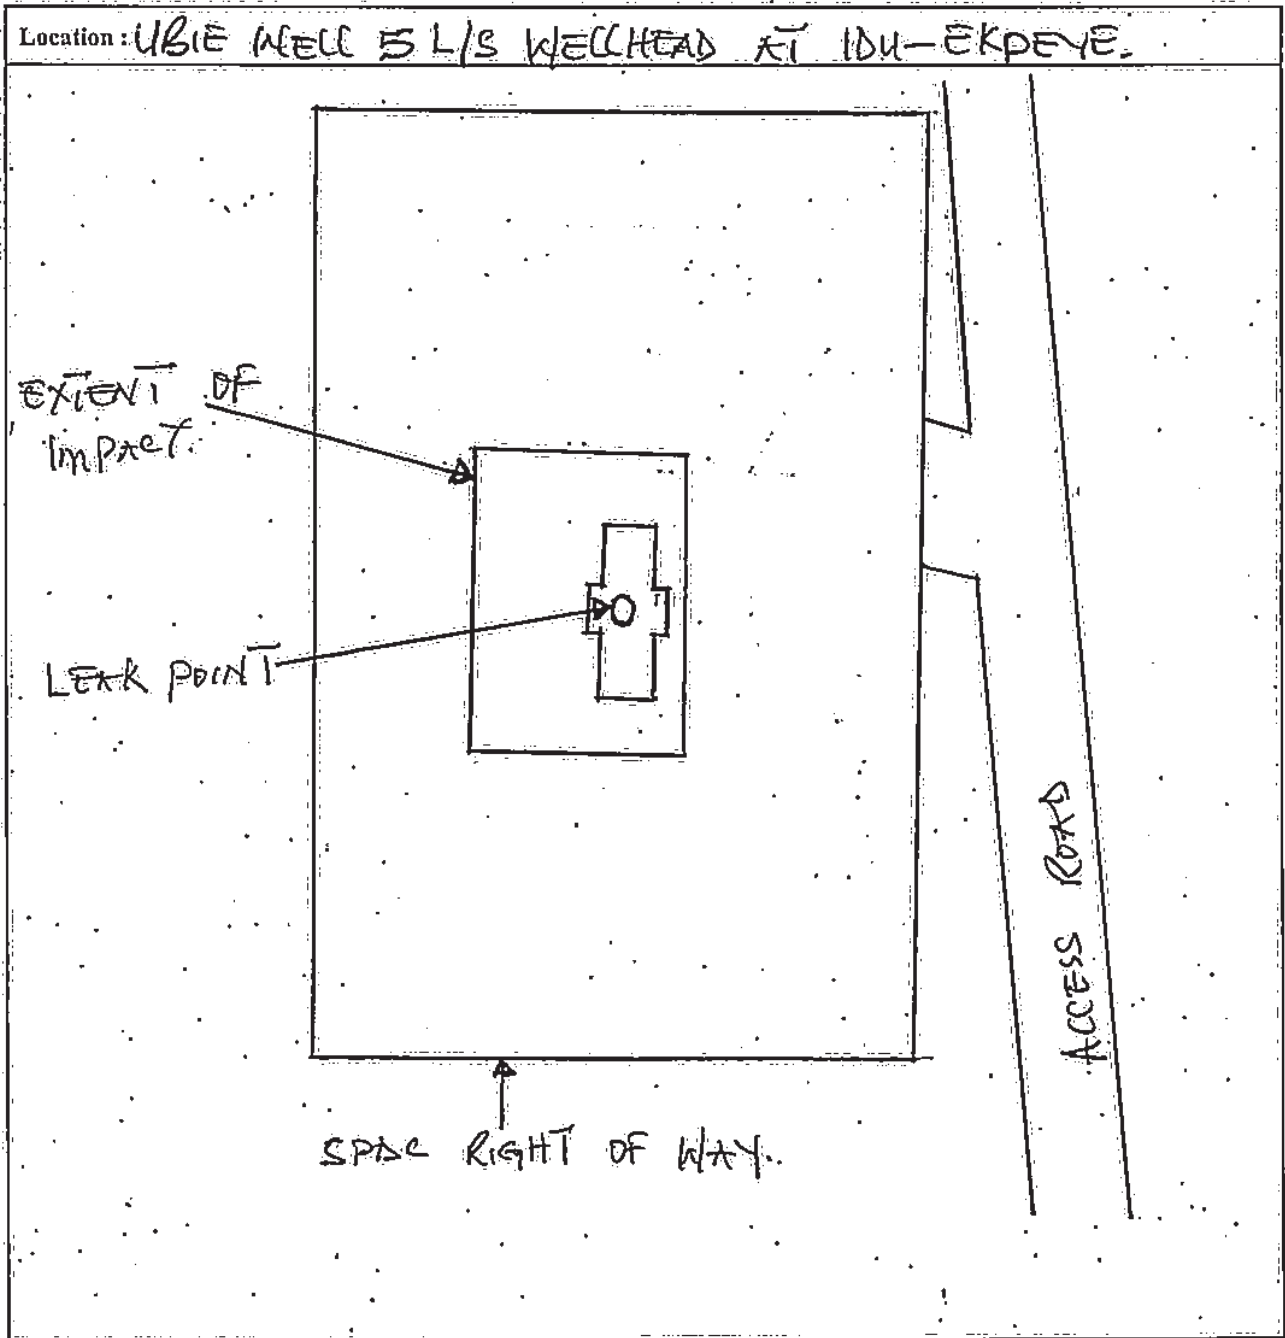
f. Appendix 1: Overview sketch of the site

Additional observations around the spill point: THE JOINT INVESTIGATION TEAM OBSERVED THAT UBIE WELL 5 XMAS TREE HAD BEEN VANDALIZED.
