JOINT INVESTIGATION REPORT

INCIDENT NO: 2104692 JIV report S/N: 1083

1. Spill incident Number: 2104692 2. Type of incident* OIL SPILL
3. Name of Location 18th ASSA — RUMUEKPE TRUNKLINE AT ONJUDIOGA
4. Name of nearest community ONJUDIOGA 5. State: RIVERS 6. LGA EMBUHUA
7. Type of Production facility/Installation PIPELINE
8. Asset owner/District THE SHELL PETROLEUM DEVELOPMENT COMPANY OF NIGERIA LIMITED

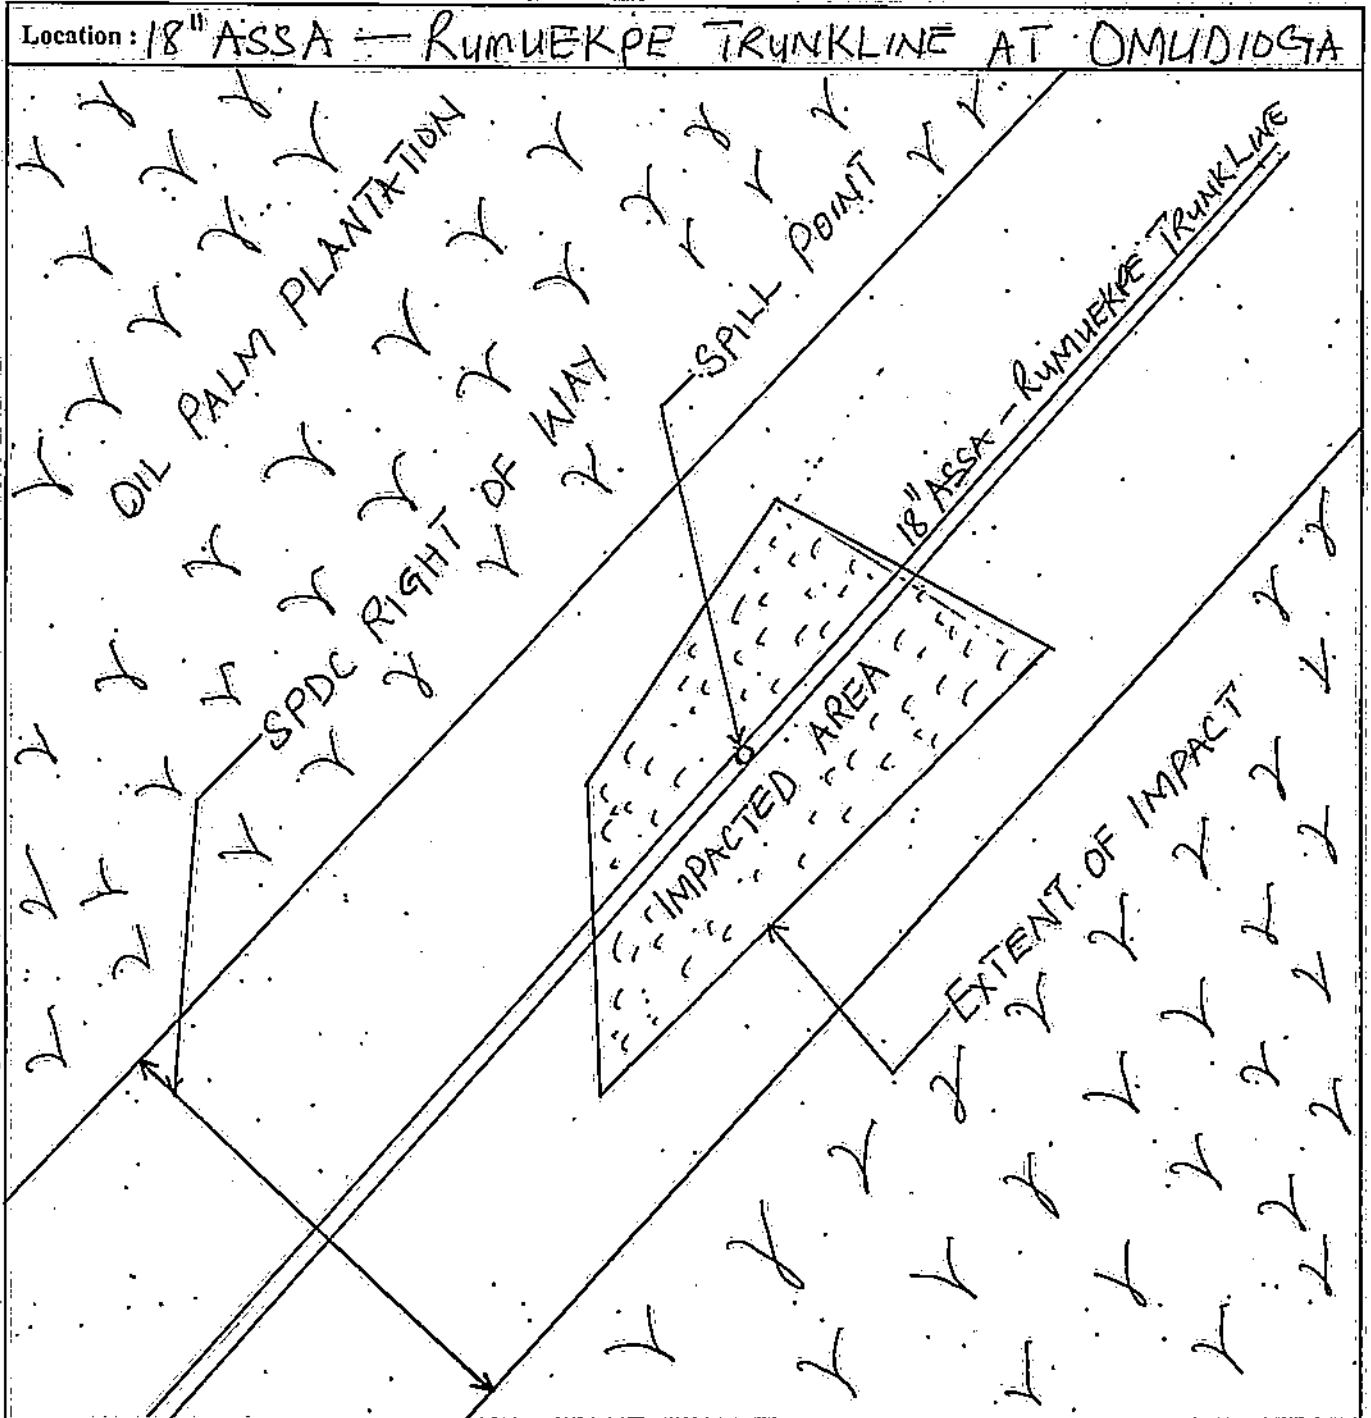
f. Appendix 1: Overview sketch of the site

Additional observations around the spill point: JIT OBSERVED THE FIFTH BOLT/NUT WAS TAMPERED WITH BY UNKNOWN PERSON(S).
